Problem Area

Date: 9-17-2024 Location: MPs 11.64 thru 18.18 Authorized workspace limits not visibly marked per Plan II.B.3. Correct within 7 days.

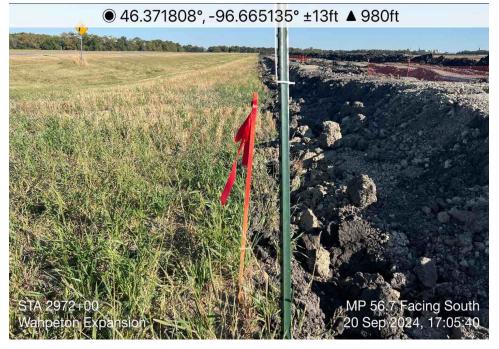
MP 56.70

Notes: Project material has been pulled back within staked approved workspaces at MP 56.70.

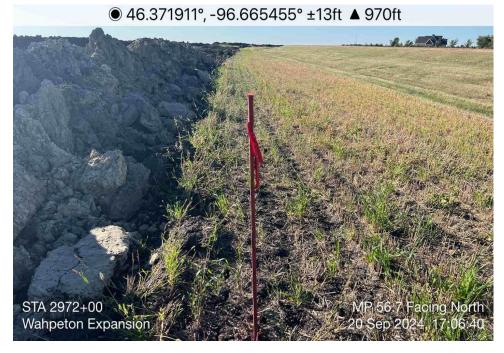
MP 56.70

Notes: Project material has been pulled back within staked approved workspaces at MP 56.70.

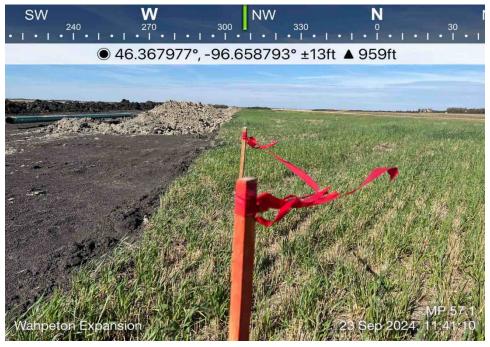
MP 57.10

Notes: On 9/19/2024, Project material was pulled back within staked approved workspaces at MP 57.10. The follow-up photo was taken on 9/23/2024.

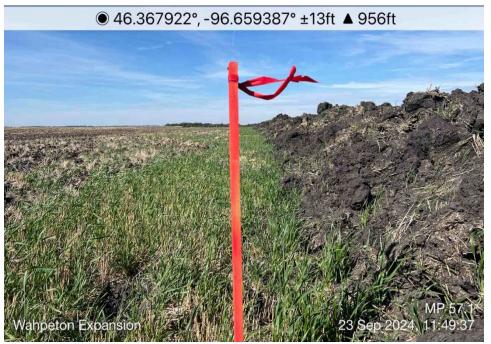
MP 57.10

Notes: On 9/19/2024, Project material was pulled back within staked approved workspaces at MP 57.10. The followup photo was taken on 9/23/2024.

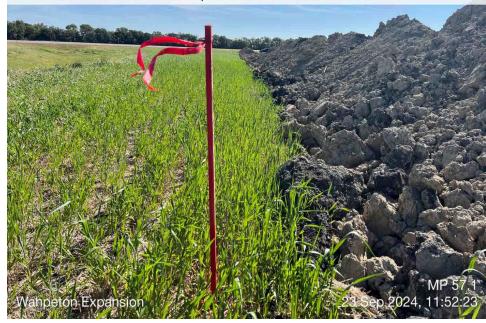
MP 57.10

Notes: On 9/19/2024, Project material was pulled back within staked approved workspaces at MP 57.10. The followup photo was taken on 9/23/2024.

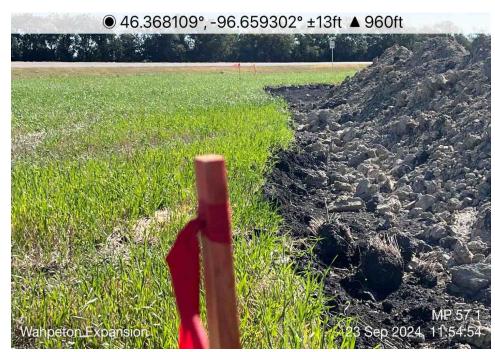
MP 57.10

Notes: On 9/19/2024, Project material was pulled back within staked approved workspaces at MP 57.10. The followup photo was taken on 9/23/2024.

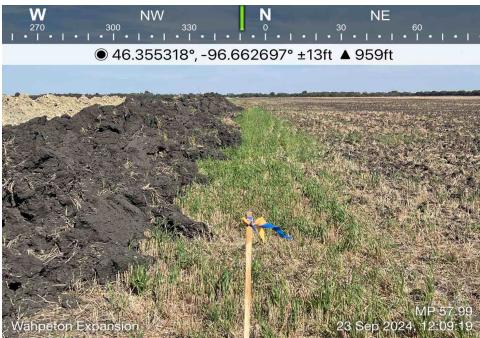
MP 57.99

Notes: On 9/19/2024, Project material was pulled back within staked approved workspaces at MP 57.99. The followup photo was taken on 9/23/2024.

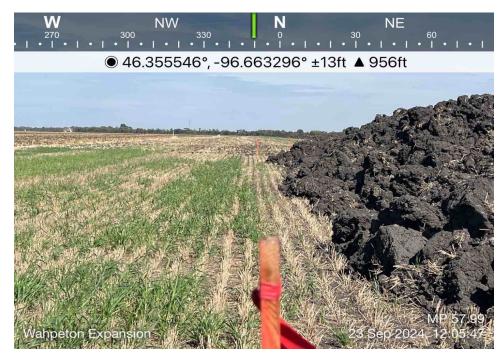
MP 57.99

Notes: On 9/19/2024, Project material was pulled back within staked approved workspaces at MP 57.99. The followup photo was taken on 9/23/2024.

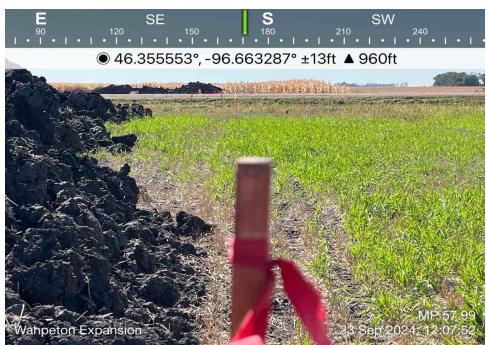
MP 57.99

Notes: On 9/19/2024, Project material was pulled back within staked approved workspaces at MP 57.99. The followup photo was taken on 9/23/2024.

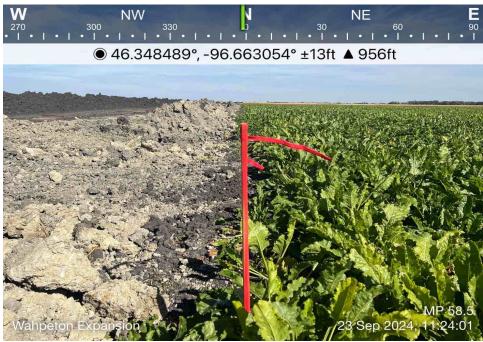
MP 58.50

Notes: On 9/19/2024, Project material was pulled back within staked approved workspaces at MP 58.50. The followup photo was taken on 9/23/2024.

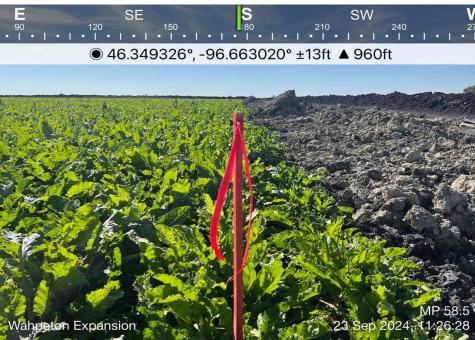
MP 58.50

Notes: On 9/19/2024, Project material was pulled back within staked approved workspaces at MP 58.50. The followup photo was taken on 9/23/2024.

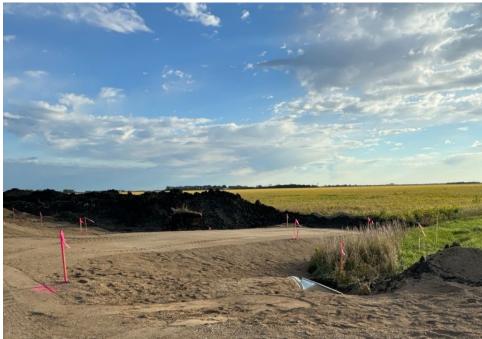
MP 11.70

Notes: Looking across Valve Site 2 pad and re-installed right-of-way markers at MP 11.70.

The right-of-way markers from MPs 11.64 thru 18.18 were reinstalled by September 22, 2024.

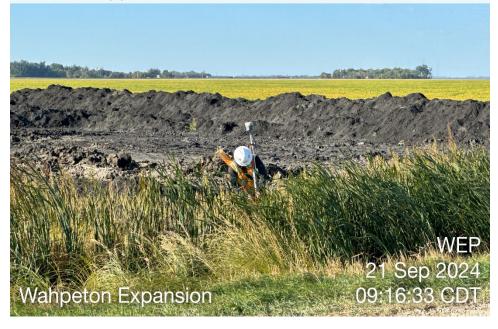
MP 15.74

Notes: Re-installing right-of-way markers MP 15.74.

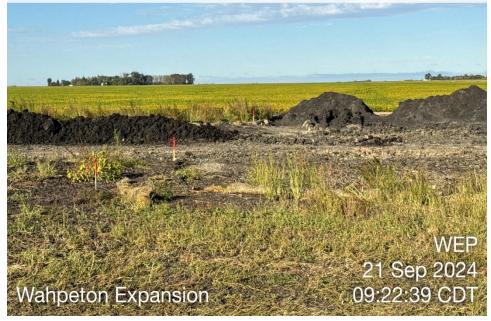
MP 15.88

Notes: Re-installed right-of-way markers at MP 15.88.

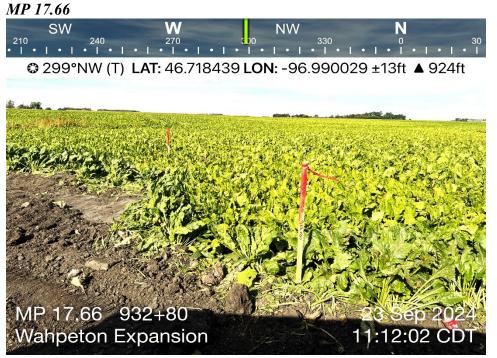
Notes: On 9/22/2024, reinstalled right-ofway markers at MP 17.66. The followup photo was taken on 9/23/2024.

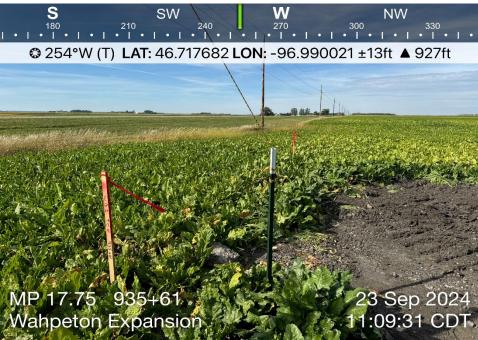
MP 17.75

Notes: On 9/22/2024, reinstalled right-ofway markers MP 17.75. The followup photo was taken on 9/23/2024.

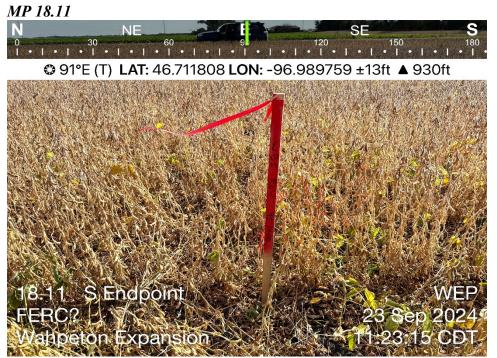
Notes: On 9/22/2024, reinstalled right-ofway marker at MP 18.11. The followup photo was taken on 9/23/2024.

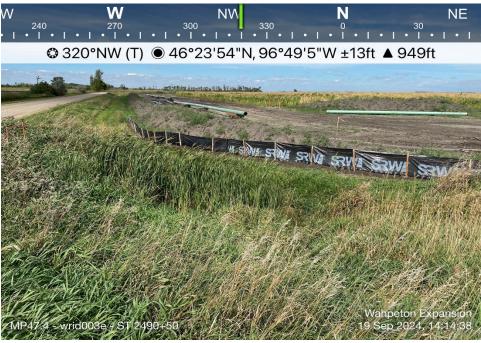
MP 47.40

Date: 9-18-2024 Location: MP 47.4 Temporary ECDs not installed along resources per Procedures V.B.10.b. Correct within 2 days.

Notes: Installed erosion control devices at MP 47.40.

On September 19, 2024, erosion control devices (straw wattles and silt fence) were installed adjacent to the resources (wetland wrid003e and waterbody srid001e) along the construction right-of-way. No sediment has been transported off the construction right-of-way into these resources.

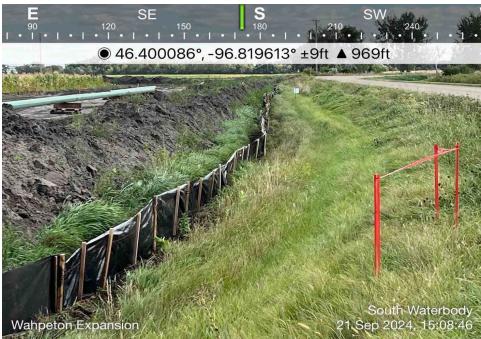
MP 47.40

Notes: On 9/19/2024, installed erosion control devices at MP 47.40. The followup photo was taken on 9/21/2024.

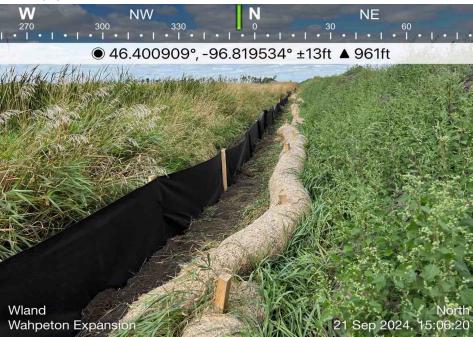
MP 47.40

Notes: On 9/19/2024, installed erosion control devices at MP 47.40. The followup photo was taken on 9/21/2024.

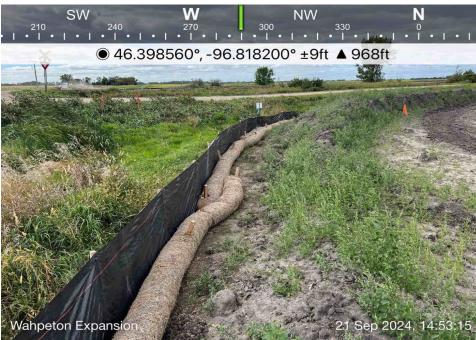
MP 47.40

Notes: On 9/19/2024, installed erosion control devices at MP 47.40. The followup photo was taken on 9/21/2024.
