## FEDERAL ENERGY REGULATORY COMMISSION FIELD INSPECTION REPORT

**Date** September 17 and 18, 2024

**Project** WBI Energy Transmission, Inc.  
Wahpeton Expansion Project  
Cass and Richland Counties, North Dakota  
Docket No.: CP22-466-000  
Authority: Section 7(c)

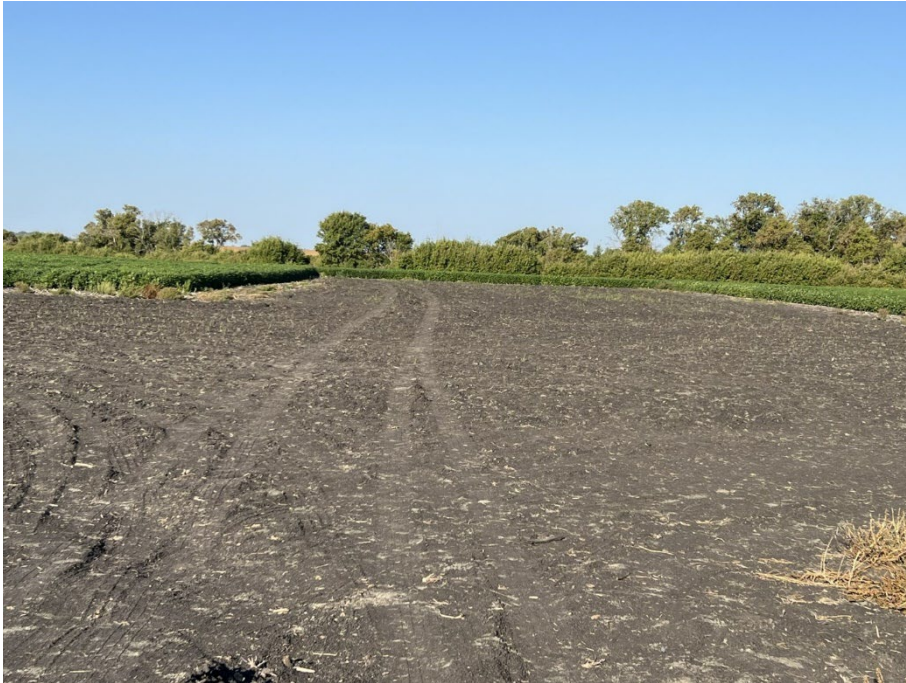
**Photo No.:** 1

**Comments:** Agricultural ROW, Bore #2 Site. Final grading was complete at the guided bore site and along the adjacent ROW. According to WBI, some additional decompaction may be needed. The area was free of rutting, large rock, and construction debris. Equipment mats remained in place at the construction entry point from the public roadway. The entry was well maintained, and the roadway was free of tracked mud and construction materials. No environmental concerns were identified.

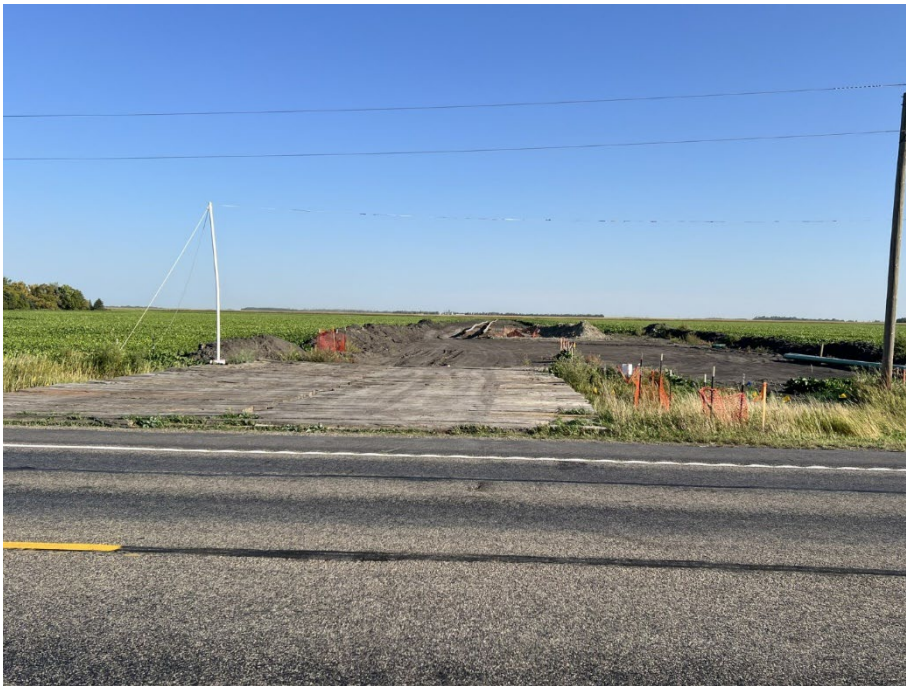
**Photo No.:** 2

**Comments:** Agricultural ROW, Bore #7 Site. Completion of the guided bore crossing was pending at this location. Safety measures at the construction entrance were in place, and the equipment mats at the entry point were properly installed and maintained. The public roadway was free of tracked mud and debris. No environmental concerns were identified.

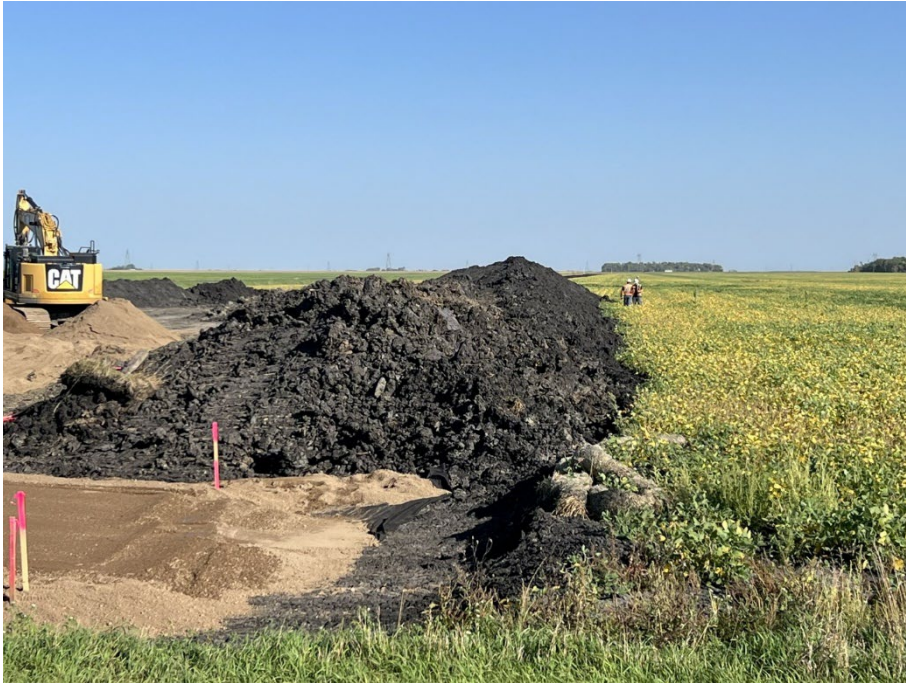
A second problem area was identified because of the lack of visual markers to identify approved workspace limits, per the FERC Plan, Section II.B.3. Instances of this were observed from approximately MP 11.64 through MP 18.18 (Photo Nos. 3, 4, and 5). There did not appear to be any construction activities or materials outside the approved workspace limits, but the workspace limits could not be clearly determined. A contractor was observed removing wooden stakes from the ROW edge near MP 18.30, reportedly per landowner request. In response, WBI immediately instructed the contractor to stop removing markers along workspace limits and to begin re-installing markers, where needed.

**Comments:** Agricultural ROW, Valve Set #2 Site. Survey crews were reinstalling stakes and flagging along approved workspace limits along the active construction area. A problem area was issued for the lack of visual markers to identify approved workspace limits, per the FERC Plan, Section II.B.3. Instances of this were observed from approximately MP 11.64 through approximately MP 18.18. It did not appear that any construction activities or materials were outside the approved workspace limits.

Date	Location (MP Station No., etc.)	Problem Area(s)	Correct Within	
			24 hrs	Other
9-17-24	~ 11.64 THRU 18.18	AUTHORIZED WORKSPACE LIMITS NOT VISIBLY MARKED PER PLAN II-B.3		7-DAYS
9-18-24	47.4	TEMP ECD'S NOT INSTALLED ALONG RESOURCES PER PROCEDURES V.B.10.b		2-DAYS

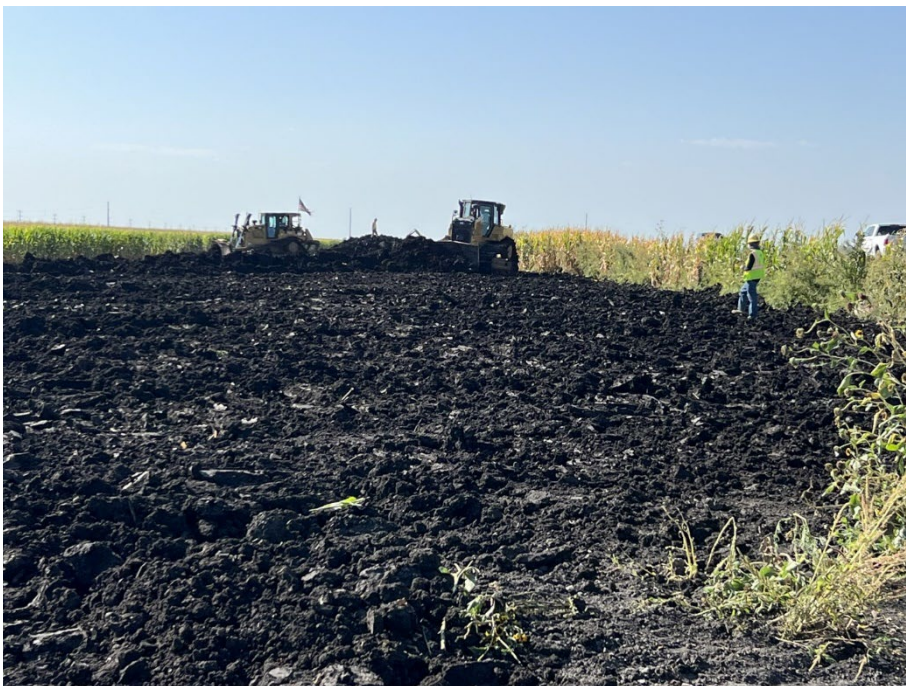
**Photo No.:** 4

**Comments:** Agricultural ROW. Rough grading was in progress along the ROW. Spotters were present to monitor the work, but the approved workspace limits were not clearly marked, per the FERC Plan, Section II.B.3, to ensure construction activities and materials would not exceed approved workspace limits. It was not possible to determine whether any construction activities or materials were outside the approved workspace limits.

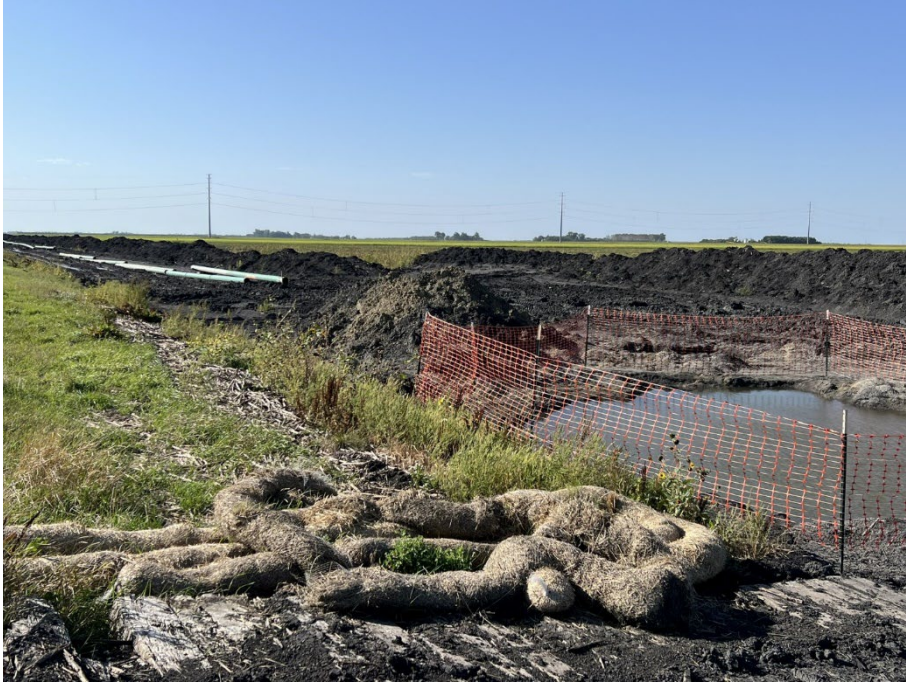
**Photo No.:** 5

**Comments:** Agricultural and Open ROW, Bore #23 Site. Pipe segments were staged along the ROW from approximately MP 14.75 through MP 15.70, pending dryer site conditions needed to complete welding and pipe installation, according to WBI. Construction materials and topsoil were staged along the edge of the ROW, but the approved workspace limits were not clearly marked, per the FERC Plan, Section II.B.3.

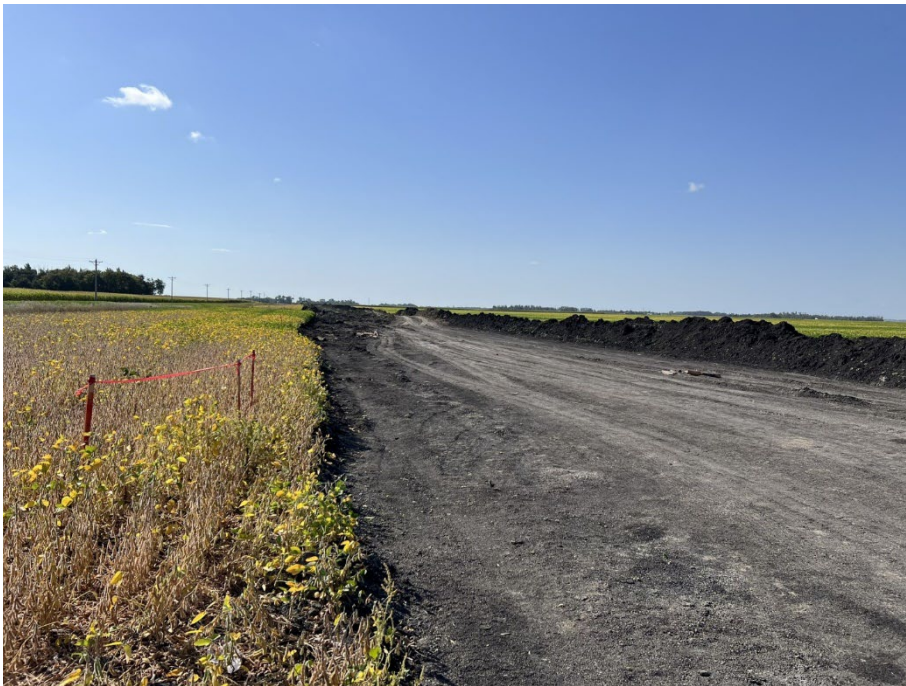
**Photo No.:** 6

**Comments:** Agricultural ROW. Trench backfilling was complete, and approved workspace limits along this section of the ROW were marked with wooden stakes and flagging. Topsoil was properly segregated and staged along the edge of the ROW. Nearby to the north, a contractor was observed removing wooden stakes from the ROW edge. WBI immediately instructed contractors to stop removing markers along workspace limits and to begin re-installing markers, where needed.

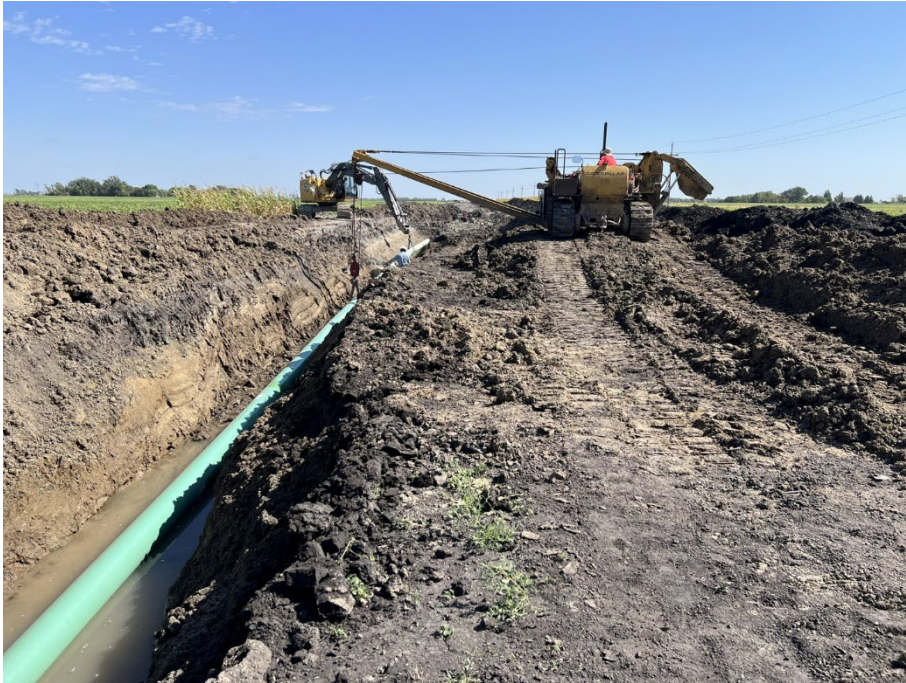
**Photo No.:** 7

**Comments:** Agricultural ROW, Bore #34 Site. Crews were completing tie-in work at the bore site. Topsoil was properly segregated and staged within approved workspace limits that were clearly marked with stakes and flagging. No construction activity or materials were observed outside of approved workspace limits. No environmental concerns were identified.

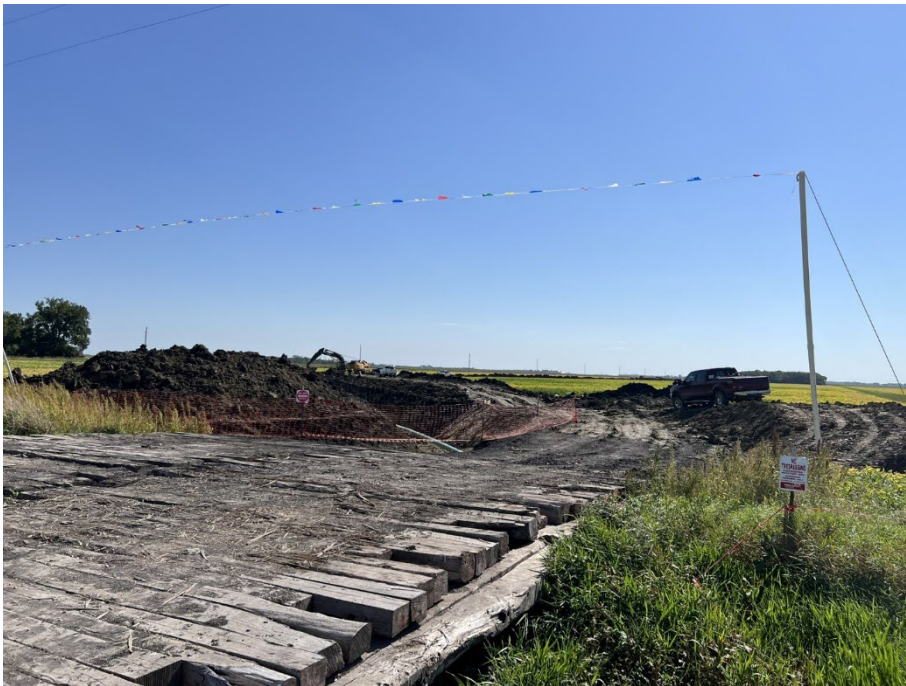
**Photo No.:** 8

**Comments:** Agricultural ROW, Bore #38 Site. Contractors were completing tie-ins at the bore site. Topsoil was properly segregated, and all construction materials and activities were within well-marked workspace limits. Equipment mats at the construction entry point were well maintained, and the adjacent public roadway was free of tracked mud and construction debris. No environmental concerns were identified.

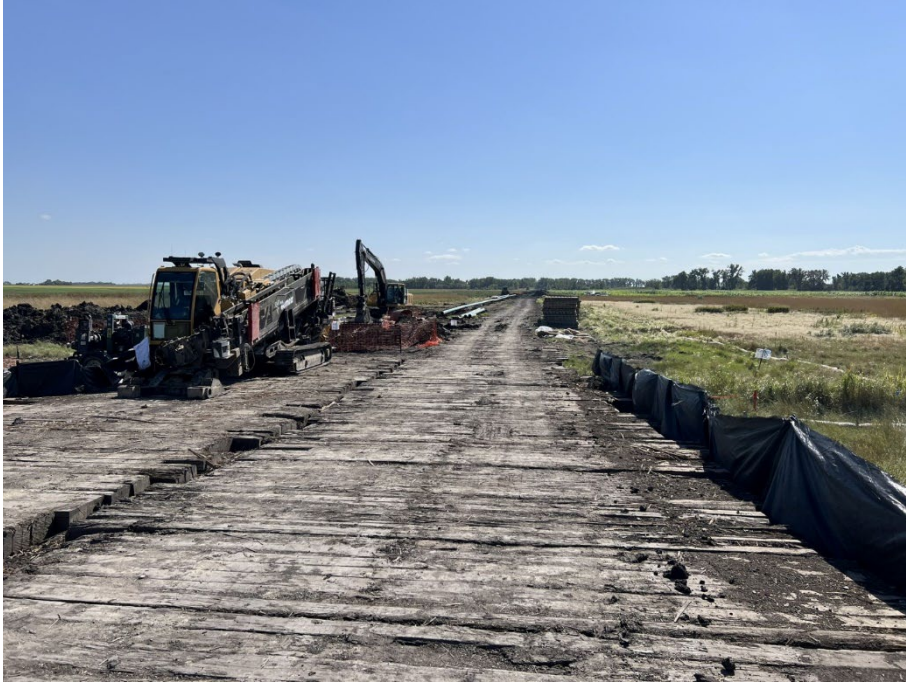
**Photo No.:** 9

**Comments:** Agricultural ROW, Bore #41 Site, Wetland wrib007e. A crew was completing the guided bore road crossing. Equipment mats and ECDs were properly installed and maintained. Workspace limits were well marked, and resource identification signs were in place. Construction materials staged within the wetland along the west edge of the equipment mats were within a temporary workspace in the resource that was approved by the FERC. No environmental concerns were identified.

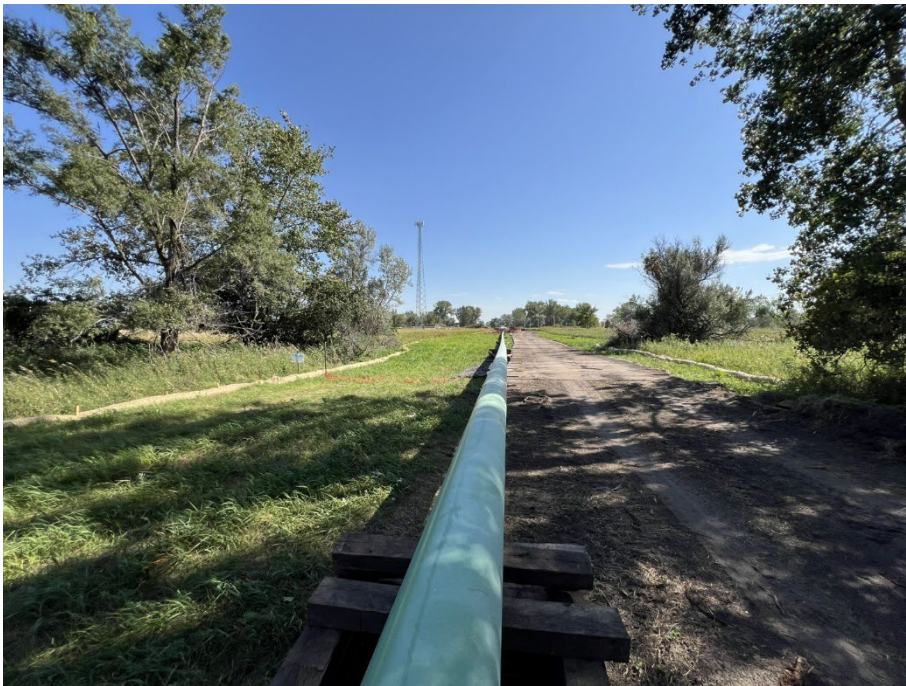
**Photo No.:** 10

**Comments:** Agricultural ROW, Wetland wrib019e. Pipe was welded and staged along the ROW and wetland. Work along this area was on hold due to the presence of several migratory bird nests. Installed ECDs and equipment mats were well maintained. Resource protection signs were in place along the wetland edge. Inspection participants discussed the importance of installing additional ECDs along the toe of slope at the wetland boundary across the ROW prior to grading in the area.

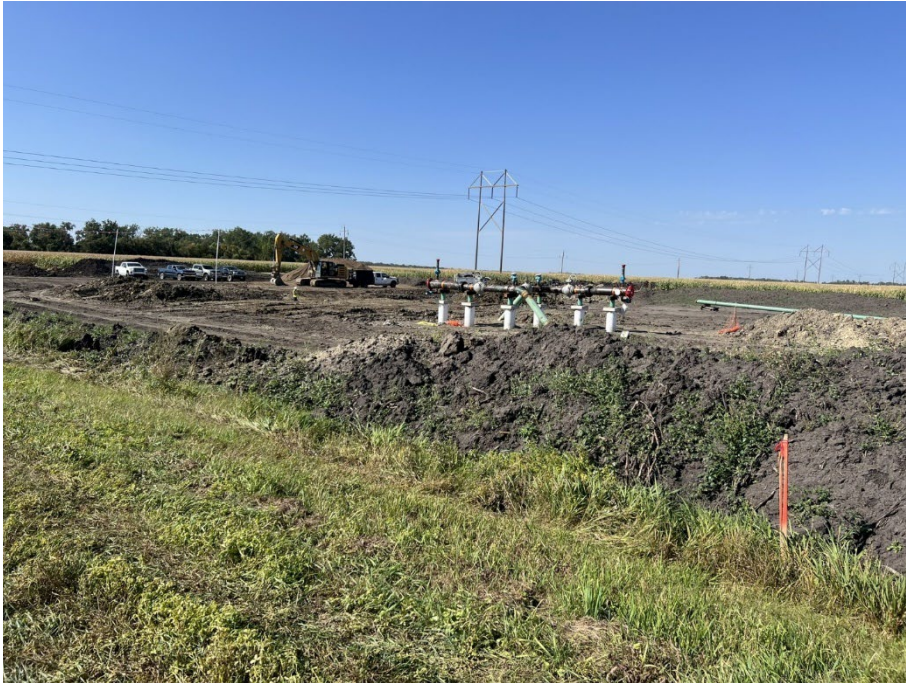
**Photo No.:** 11

**Comments:** Agricultural ROW, Valve Set #4 Site. The ROW and valve site were stable and free of excessive rutting and erosion. Topsoil was properly segregated and staged within workspace limits. Nearby, the trench was backfilled, and rough grading was complete. The adjacent construction access point from the public road was well maintained, and the roadway was free of tracked mud and construction debris. No environmental concerns were identified.

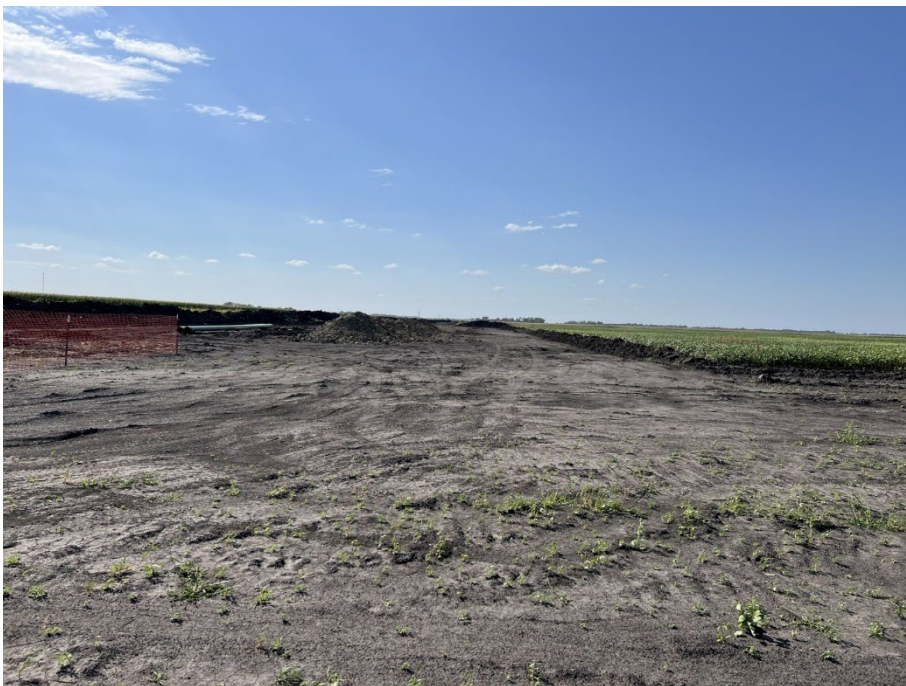
**Photo No.:** 12

**Comments:** Agricultural ROW, Bore #50 Site. Trench backfilling was pending at the guided bore tie-in, but was complete on the adjacent ROW to the west. Topsoil was segregated and staged along the ROW pending final restoration. Construction materials were within approved workspace limits, which were well marked with stakes and flagging. No environmental concerns were identified.

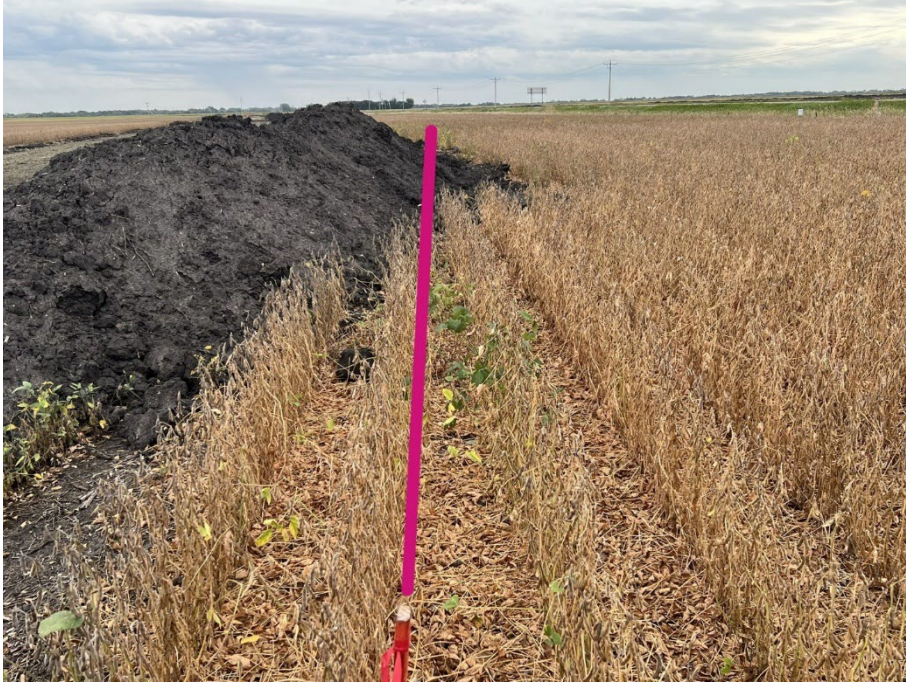
**Photo No.:** 13

However, one noncompliance was identified because of numerous observed instances along an approximately 16-mile-long section of ROW from approximately MP 42.10 through MP 58.50 where construction materials (including soil and construction materials and debris) were not contained within approved workspace limits per the FERC *Upland Erosion Control, Revegetation, and Maintenance Plan* (Plan), Section IV.A (Photo Nos. 13, 16, 18, 19, and 20).

**Comments:** Agricultural ROW. Topsoil was properly segregated along the edge of the ROW, pending final restoration, but a noncompliance was identified because soil was not contained within approved workspace limits, per the FERC Plan, Section IV.A. The trench was backfilled along the adjacent ROW, and rough grading was complete.

Date	Location (MP, Station No., etc.)	NONCOMPLIANCE(S)	Correct Within	
			24 hrs	Other
9-18-24	58.50 57.99 57.10 56.70	PROJECT-RELATED MATERIALS NOT CONTAINED WITHIN APPROVED		BEGIN RETURNING MATERIALS TO APPROVED AREAS ASAP
	52.95	WORKSPACE LIMITS PER PLAN IV.A		
	51.90	WIDESPREAD SOUTH OF I29		
	44.45			
	42.05

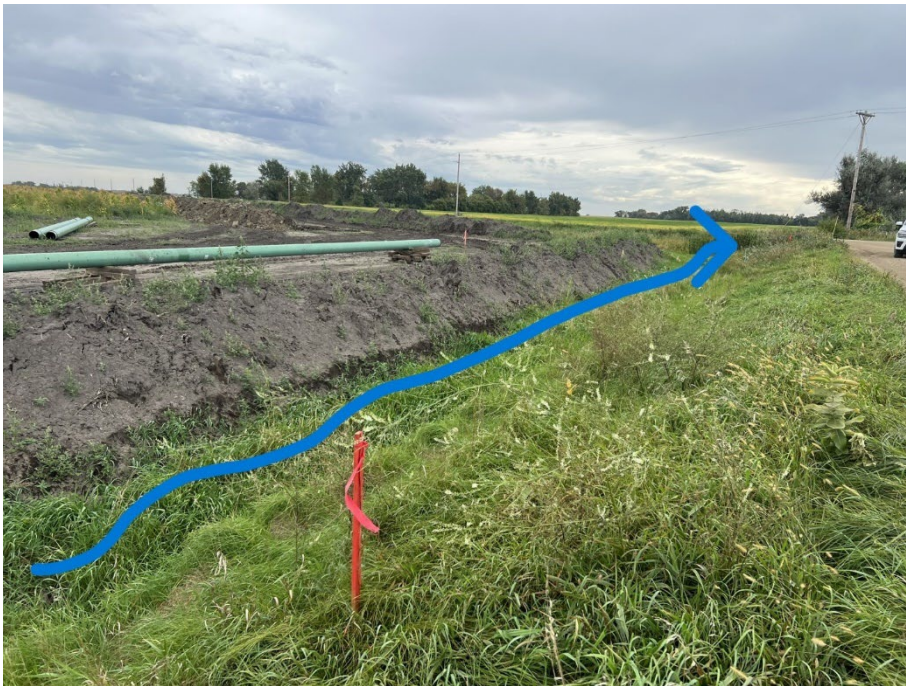
**Photo No.:** 14

Two problem areas were also identified. One problem area was identified at MP 47.40 because erosion control devices (ECDs) were not installed along the edge of the construction ROW to prevent sediment flow into nearby wetland and waterbody resources, as required by FERC *Wetland & Waterbody Construction & Mitigation Procedures* (Procedures), Section V.B.10.b. (Photo No. 14). No protected resources appeared to be impacted.

**Comments:** Agricultural ROW. Waterbody srid001e, Wetland wrid003e. ECDs were not in place, as required by FERC Procedures, Section V.B.10.b, leaving the area vulnerable to sediment movement from the staged topsoil into the wetland and stream. This created the potential for sediment to be transported beyond the approved workspace limits during future significant rainfall events.

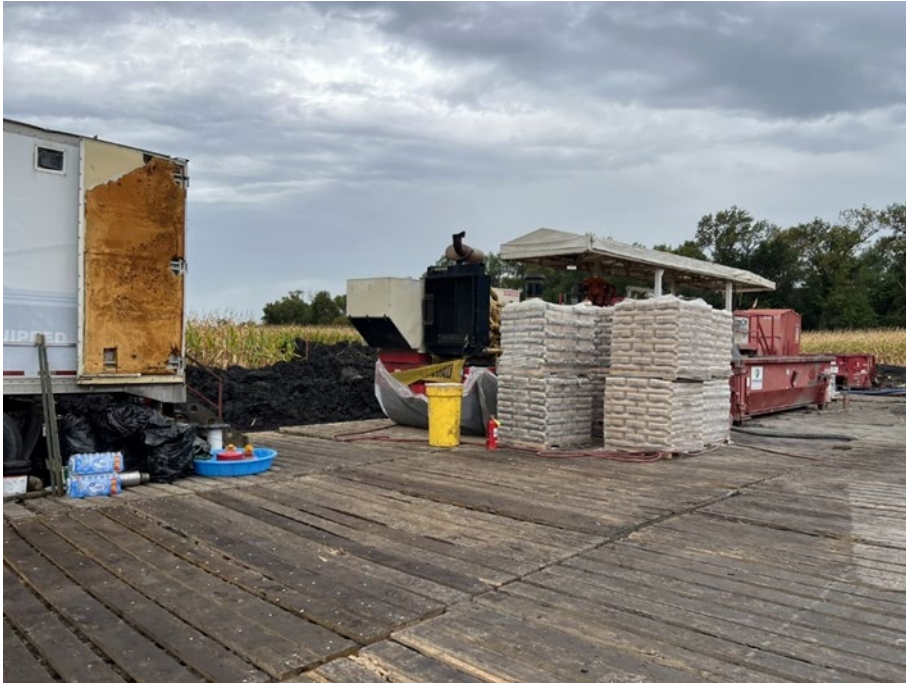
**Photo No.:** 15

**Comments:** Agricultural ROW, Bore #64 Site. Boring efforts at the Wild Rice River crossing entry site were on hold due to a bore hole collapse. All materials and equipment were within well-marked workspace limits. Hazardous materials and gas-operated pumps were stored within secondary containment, and spill kits were staged throughout the site. However, a nearby containment structure was noted to have a collapsed wall. No impacts were observed, and the structure was immediately replaced by WBI, prior to departing the site.

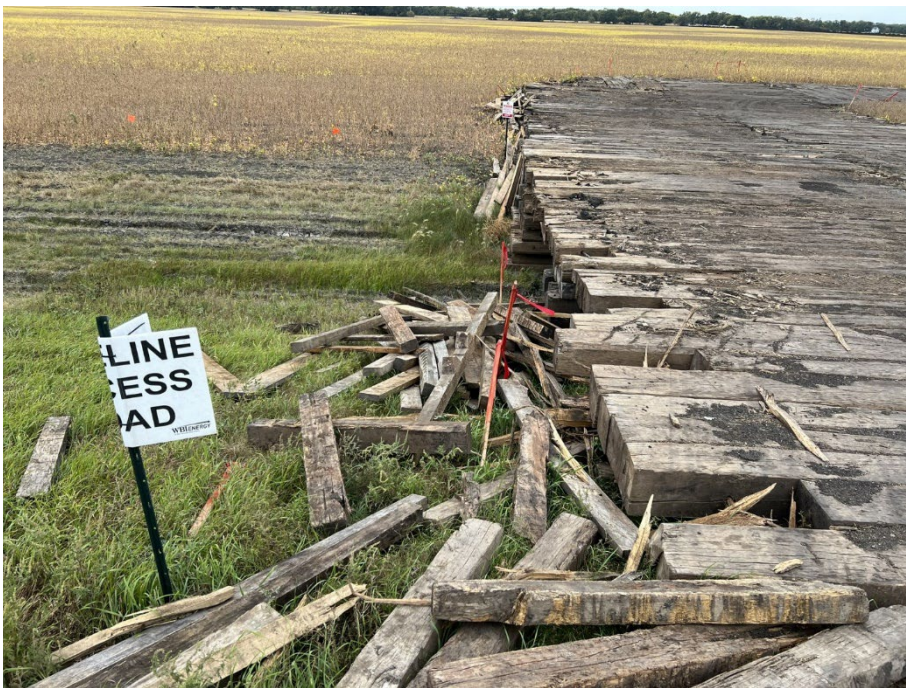
**Photo No.:** 16

**Comments:** Agricultural ROW, Temporary Access Road (AR) 56.1. A noncompliance was identified because construction materials were not contained within approved workspace limits, per the FERC Plan, Section IV.A. Elsewhere, the equipment mats were well maintained.

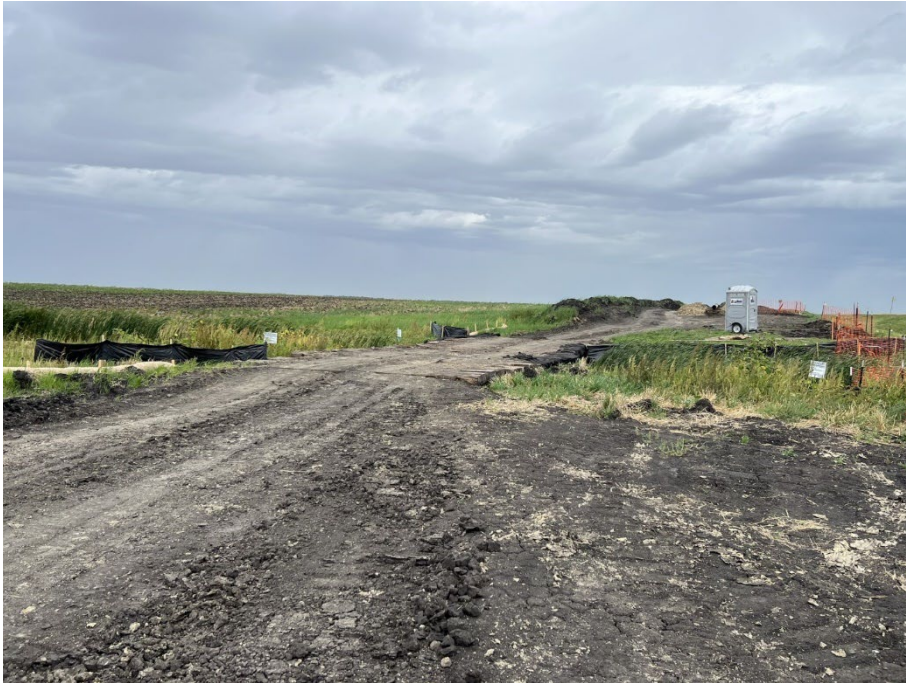
**Photo No.:** 17

**Comments:** Agricultural ROW, wrif001e. ECDs were installed and maintained along the wetland in this cultivated agricultural area. Inspection participants discussed the importance of inspection and maintenance of the geofabric material beneath the equipment mat crossing to ensure sediment would not be deposited into the resource and transported off-ROW. Resource identification signs were in place. The trench was backfilled on most of the adjacent ROW, and rough grading was complete.

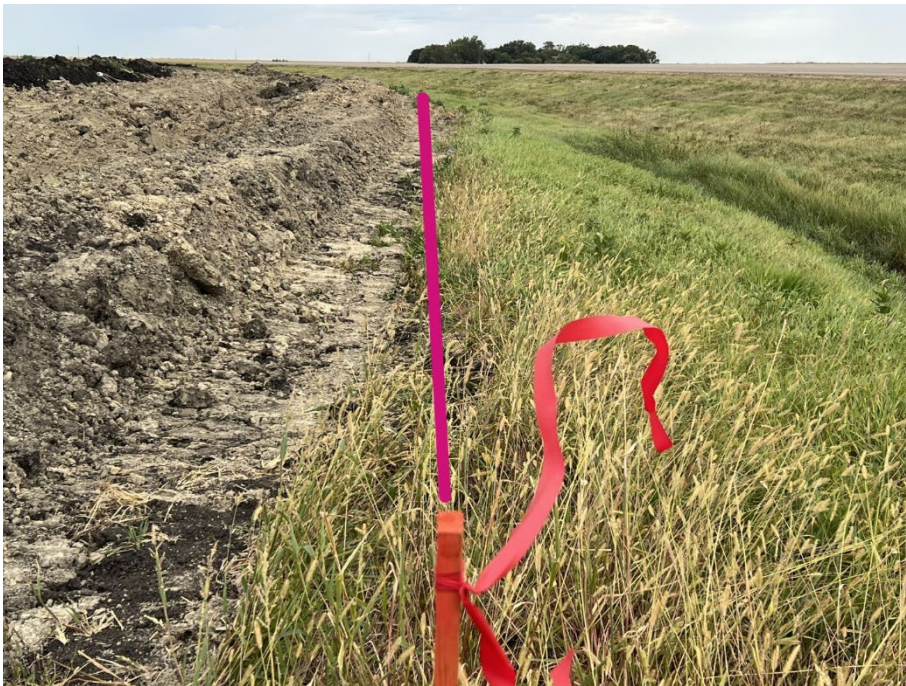
**Photo No.:** 18

**Comments:** Open ROW. The trench was backfilled along the ROW in this area. However, a noncompliance was identified because construction materials and equipment (based on track marks) were not contained within approved workspace limits, per the FERC Plan, Section IV.A.

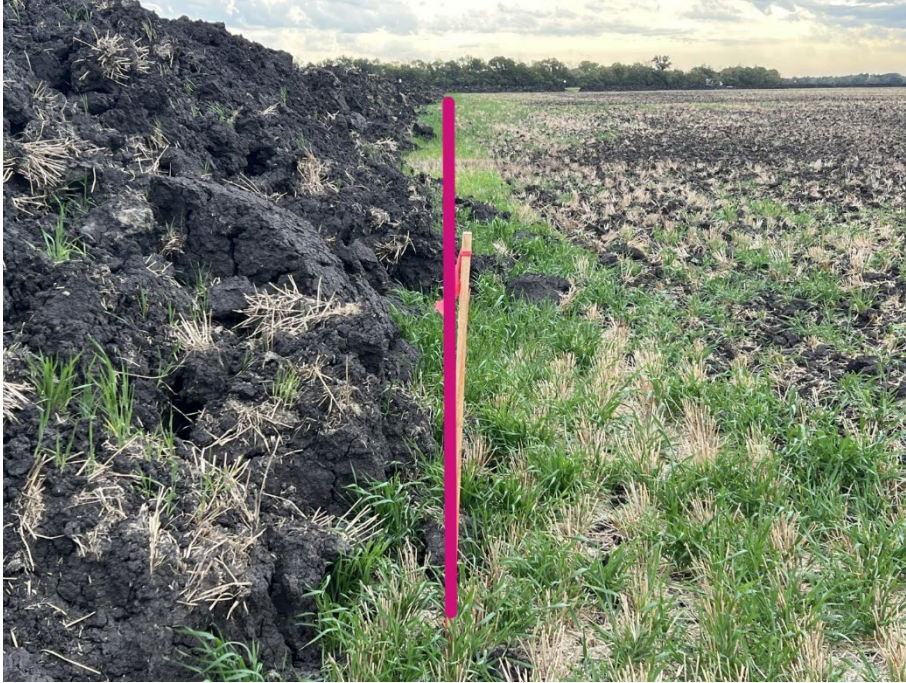
**Photo No.:** 19

**Comments:** Agricultural ROW. The trench was backfilled along the ROW. Topsoil was properly segregated and staged along the ROW edge, pending final restoration, but a noncompliance was identified because construction materials were not contained within approved workspace limits, per the FERC Plan, Section IV.A.

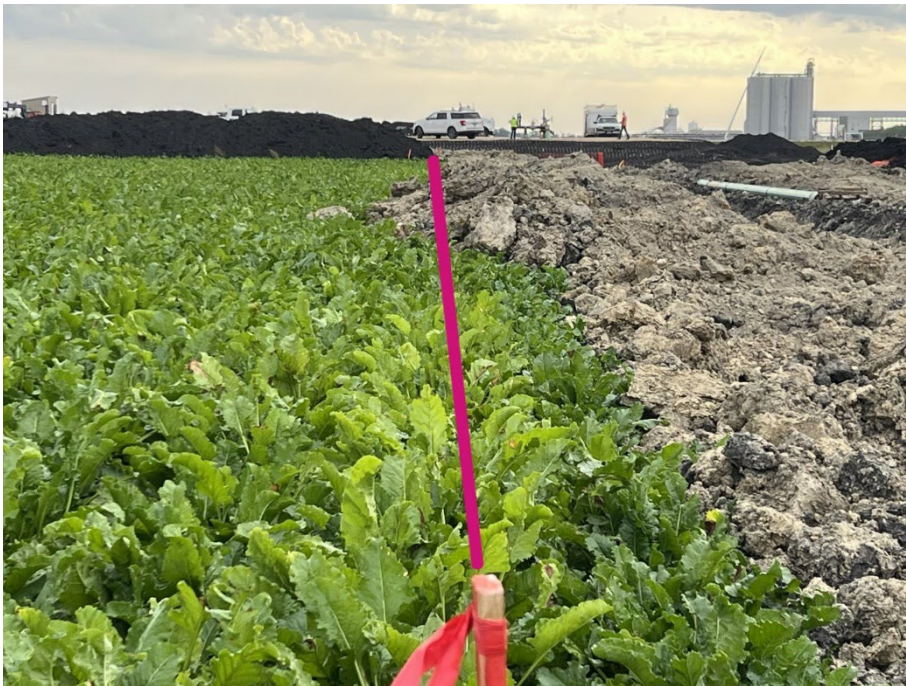
**Photo No.:** 20

**Comments:** Agricultural ROW, MDU-Wahpeton Border Station, Valve Set #7 Site. A noncompliance was identified because construction materials were not contained within approved workspace limits, per the FERC Plan, Section IV.A. At the adjacent station and valve site, pad installation was complete. Spill kits were present, and the road entry point was well maintained. Topsoil was properly segregated and staged within the site, but some soil was observed outside of the approved workspace limits.
