FEDERAL ENERGY REGULATORY COMMISSION FIELD INSPECTION REPORT

Date November 12 and 13, 2024

Project WBI Energy Transmission, Inc.
Wahpeton Expansion Project
Cass and Richland Counties, North Dakota
Docket No.: CP22-466-000
Authority: Section 7(c)

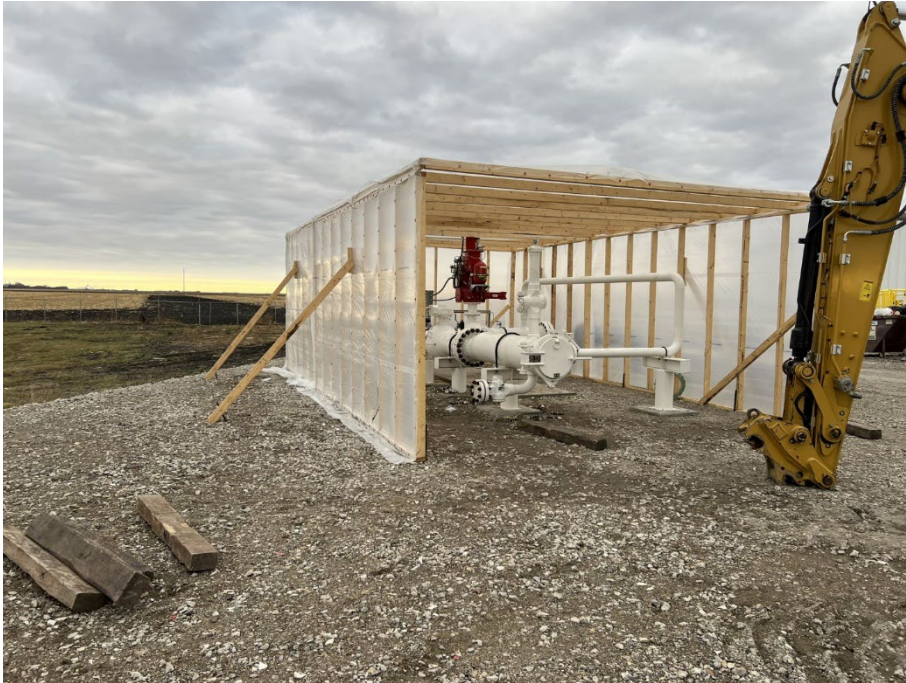
Photo No.: 1

Comments: Aboveground Facility, Valve #1 Site. Construction of the valve was complete, except for final connection of the spool. The adjacent ROW and temporary workspaces were restored, decompacted, and free of rutting, large rocks, and construction debris. The adjacent Wahpeton Station was mechanically complete. No environmental concerns were identified.

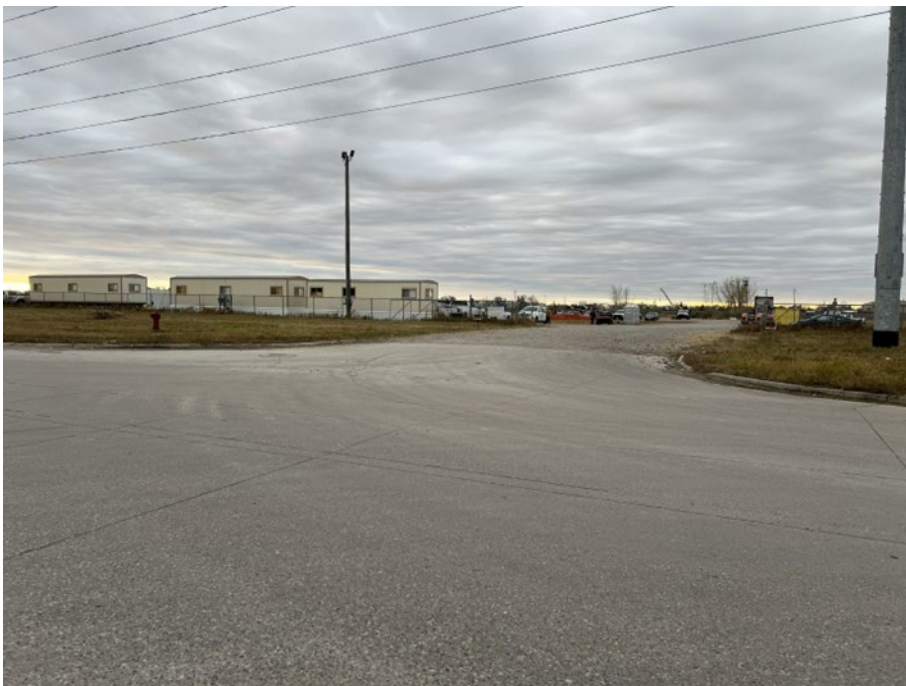
Photo No.: 2

Comments: Aboveground Facility, Contractor Yard. The entry to the existing contractor yard was well maintained, and the road was free of tracked mud and debris. The yard surface was stable and free of excessive rutting and erosion. According to WBI, construction equipment and materials would be removed from the yard, minor improvements would be made where needed, and the yard would be released back to the owner. No environmental concerns were identified.

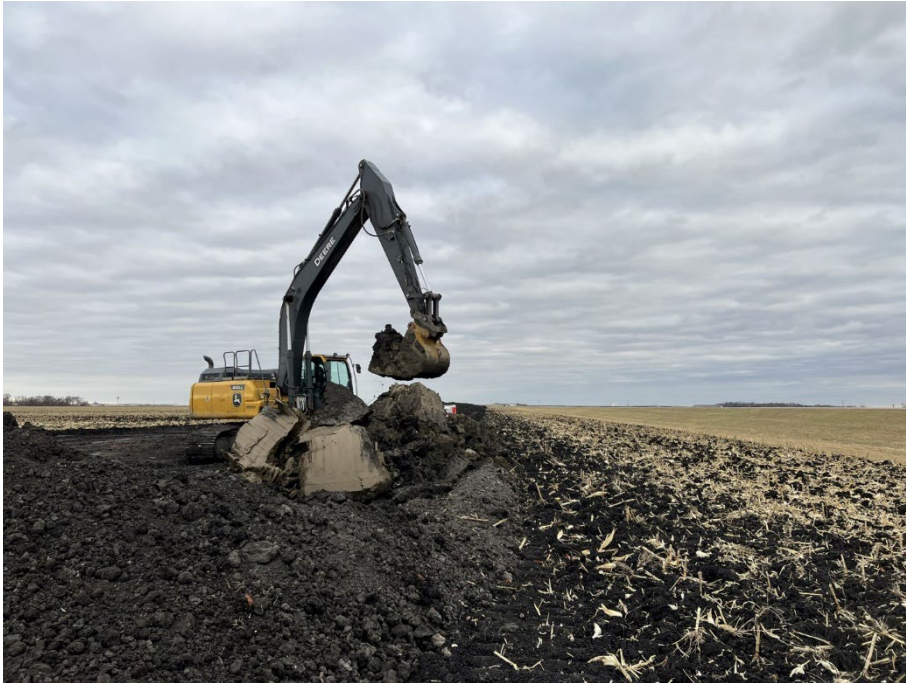
Photo No.: 3

According to WBI at the time of inspection, over 100 anomalies were recently identified in the installed pipeline, requiring contractors to re-enter previously restored (where topsoil had been reapplied) areas of the ROW (Photo Nos. 3, 4, 7, and 8). Anomalies were reportedly superficial in the pipe coating; therefore, removal of the pipe would not be necessary to complete the repairs. However, according to WBI, inspection for anomalies had not yet been completed on the segment of pipeline that was currently being hydrostatically pressure tested, south of approximately MP 49.00 to the Valve #7 site at MP 59.00. To assist with the in-service request assessment and evaluation of remediation and restoration efforts, WBI was asked to provide the inspector and FERC Project Manager with details on the number of anomalies to be addressed and to give periodic updates on the number of repairs completed.

Comments: Agricultural ROW. The ROW and temporary workspaces had been restored and decompacted, with no signs of rutting, large rocks, or construction debris. However, the area was subsequently re-disturbed to address an anomaly. A spotter was present but was observing the ROW side of the excavation and not the LOD where a small amount of material was observed beyond the LOD. The inspector reminded the spotter to monitor soil placement to ensure that construction materials remained within LOD.

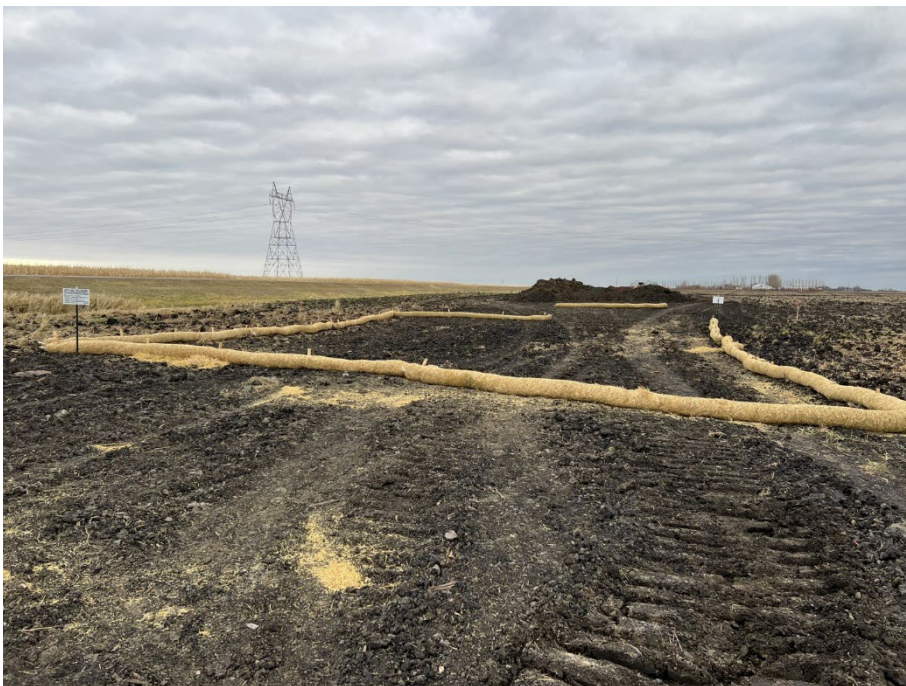
Photo No.: 4

Comments: Agricultural ROW, Agricultural Wetland wcaa005e. The ROW and temporary workspaces had been restored, but the area was subsequently re-disturbed to address an anomaly. ECDs were in place along an agricultural wetland while an anomaly repair was in progress nearby. ROW limits were marked with stakes and flagging in the active construction area, and resource identification flags were in place. No environmental concerns were identified.

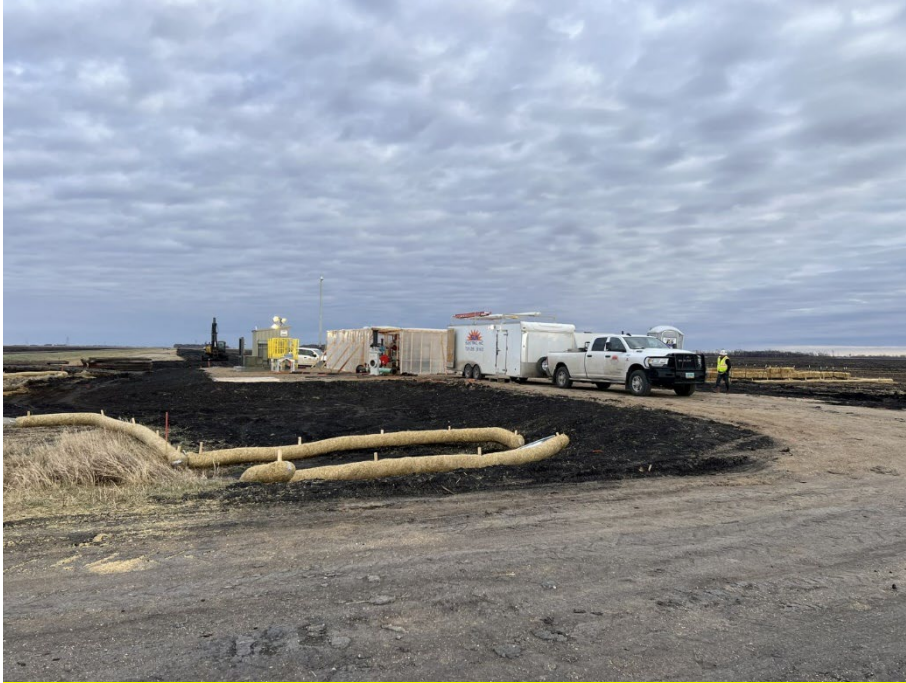
Photo No.: 5

Comments: Aboveground Facility, Valve #2 Site. Work at the valve site included pad construction, perimeter fence installation, valve settings and equipment painting, and final cleanup and restoration within and around the site. The dewatering structure appeared to be adequately designed, with no evidence of sediment release outside of the approved workspace. ECDs remained in place. The public road access points were well maintained, and WBI stated that the landowner requested that a temporary access road be left in place.

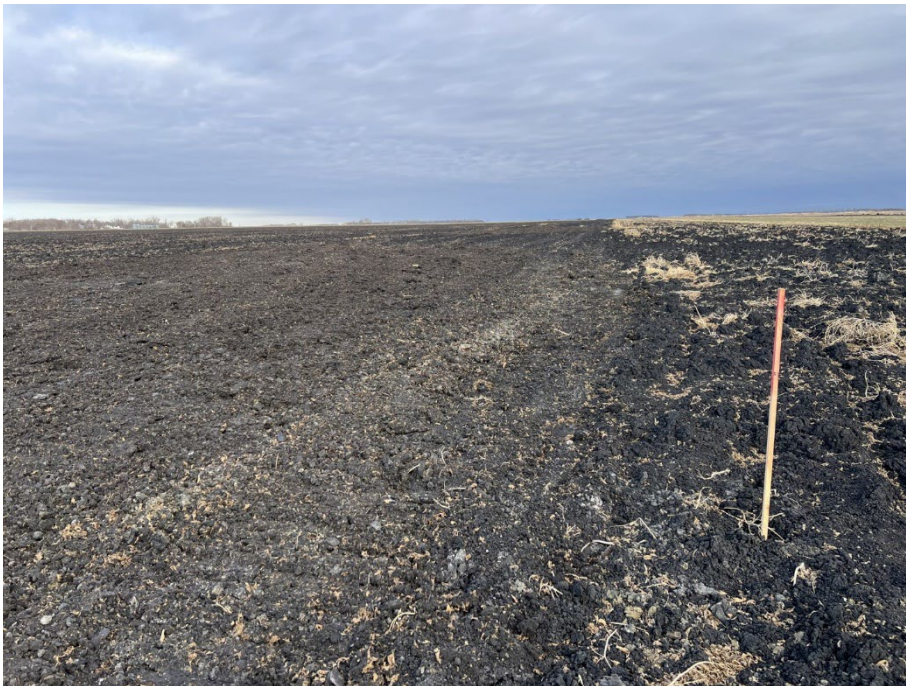
Photo No.: 6

Comments: Agricultural ROW. The ROW and temporary workspaces were restored, decompacted, and free of rutting, large rocks, and construction debris. Some wooden stakes remained in place along restored, flat, agricultural areas and would be removed upon landowner request as part of the final cleanup punch list items. No environmental concerns were identified.

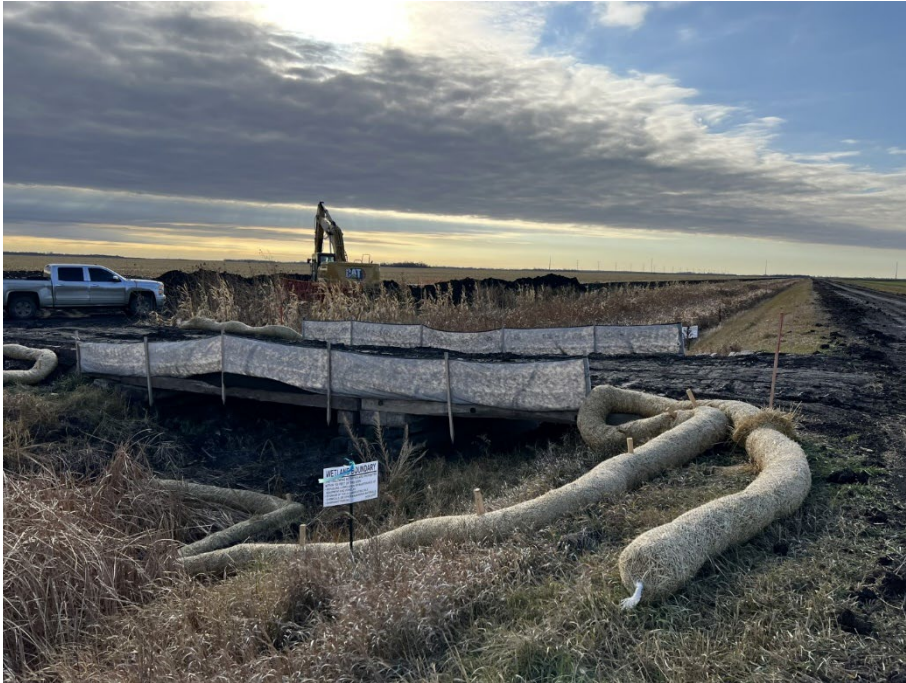
Photo No.: 7

Comments: Agricultural ROW. The road access point remained in place, pending completion of nearby anomaly repairs. Resource identification signs were in place, and the ROW limits in active construction areas were marked with stakes and flagging. The site was stable with no environmental concerns identified. The road entry point was well maintained, and, although somewhat muddy, conditions were similar to the adjacent unimproved public roadway.

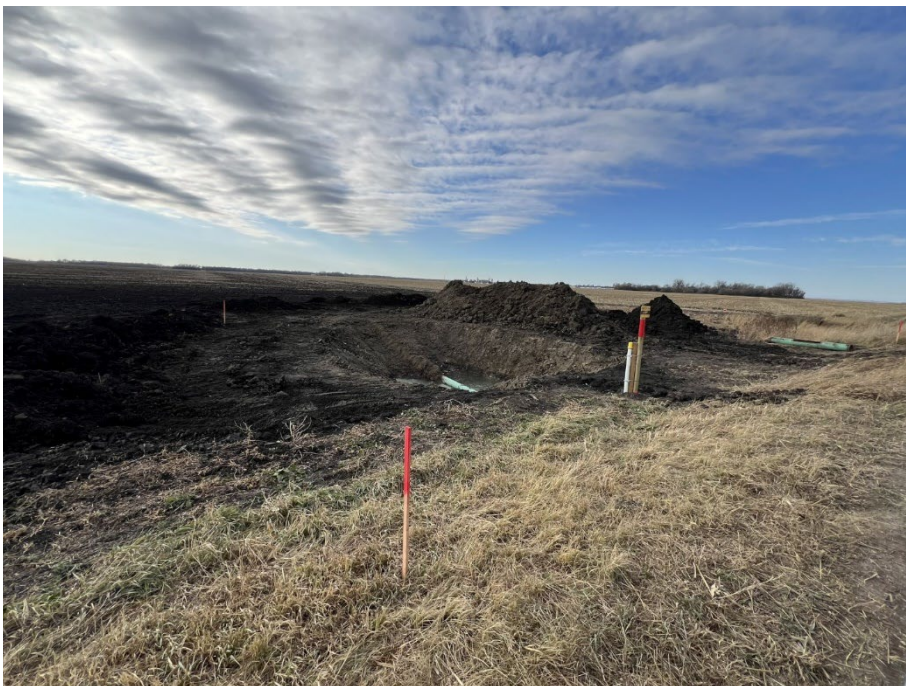
Photo No.: 8

Comments: Agricultural ROW. The ROW and temporary workspaces had been restored and decompacted, with no signs of rutting, large rocks, or construction debris. However, the area was subsequently re-disturbed to address an anomaly. ROW limits in active construction areas were marked with stakes and flagging. No environmental concerns were identified.

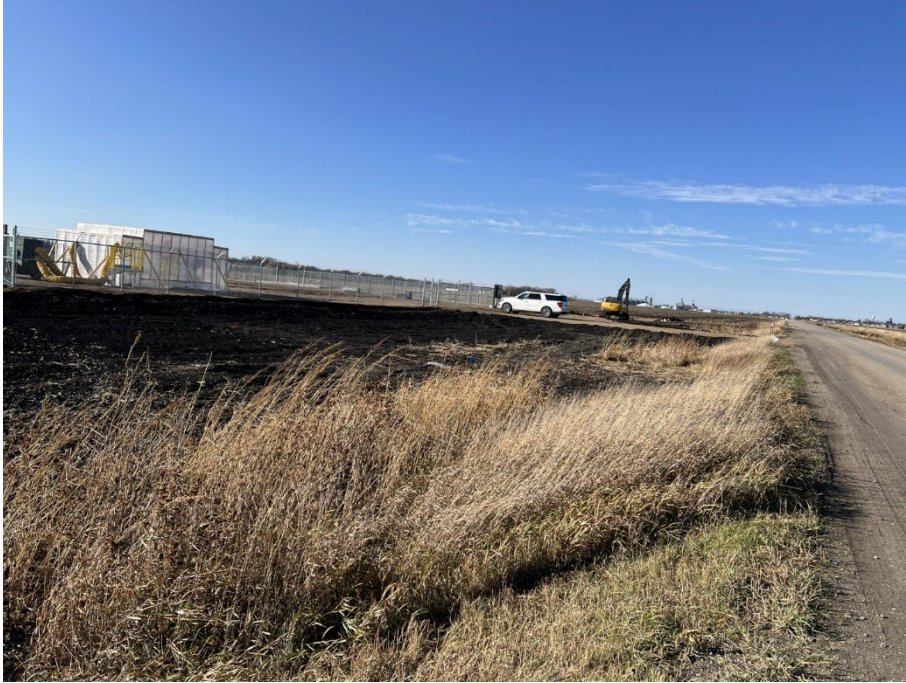
Photo No.: 9

Comments: Aboveground Facility, Valve #3 Site. Work at the valve site was nearing completion, with only minor pad stabilization, painting, and restoration of small areas within the temporary workspace remaining. An anomaly repair was underway on the nearby restored ROW. The access point to the public roadway was well maintained, with no tracked mud or construction materials present on the road. No environmental concerns were identified.

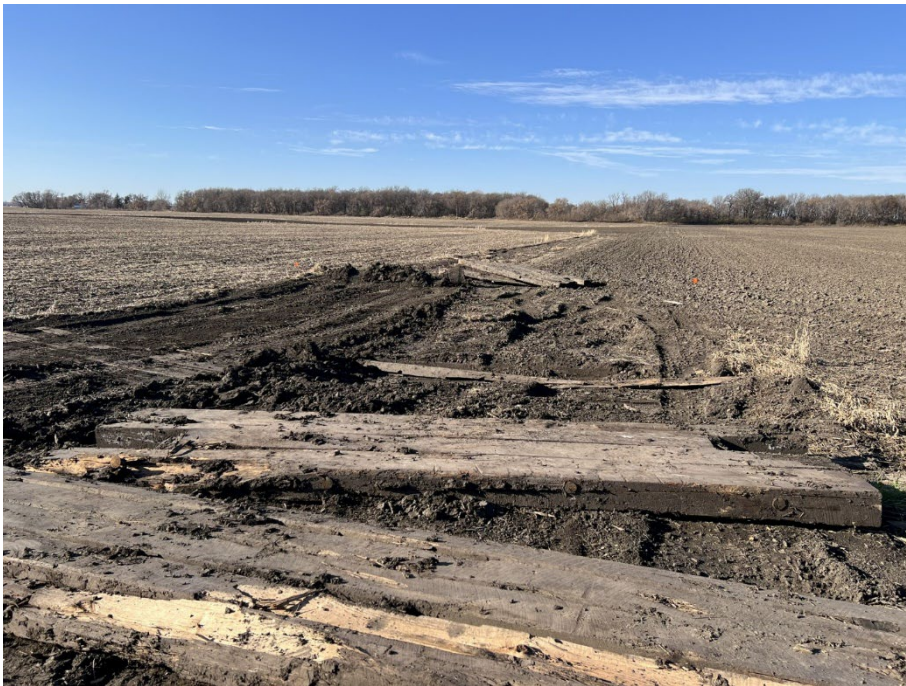
Photo No.: 10

Most construction debris and equipment had been cleared from restored areas; however, some materials remained staged at access points near public roadways (Photo No. 10, 12, 20, and 21). WBI stated that these materials would be removed, with the areas restored once it was confirmed that no further entry would be required for anomaly repairs. ECDs, including silt fence, hay bales, and fiber logs, remained in place in wooded, well-vegetated areas near the Wild Rice River crossing, where inadvertent releases (IR) of drilling mud had occurred (Photo No. 18). The IR sites appeared to have been adequately contained, with released materials removed in compliance with WBI's Guided Bore Drilling Fluid Monitoring and Operations Plan. Consequently, WBI was directed to remove ECDs at all IR locations that were sufficiently stabilized as part of ongoing cleanup efforts at the Antelope Creek and Wild Rice River HDD sites.

Comments: Agricultural ROW. The ROW and temporary workspaces were restored, decompacted, and free of rutting, large rocks, and construction debris, except near the access point to the public roadway. According to WBI, construction debris and materials would be removed and the area restored pending confirmation that no re-entry would be needed into the area for anomaly repair.

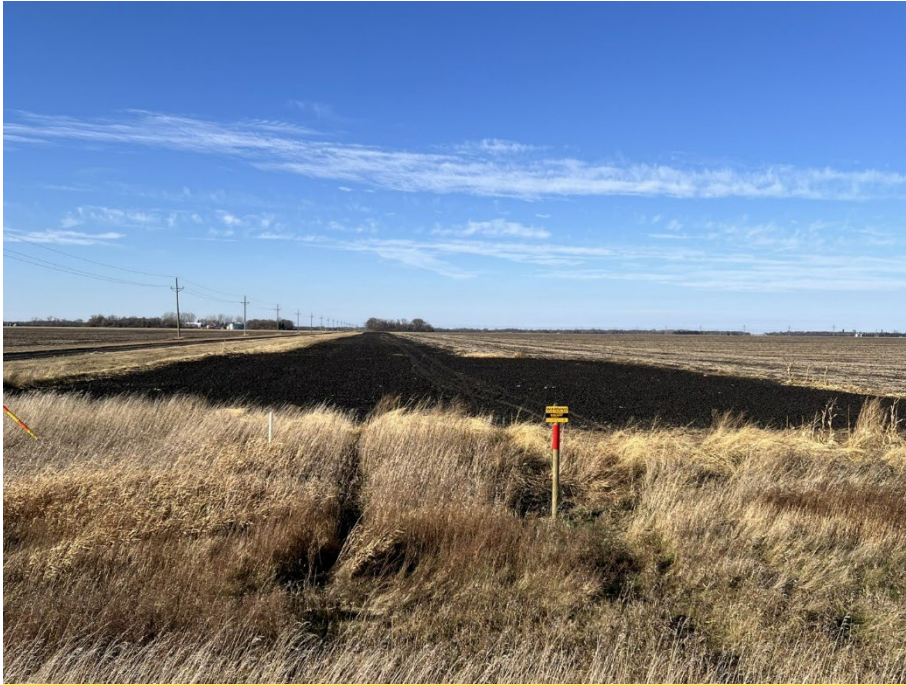
Photo No.: 11

Comments: Agricultural ROW. The ROW and temporary workspaces were restored, decompacted, and free of rutting, large rocks, and construction debris. According to WBI, some ECDs remained in place at low-lying areas along the edge of the ROW and would be removed upon landowner request as part of the final cleanup punch list items. No environmental concerns were identified.

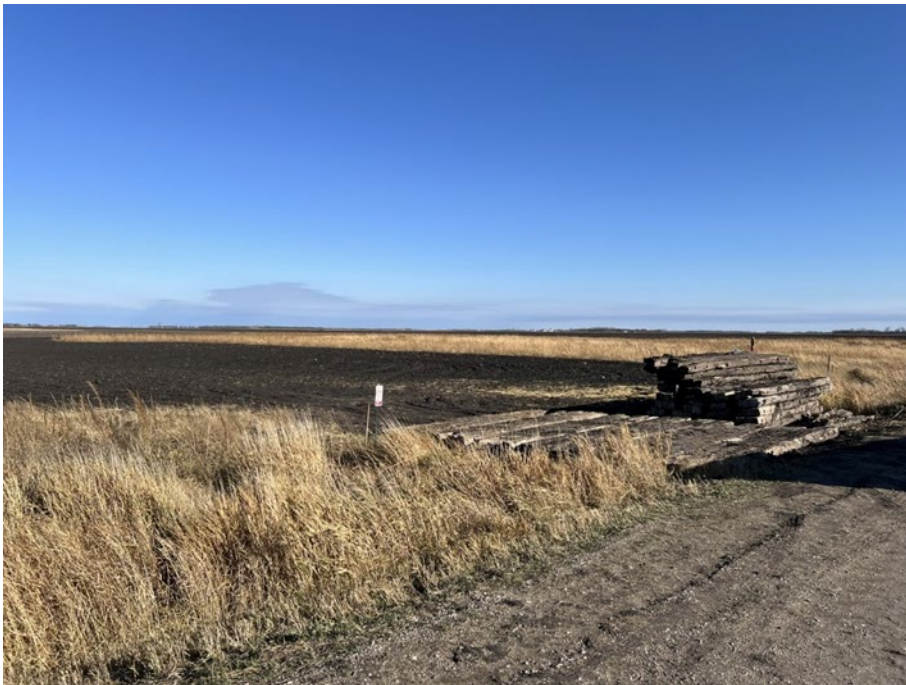
Photo No.: 12

Comments: Agricultural ROW. The ROW and temporary workspaces were restored, decompacted, and free of rutting, large rocks, and evidence of erosion. According to WBI, the construction materials and access point onto the adjacent unimproved public road would be removed and the area restored once confirmation was received that no further re-entry for anomaly repair would be required.

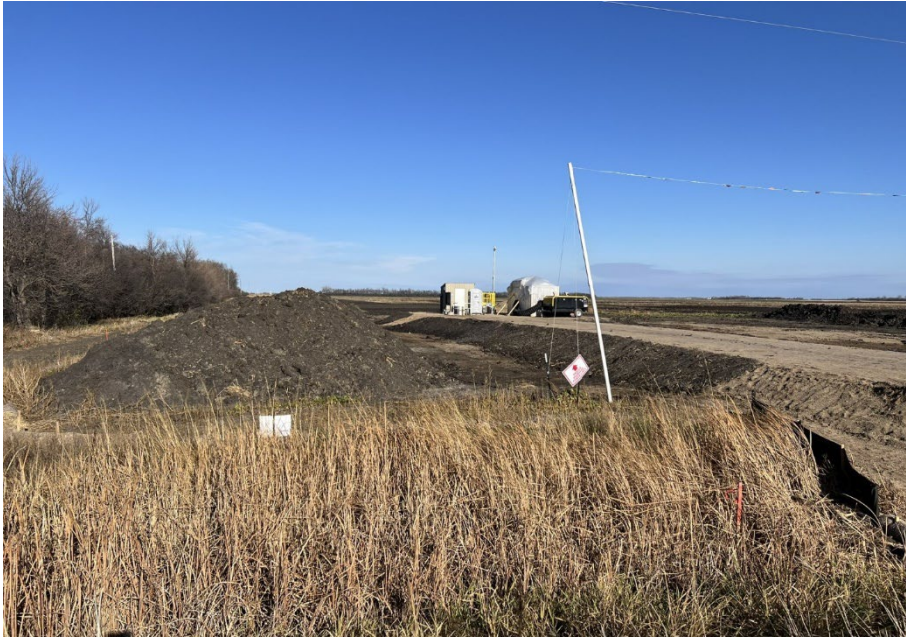
Photo No.: 13

Comments: Aboveground Facility, Valve #4 Site. Work at the valve site included pad construction, perimeter fence installation, valve settings and equipment painting, and final cleanup and restoration within and around the valve site. Workspace limits were well marked, and topsoil remained properly segregated and staged within workspace limits. ECDs were in place around the staged topsoil. The adjacent ROW was restored. No environmental concerns were identified.

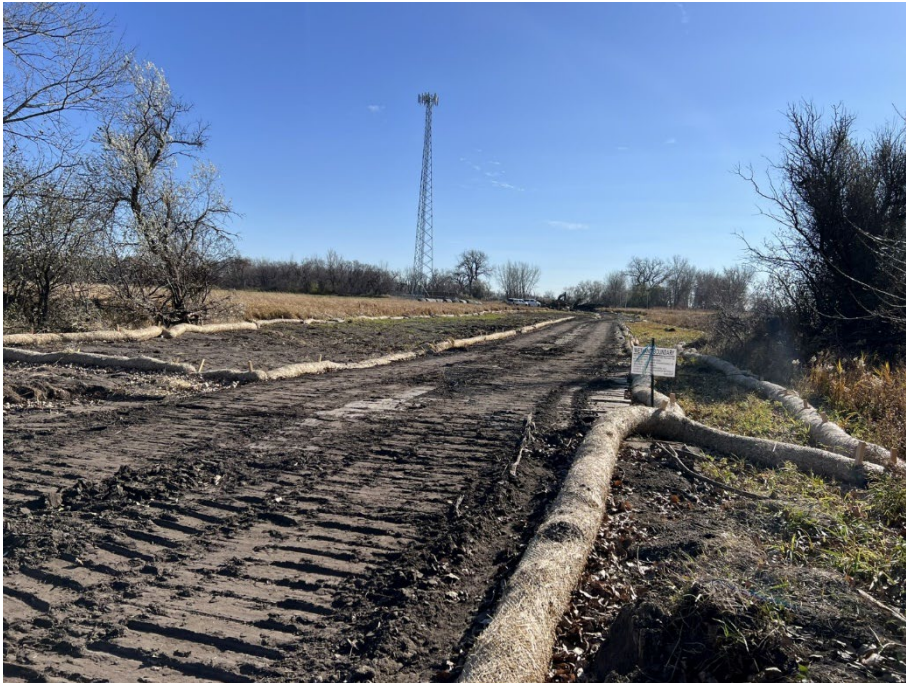
Photo No.: 14

Comments: Forested ROW, Wetland wria006e. Cleanup and restoration were in progress along this section of ROW from MP 35.60 to 36.80; where construction had been delayed due to migratory bird restrictions. Resource identification signs were in place. ECDs were installed and were well maintained. Protective mats were in place to prevent rutting within the resource and were installed in a manner that prevented upland soil from entering the resource. No environmental concerns were observed.

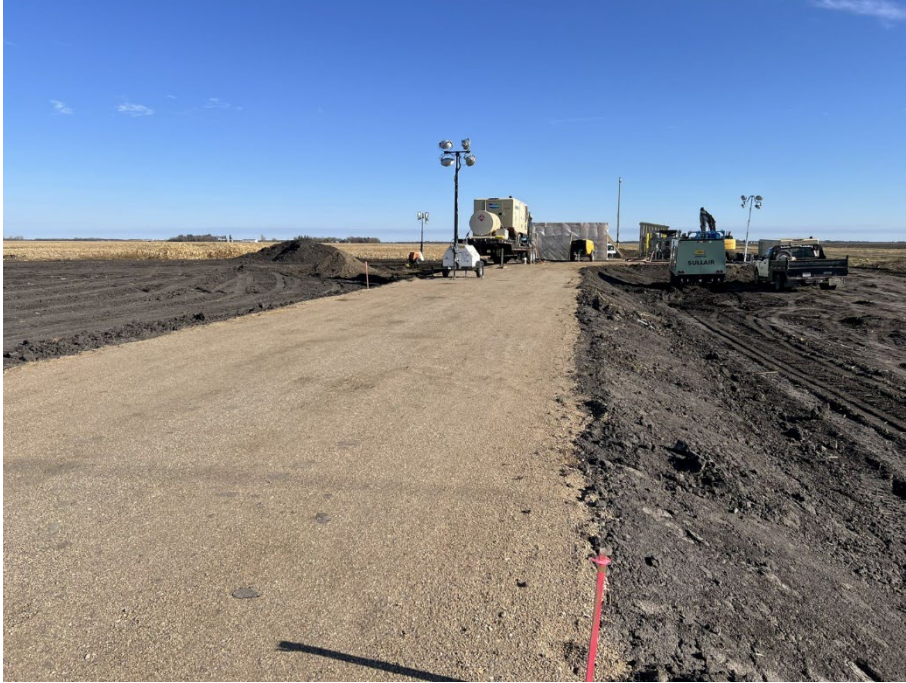
Photo No.: 15

Comments: Aboveground Facility, Valve #5 Site. Work at the valve site included pad construction, perimeter fence installation, valve settings and equipment painting, and final cleanup and restoration within and around the valve site. Topsoil was restored along temporary workspaces, but final grading and decompaction were pending. Wooden stakes remained in place to identify the workspace limits in areas of active construction. No off-ROW impacts or other environmental concerns were identified.

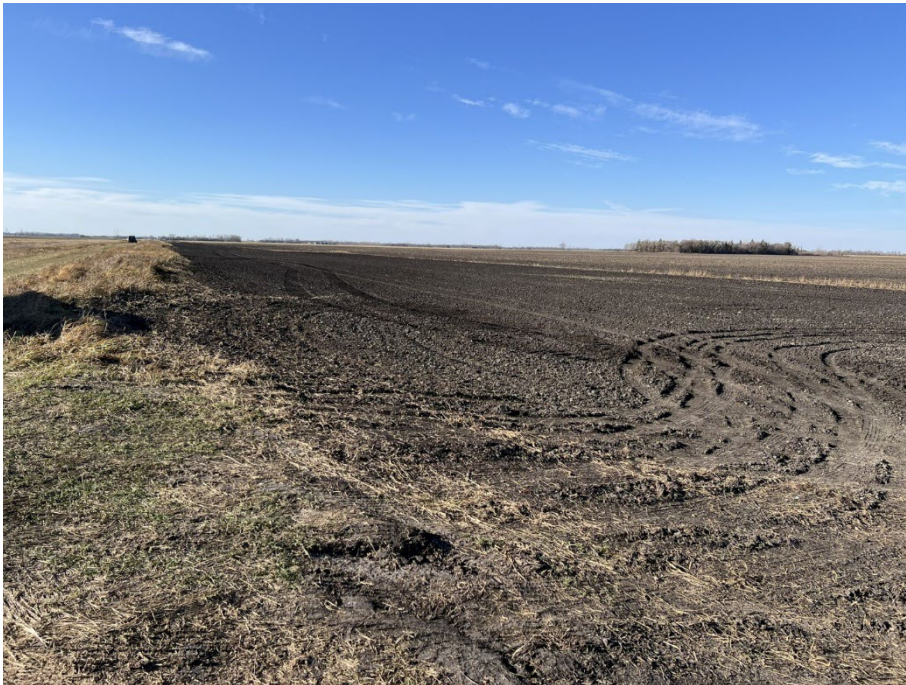
Photo No.: 16

Comments: Agricultural ROW. The ROW and temporary workspace at the bore crossing site for Interstate 29 were restored, decompacted, and free of rutting, large rocks, and construction debris. Wooden stakes and temporary ECDs were removed, per landowner request. The site was stable with no environmental concerns identified.

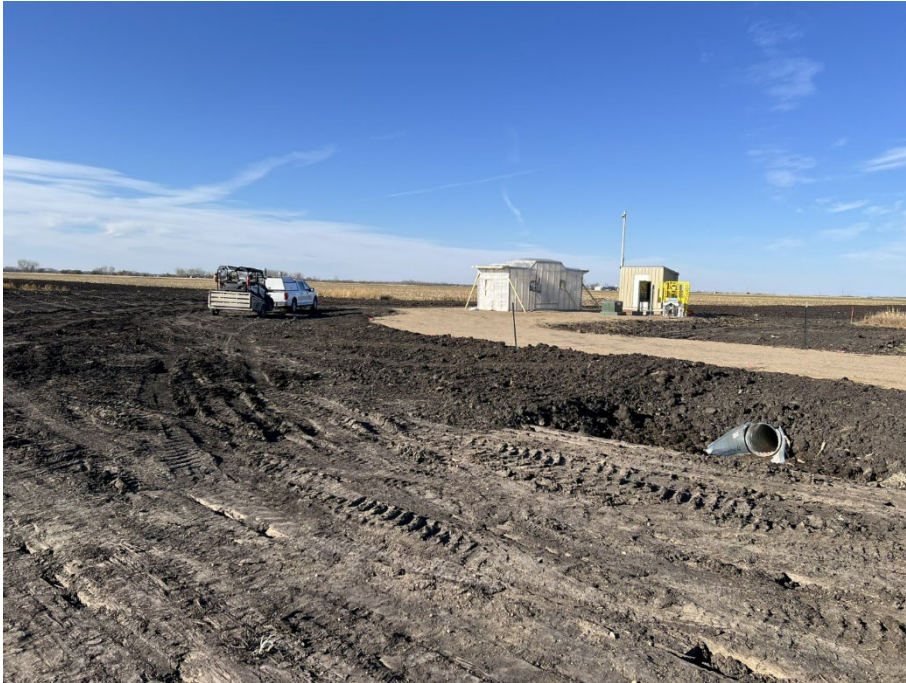
Photo No.: 17

Comments: Aboveground Facility, Valve #6 Site. The valve was mechanically complete, and only minor work remained, including painting, some electrical work, perimeter fence installation, and final restoration of adjacent temporary workspaces around the facility. Workspace limits in active construction areas were well marked. No environmental concerns were identified.

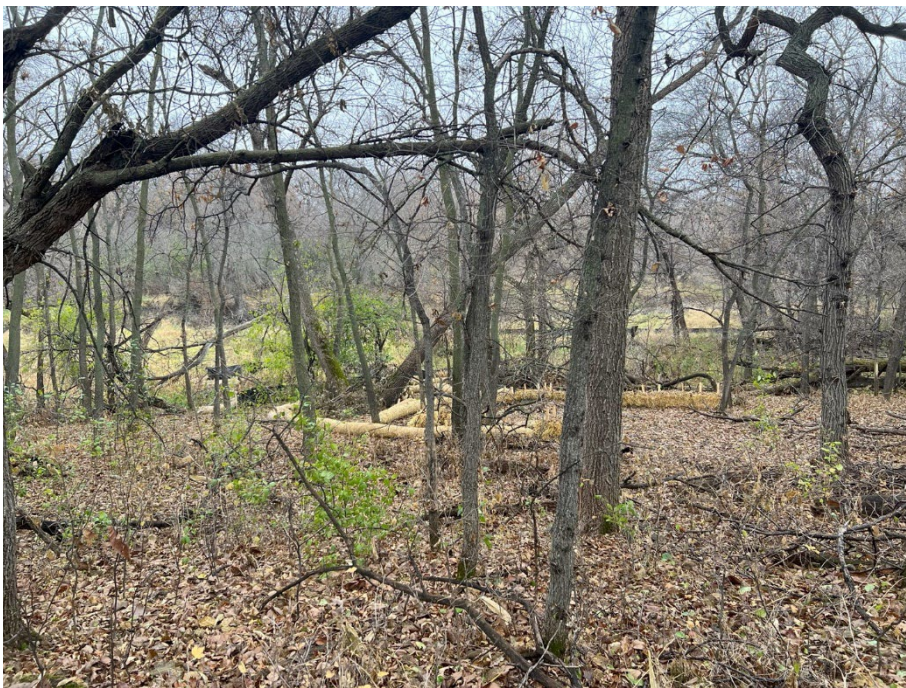
Photo No.: 18

Comments: Aboveground Facility, Red River HDD Site. Areas of inadvertent releases appeared to have been adequately contained, with IR material removed per WBI's Guided Bore Drilling Fluid Monitoring and Operations Plan. Therefore, WBI was asked to remove the remaining ECDs as part of cleanup of the adjacent HDD entry site and ROW and to provide photographic evidence to the FERC Project Manager that all materials had been removed.

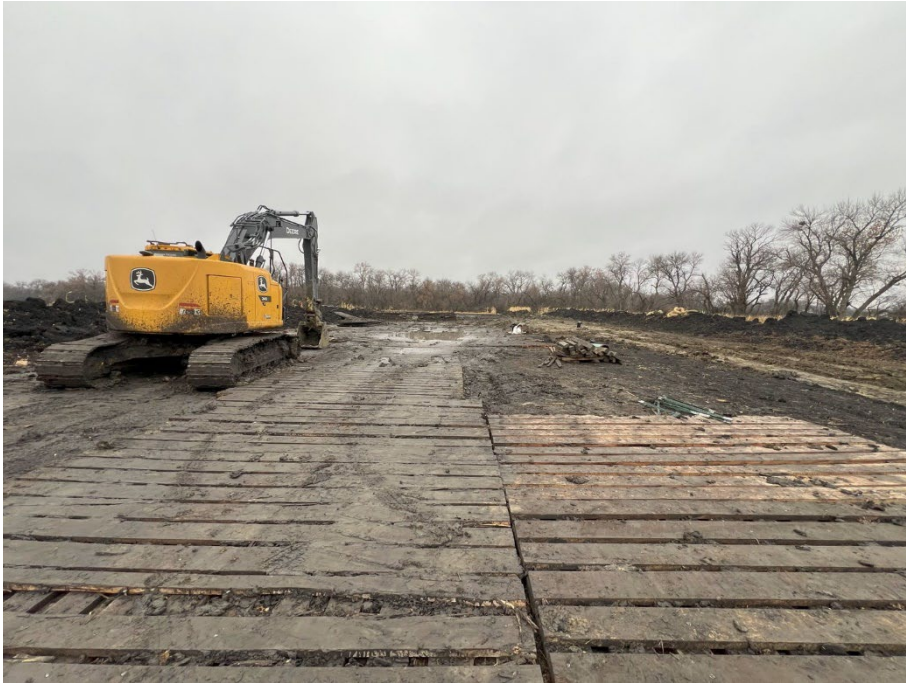
Photo No.: 19

Rice River and Antelope Creek due to a bore hole collapse (Photo No. 19); and some remaining areas within and around valve sites, where construction activities were still in progress (Photo Nos. 13, 15, 17, and 22).

Comments: Agricultural ROW, Bore #64 HDD Site. The HDD crossing was complete, and the trench was backfilled approximately 10 to 14 days ago, according to WBI. Cleanup and restoration were underway but incomplete along an approximately 0.7-mile-long portion of the ROW between MP 51.30 and MP 51.92. Topsoil remained properly segregated along the ROW edge, and no off-ROW impacts or environmental concerns were identified. WBI was asked to provide the FERC Project Manager with restoration progress updates for this section of ROW.

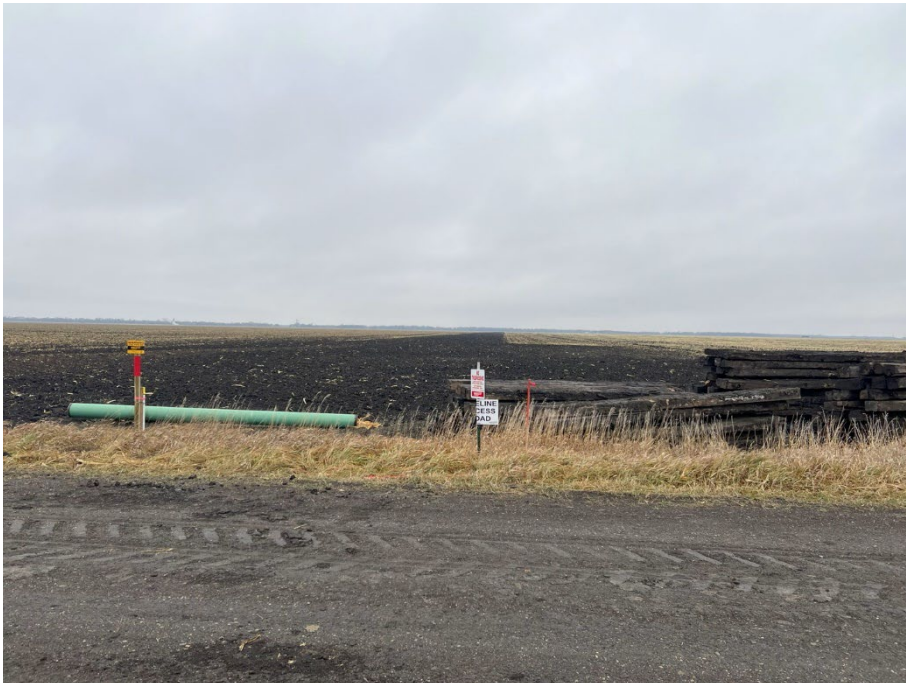
Photo No.: 20

Comments: Agricultural ROW. The ROW and temporary workspaces were restored, decompacted, and free of rutting, large rocks, and evidence of erosion. According to WBI, the construction materials and nearby access point onto the adjacent unimproved public road would be removed, with the area restored, once confirmation was received that no further re-entry for anomaly repair would be required. No environmental concerns were identified.

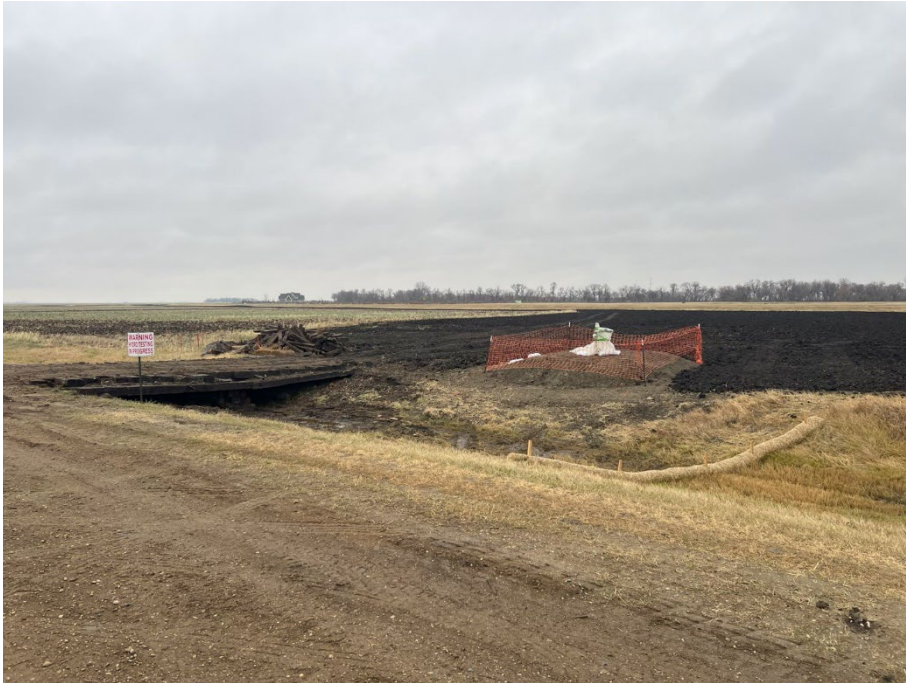
Photo No.: 21

Comments: Agricultural ROW. A tap was installed at this location, per landowner request. The ROW and temporary workspaces were restored, decompacted, and free of rutting, large rocks, and evidence of erosion. According to WBI, the construction materials and access point onto the adjacent unimproved public road would be removed, with the area restored, once confirmation was received that no further re-entry for anomaly repair would be required. No environmental concerns were identified.

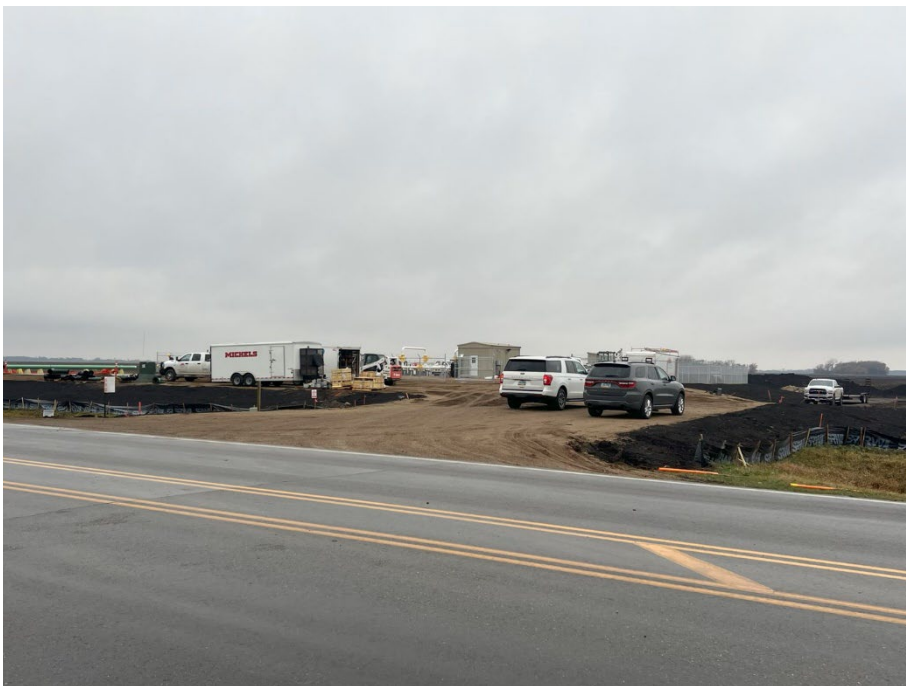
Photo No.: 22

Comments: Aboveground Facility, Valve #7 Site. The valve was mechanically complete, and only minor work remained, including pad completion, painting, electrical work, perimeter fence installation, and final restoration of temporary workspaces. Construction along the east side of the valve site was associated with Montana-Dakota Utilities (local gas delivery provider). The construction access point was well maintained, and the public road was free of tracked mud and construction debris. The site was stable, with no environmental concerns identified.
