FEDERAL ENERGY REGULATORY COMMISSION FIELD INSPECTION REPORT

Date June 26, 2024

Project WBI Energy Transmission, Inc.
Wahpeton Expansion Project
Cass and Richland Counties, North Dakota
Docket No.: CP22-466-000
Authority: Section 7(c)

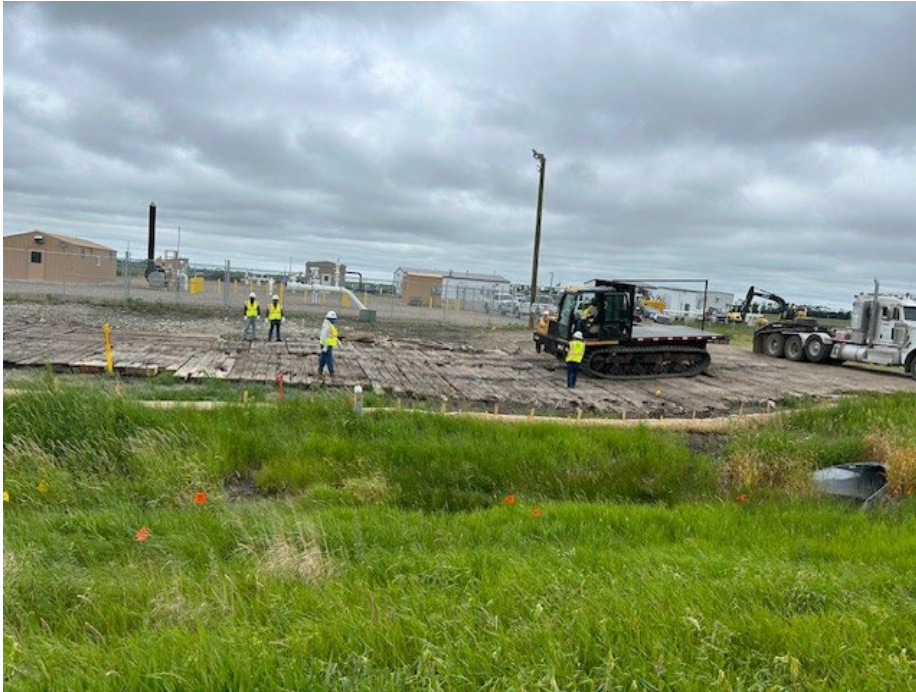
Photo No.: 1

At the WBI Mapleton CS, expansion loop tie-in was in progress, and equipment mats and ECDs were in place within the clearly staked ROW boundaries (Photo Nos. 1 and 2). Along the ROW at MP 1.5 and the Bore #1 site, topsoil was being properly segregated and stockpiled along the edge of the ROW (Photo No. 3), and pipeline was strung or lowered into the trench (Photo Nos. 3, 5, and 7). Project signage was posted, and an equipment mat access pad was in place from the public road (Photo Nos. 4 and 7). WBI stated that one of two self-reported noncompliances was issued at this location for moving the access road from the public road to the ROW to improve safety conditions and access for construction equipment (Photo No. 6). Signage was in place to stop access via the un-approved road, and no other environmental concerns were identified. WBI stated that a recent release of fuel from a fuel truck was restricted to the pavement on the road and a small section of equipment mat (Photo No. 7). The fuel was absorbed with absorbent material which, along with the impacted equipment mat section, was properly disposed of by a licensed contractor. Otherwise along this section of ROW, equipment mats and ECDs were in place within the clearly staked ROW boundaries, and no erosion, off-ROW impacts, or environmental concerns were identified.

Comments: Aboveground Facility, WBI Mapleton CS. At the WBI Mapleton CS, expansion loop tie-in was in progress. Equipment mats and ECDs were in place, and the ROW boundaries were clearly staked. No environmental concerns were identified.

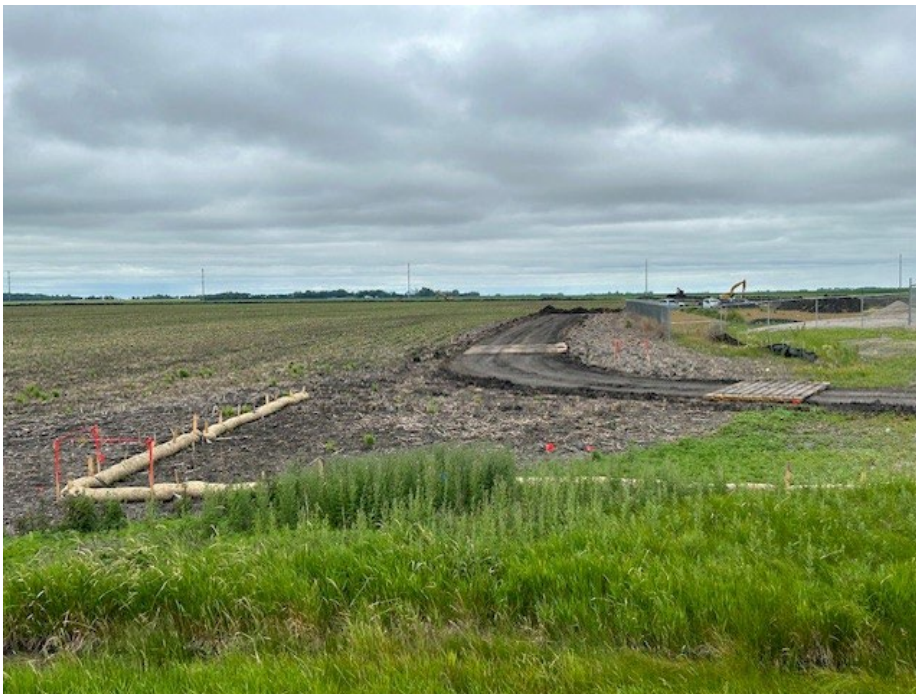
Photo No.: 2

Comments: Agricultural ROW, WBI Mapleton CS. At the WBI Mapleton CS, the expansion loop ROW was clearly staked, with equipment mats installed over ditch lines and ECDs properly installed, as needed. No environmental concerns were identified.

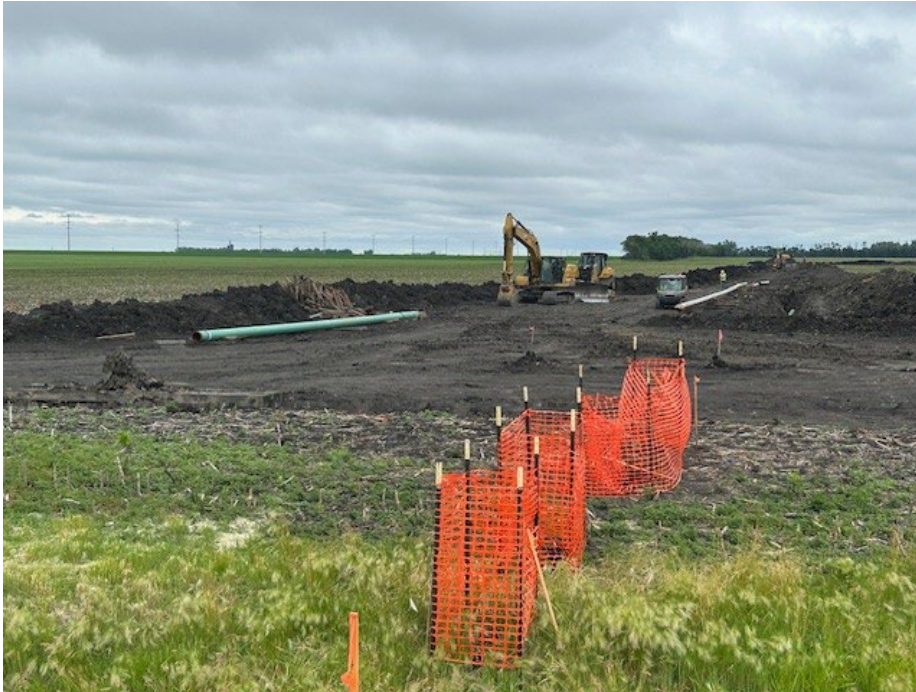
Photo No.: 3

Comments: Agricultural ROW, Bore #1 Site. Topsoil was being properly segregated and stockpiled along the edge of the ROW, and no other environmental concerns were identified.

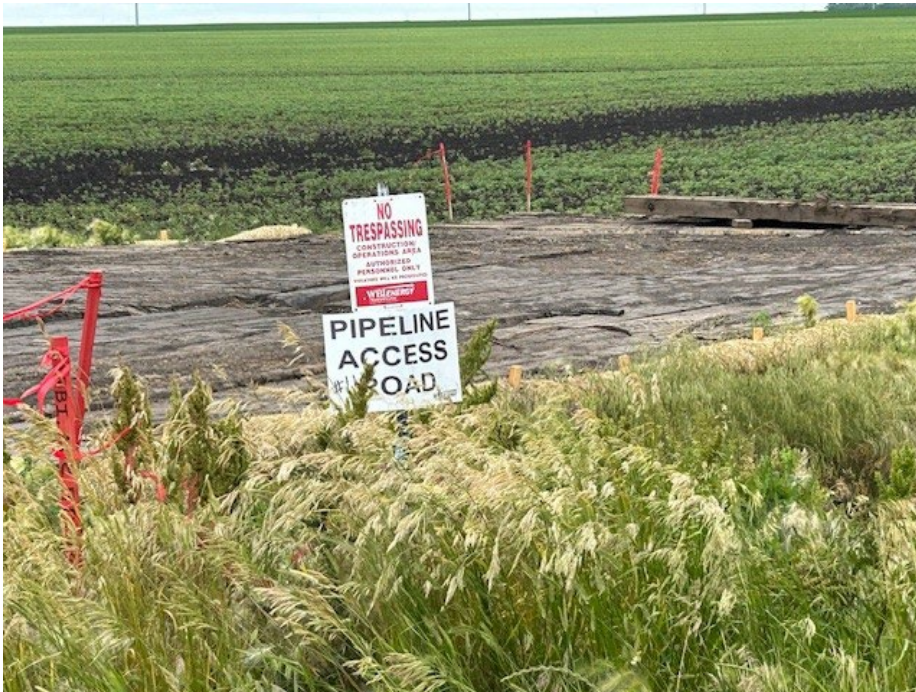
Photo No.: 4

Comments: Agricultural ROW, Bore #1 Site. Project signage was posted, the ROW was clearly staked, and an equipment mat access pad was in place from the public road. No environmental concerns were identified.

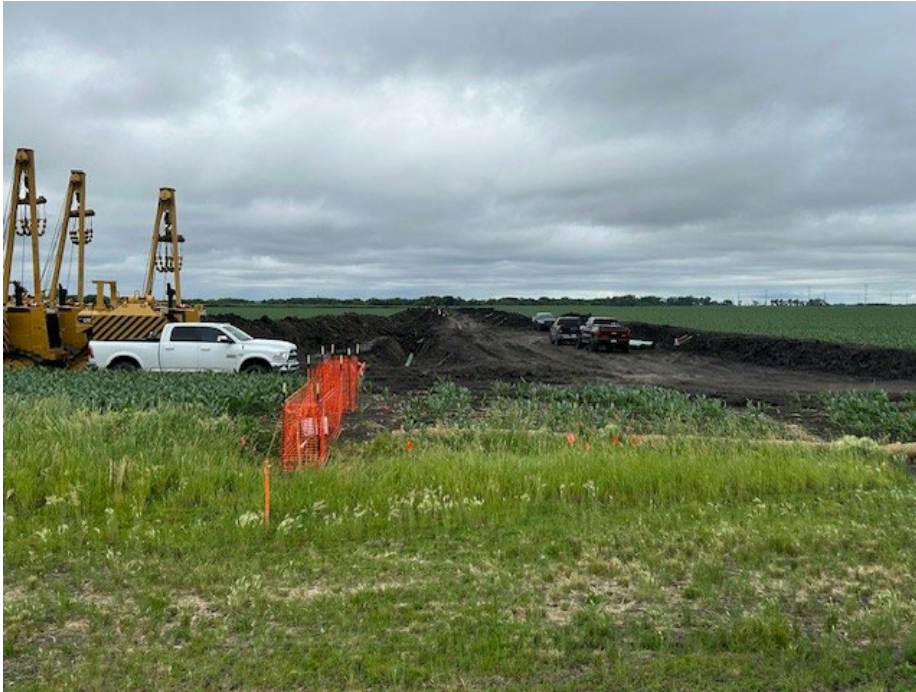
Photo No.: 5

Comments: Agricultural ROW. Topsoil was segregated and stockpiled along the ROW, ECDs were properly installed, as needed, and pipe was lowered into the trench. No environmental concerns were identified.

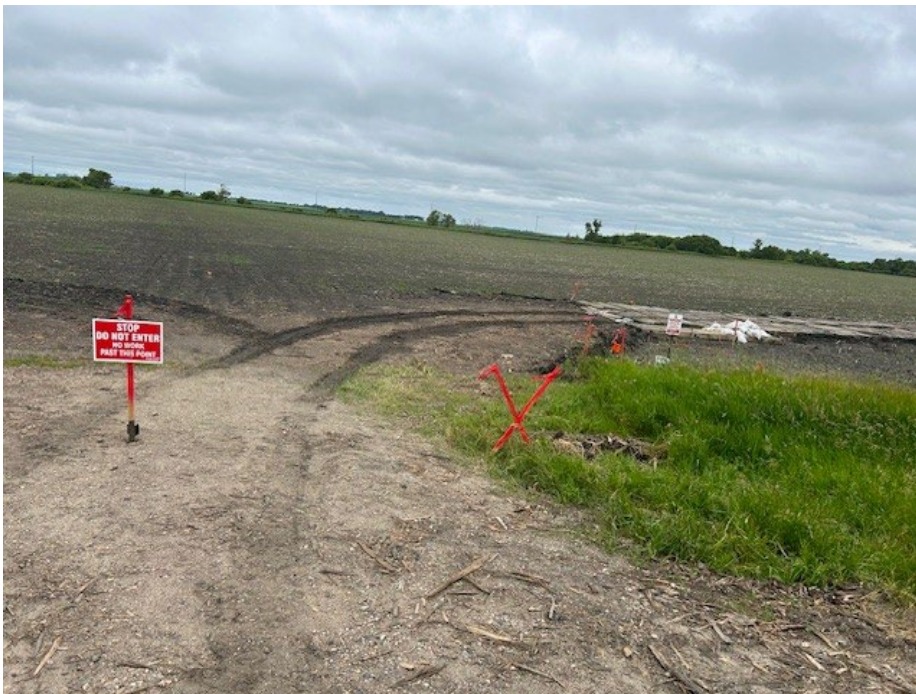
Photo No.: 6

Comments: Agricultural ROW. A self-reported noncompliance was issued for moving the access road near MP 1.5 from the public road to the ROW to improve safety conditions and access for construction equipment. Signage was in place to stop access. No other environmental concerns were identified.

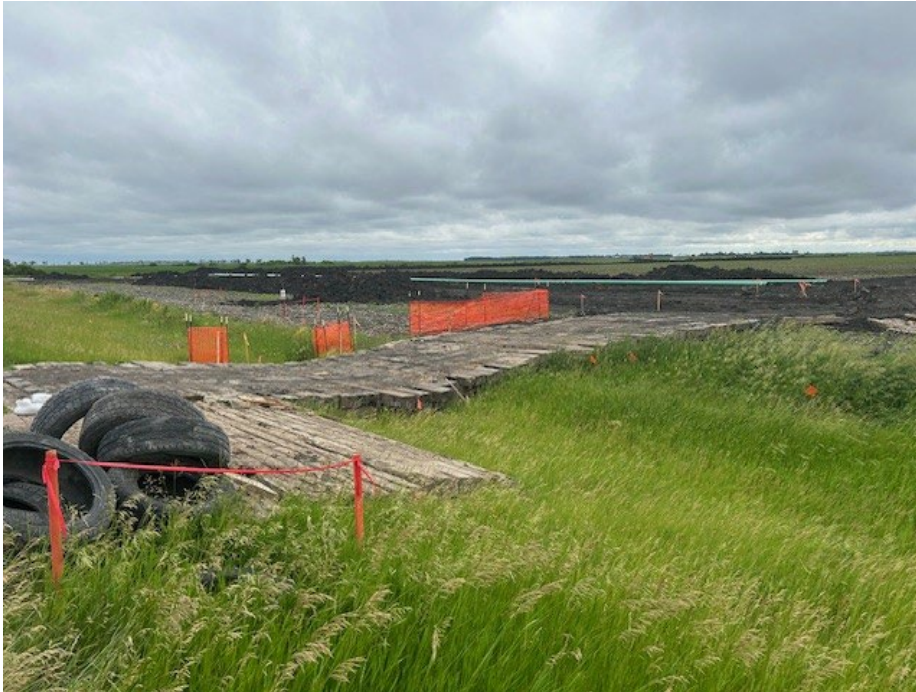
Photo No.: 7

Comments: Agricultural ROW. An equipment mat access pad was in place from the public road to the ROW. ECDs were properly installed along the clearly staked ROW. WBI stated that a recent release of fuel from a fuel truck was restricted to the pavement on the road and a small section of the equipment mat. The fuel was absorbed with absorbent material which, along with the impacted equipment mat section, was properly disposed of by a licensed contractor. No environmental concerns were identified.

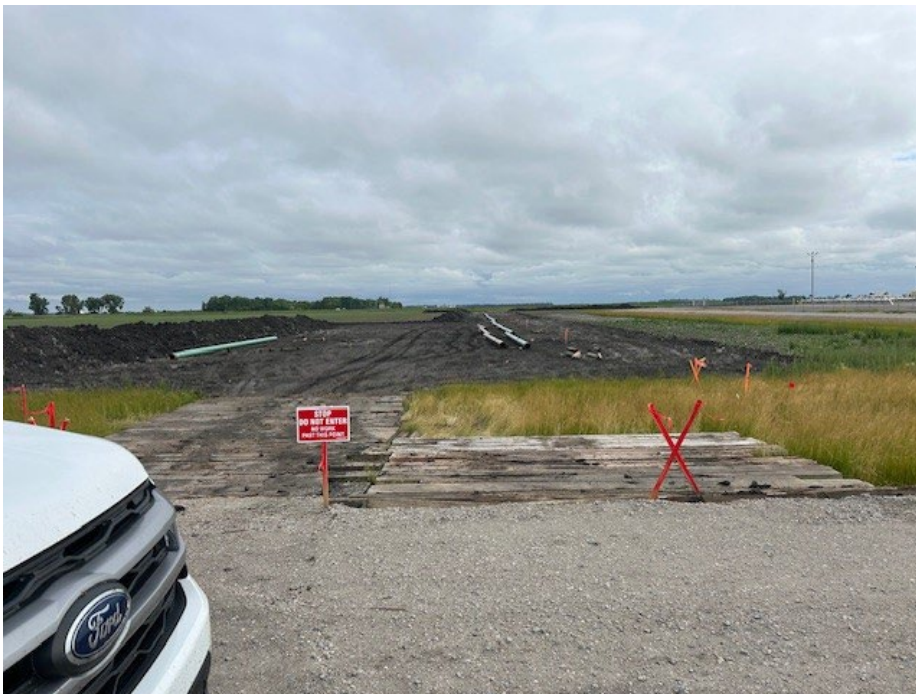
Photo No.: 8

WBI stated that a another self-reported noncompliance was issued near MP 5.5 and the Bore #8 site for an error in surveying and grading, placing the ROW in a non-approved location (Photo No. 8). Near MP 6.4 and the Bore #10 site, welding of pipe string was in progress (Photo No. 9). Near MP 7.2 and the

Comments: Agricultural ROW, Bore #8 Site. A self-reported noncompliance was issued for a surveyor error that placed the ROW in a non-approved location. No other environmental concerns were identified.

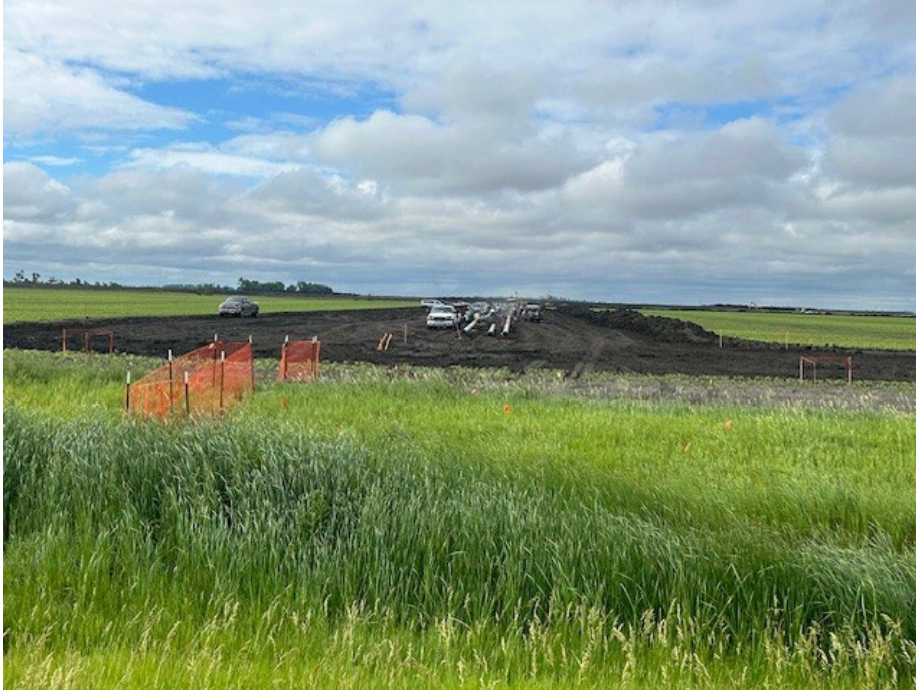
Photo No.: 9

Comments: Agricultural ROW, Bore #10 Site. Welding of pipe string was in progress. ECDs were properly installed, as needed, and topsoil was segregated and stockpiled along the edge of the ROW. No environmental concerns were identified.

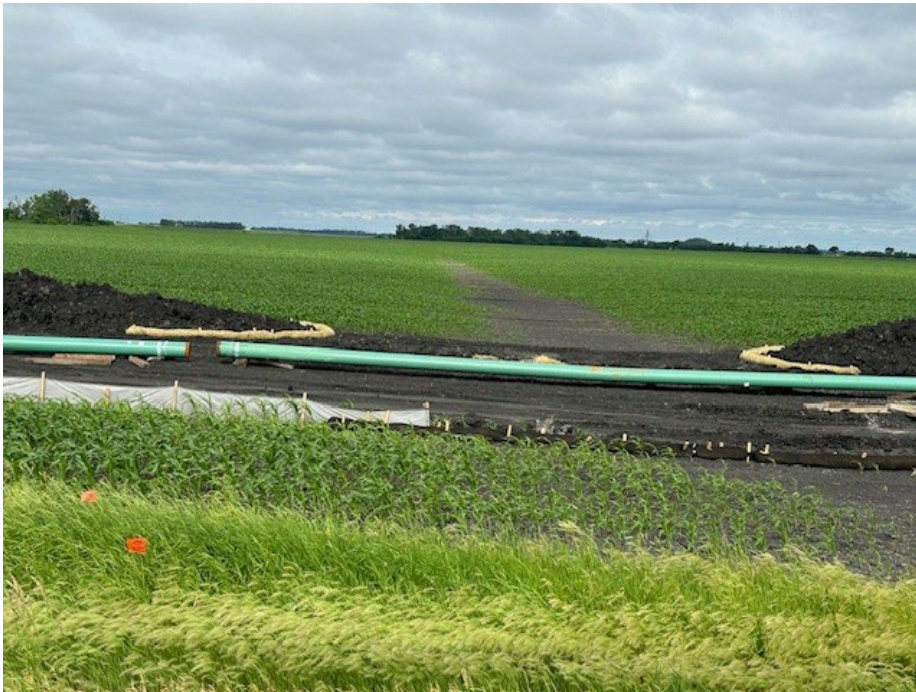
Photo No.: 10

Comments: Agricultural ROW. Topsoil was properly segregated and stockpiled along the edge of the ROW. ECDs were in place to prevent sediment transport into the adjacent low-lying wetland area. No environmental concerns were identified.

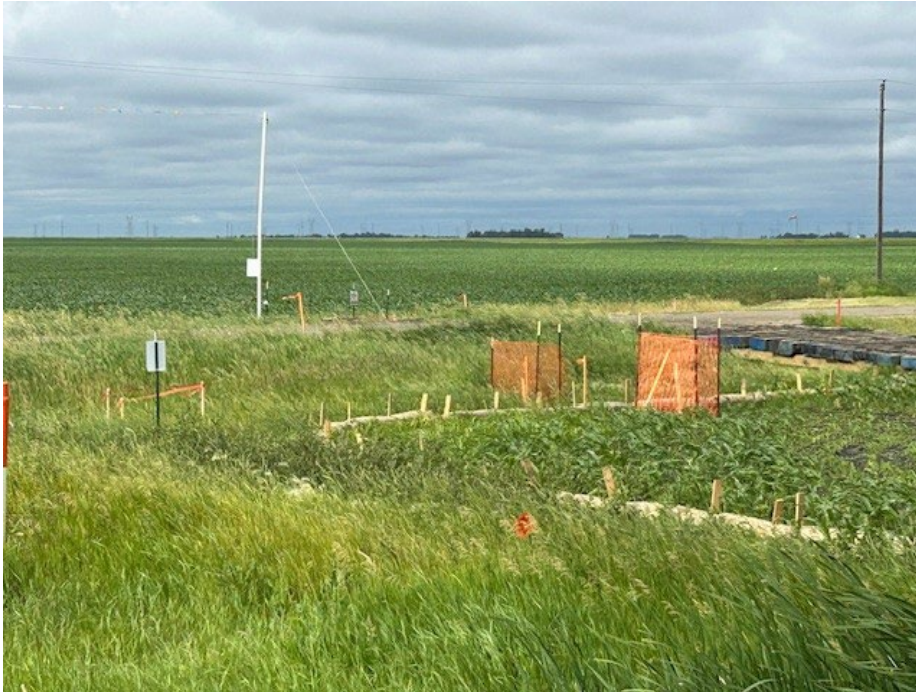
Photo No.: 11

Bore #13 site, the graded ROW was stable and clearly staked, with equipment mats and ECDs properly installed, as needed (Photo No. 11). Pipeline stringing was complete up to near MP 11.7 (Photo No. 12); spotters were placed with each grader to prevent topsoil placement beyond the staked ROW near MP 14.8 and the Bore #22 site (Photo No. 13); and grading of the ROW was complete, with equipment mats being installed, as needed, up to near MP 14.9 and the Bore #23 site (Photo No. 14). Along these sections, the ROW was stable, with no off-ROW impacts or environmental concerns identified.

Comments: Agricultural ROW, Bore #13 Site. The ROW was stable and clearly staked, with equipment mats and ECDs properly installed, as needed. No environmental concerns were identified.

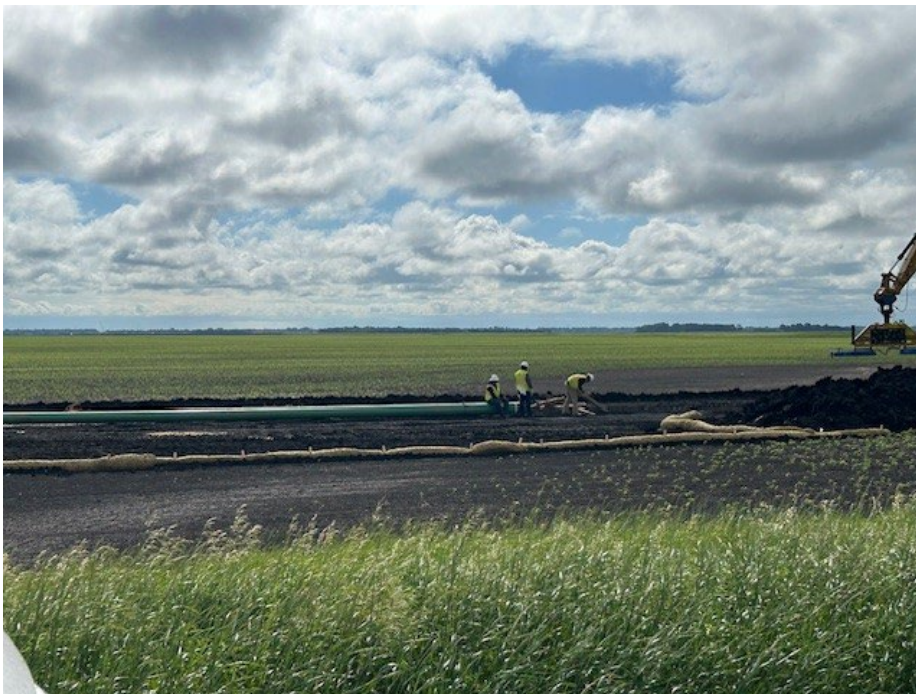
Photo No.: 12

Comments: Agricultural ROW. This location was the end of pipe stringing along the ROW at the time of the inspection. The ROW was stable and clearly staked, with equipment mats and ECDs properly installed, as needed. No environmental concerns were identified.

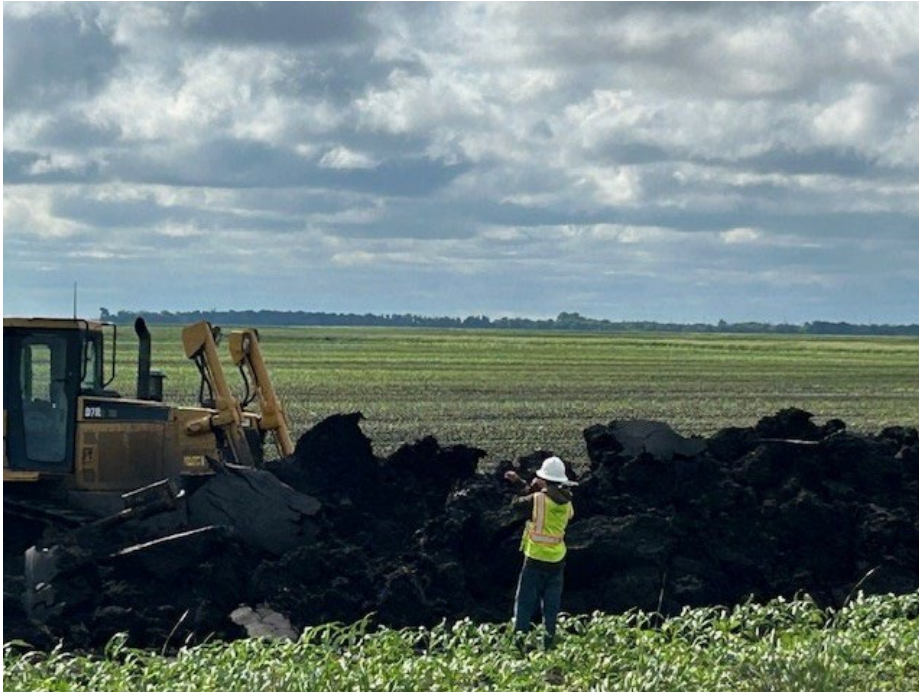
Photo No.: 13

Comments: Agricultural ROW, Bore #22 Site. Spotters were placed with each grader to prevent topsoil placement beyond the staked ROW. The ROW was stable and clearly staked, and no environmental concerns were identified.

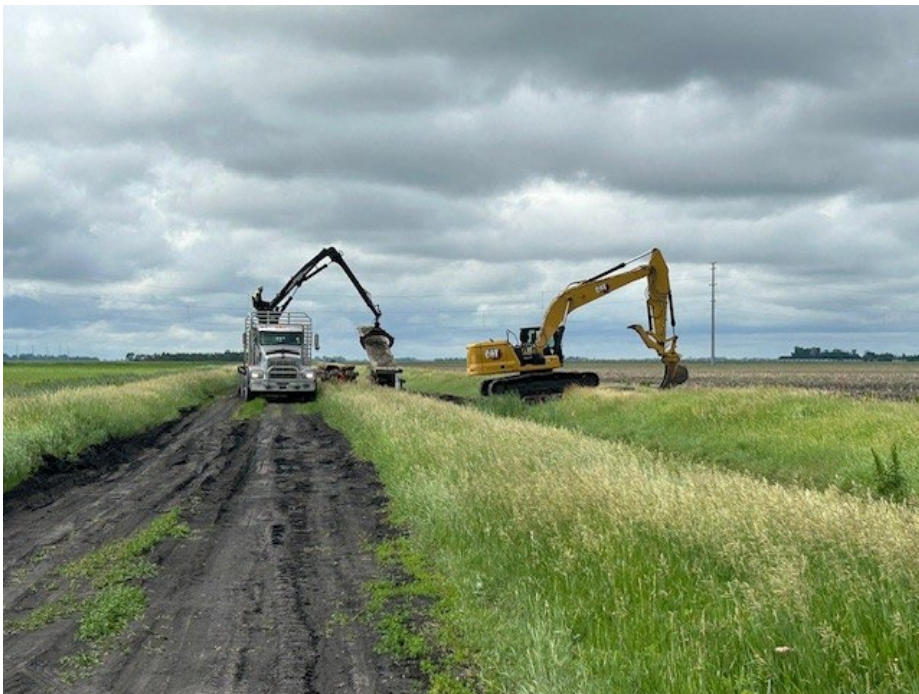
Photo No.: 14

Comments: Agricultural ROW, Bore #23 Site. Equipment mats were being installed to allow access to the ROW. No environmental concerns were identified.

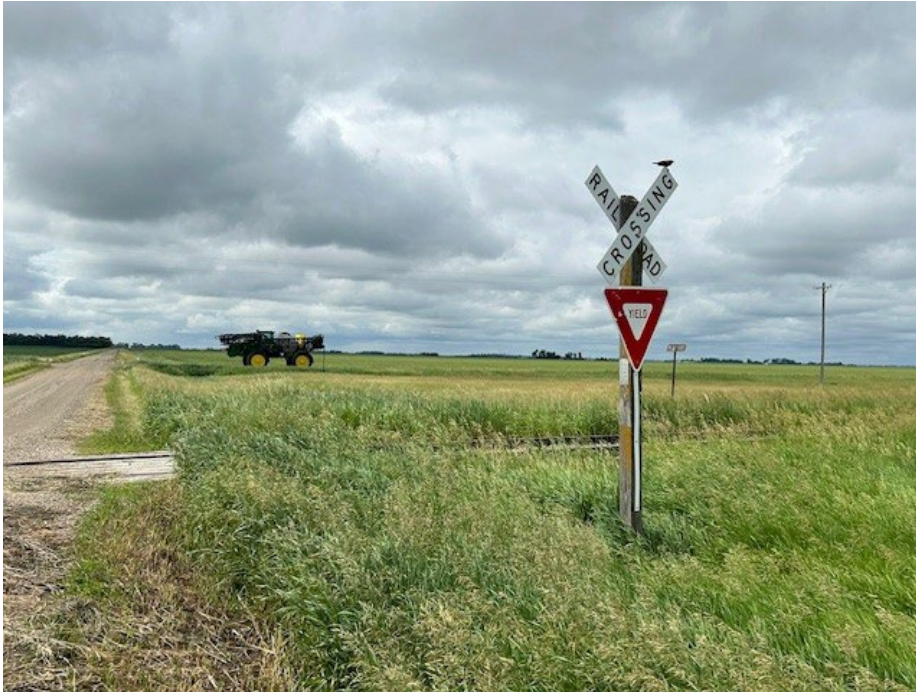
Photo No.: 15

Near MP 16.8 and the Bore #25 site, the agricultural ROW near the Red River Valley and Western Railroad crossing was documented (Photo No. 15). One of two private, one-inch taps will be installed as part of the Project at MP 17.9, near the Bore #26 site (Photo No. 16). Stakes and flagging were in place to delineate the boundaries of the Valve Set 3, near MP 23.5 and the Bore #31 site (Photo No. 17). Near MP 24.4 and the Bore #32 site, a pre-construction view of the Sheyenne River crossing site was documented (Photo No. 18). Grading was not yet underway along these portions of the ROW; however, some initial clearing was conducted as part of staking (Photo Nos. 16 and 17).

Comments: Agricultural ROW, Bore #25 Site. The ROW near the Red River Valley and Western Railroad crossing was documented. Grading was not yet underway along this portion of the ROW.

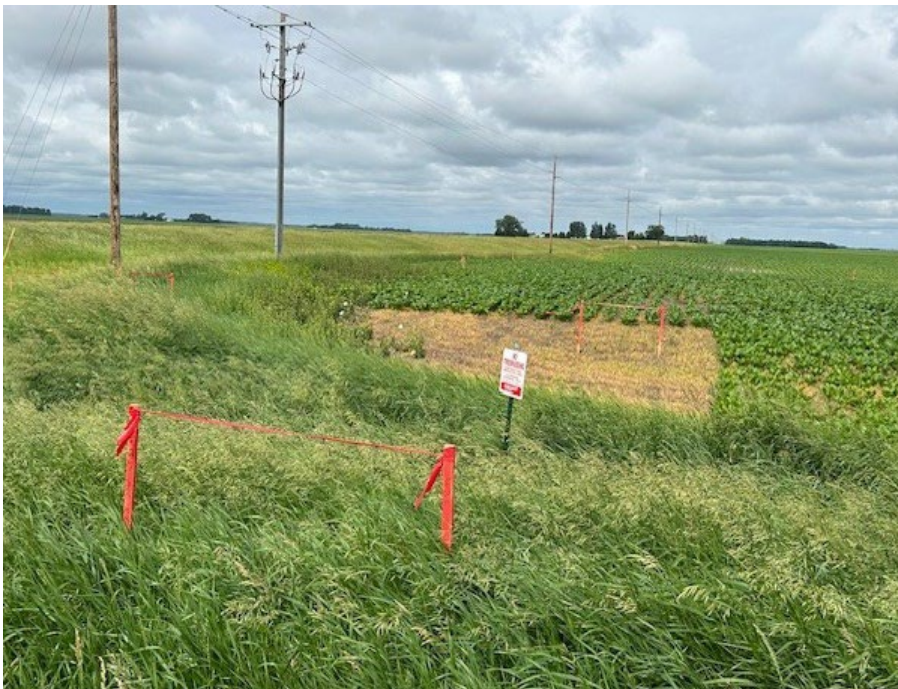
Photo No.: 16

Comments: Agricultural ROW, Bore #26 Site. One of two private, one-inch taps will be installed as part of the Project at this location. Grading was not yet underway along this portion of the ROW.

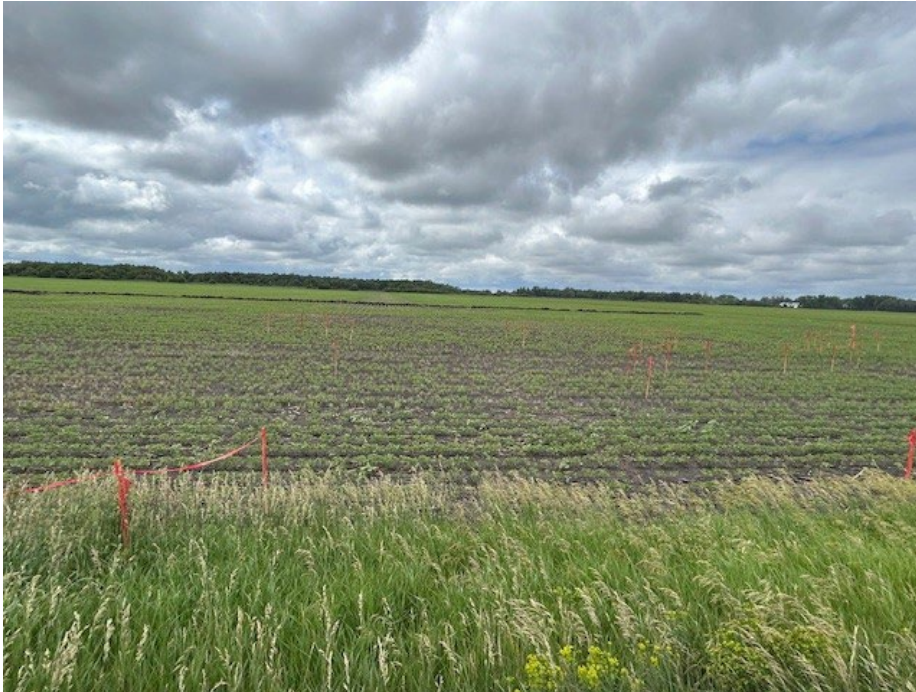
Photo No.: 17

Comments: Aboveground Facility, Valve Set 3 Site. Stakes and flagging were in place to delineate the boundaries of the Valve Set 3 site near the Bore #31 site. To date, no construction had occurred in this location.

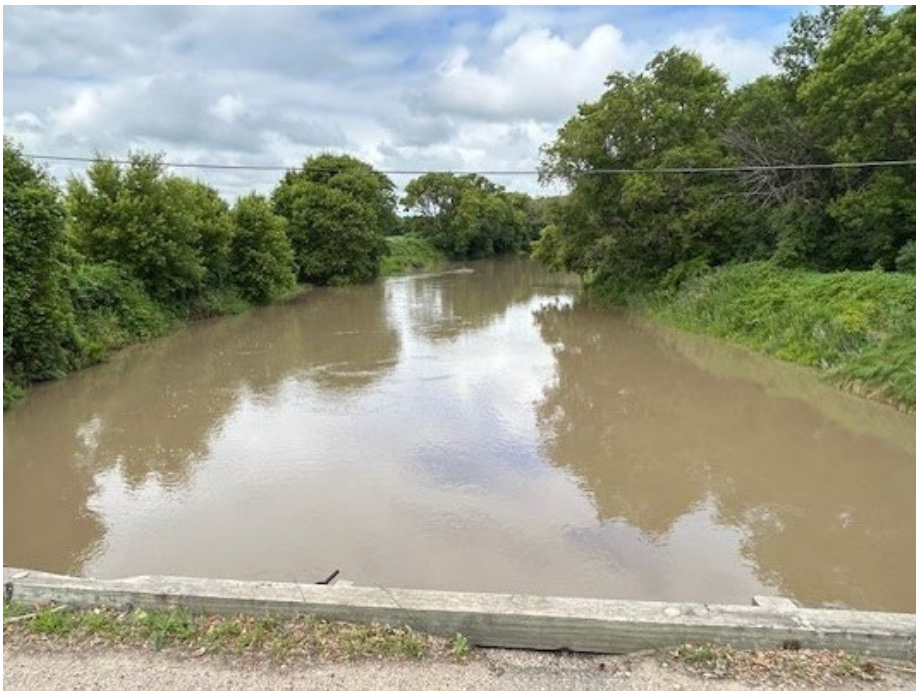
Photo No.: 18

Comments: Waterbody ROW, Bore # 32 Site, Sheyenne River. A pre-construction view of the Sheyenne River crossing site was documented.

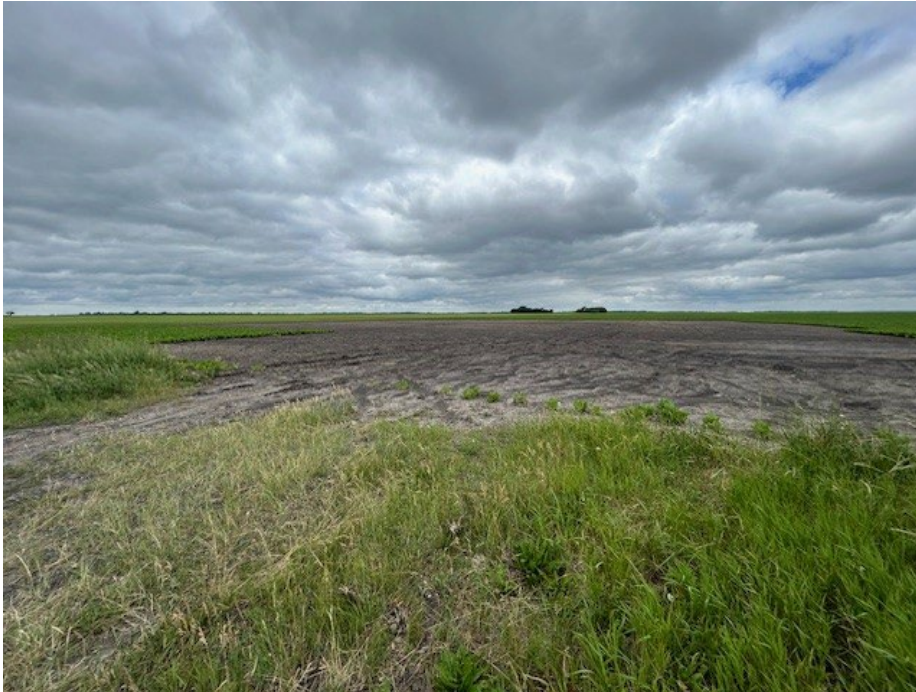
Photo No.: 19

At MP 59.0, clearing was complete at the Wahpeton Border Station site; however, no other construction activities had taken place at the time of the inspection (Photo No. 19). The inspection ended at the Wahpeton Storage Yard, where equipment and materials were being mobilized and staged, and no off-ROW impacts or environmental concerns were identified (Photo No. 20).

Comments: Aboveground Facility, Wahpeton Border Station. Clearing was complete at the Wahpeton Border Station site. No other construction activities had taken place at the time of the inspection.

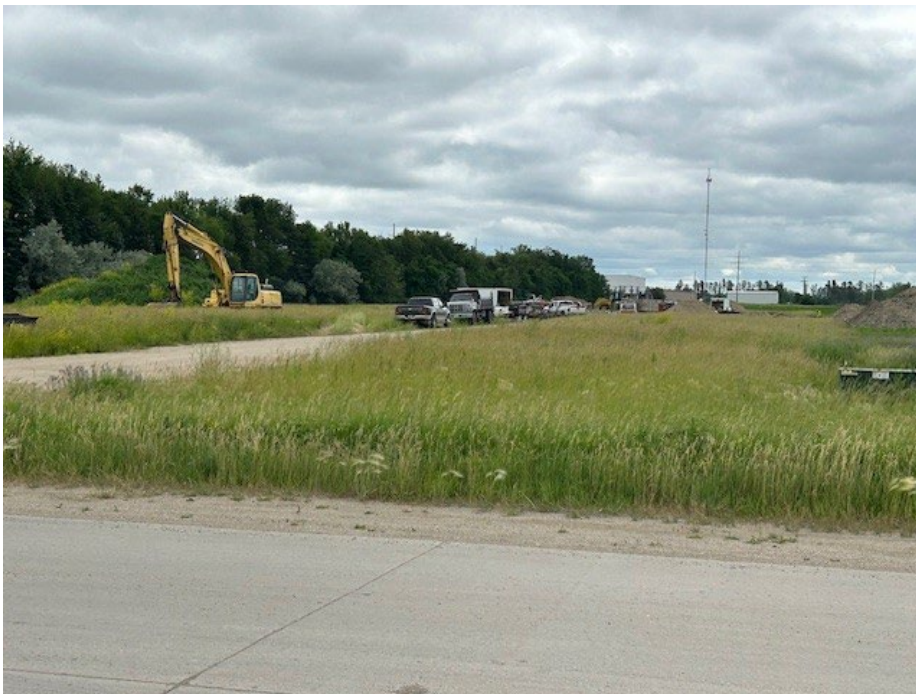
Photo No.: 20

Comments: Wahpeton Storage Yard. Equipment and materials were being mobilized and staged at the storage yard. No off-ROW impacts or environmental concerns were identified.
