FEDERAL ENERGY REGULATORY COMMISSION FIELD INSPECTION REPORT

Date July 24 and 25, 2024

Project WBI Energy Transmission, Inc.
Wahpeton Expansion Project
Cass and Richland Counties, North Dakota
Docket No.: CP22-466-000
Authority: Section 7(c)

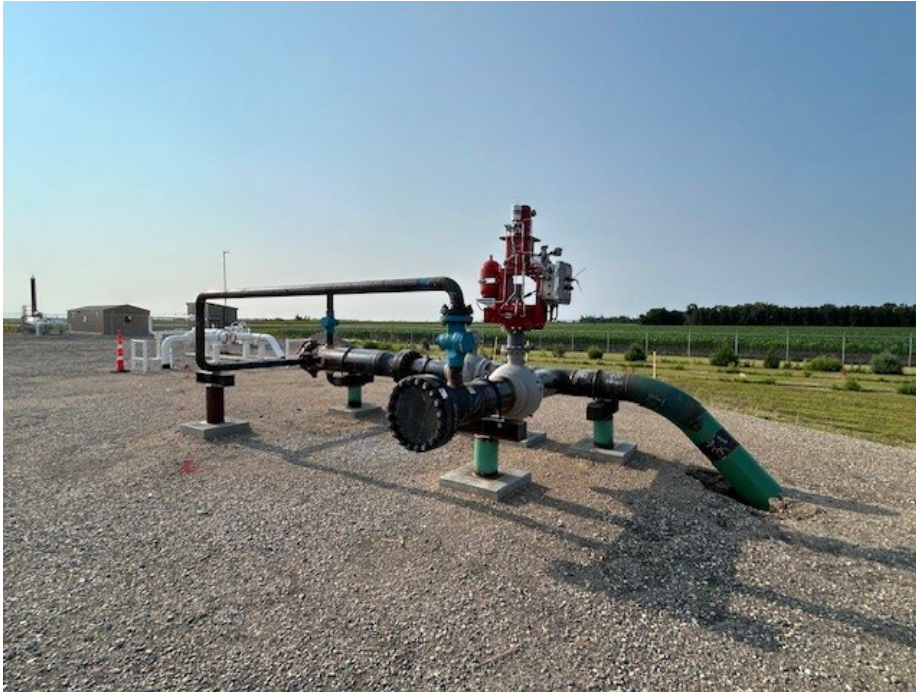
Photo No.: 1

Comments: Aboveground Facility, WBI Mapleton CS. At the WBI Mapleton CS, the new Valve Set #1 installation and pad were completed. The site was stable, and no environmental concerns were identified.

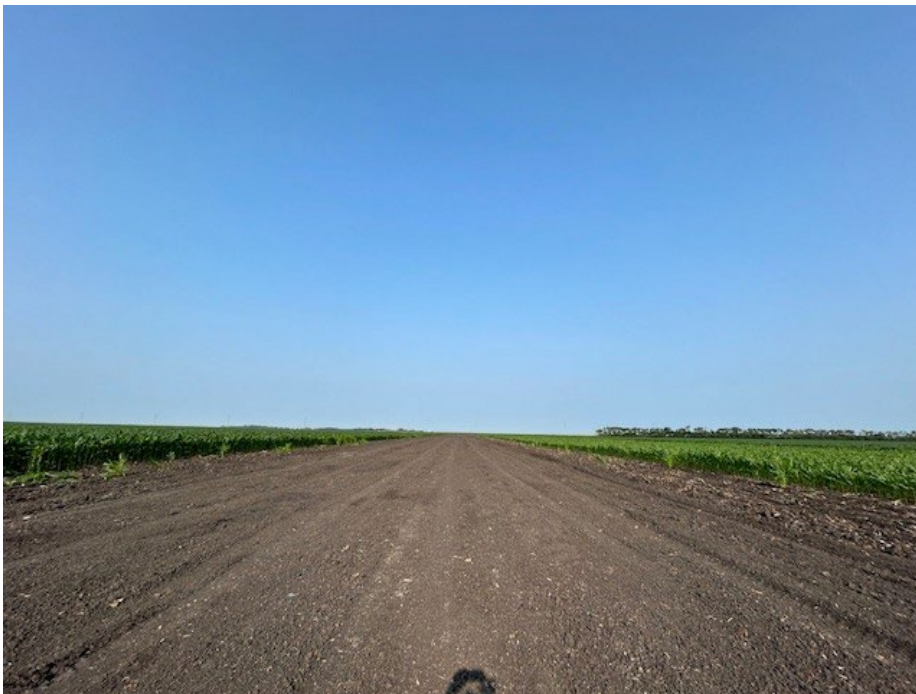
Photo No.: 2

Comments: Agricultural ROW. West of the WBI Mapleton CS, the expansion loop ROW was final-graded, and new vegetation was starting to emerge along the ROW. No environmental concerns were identified.

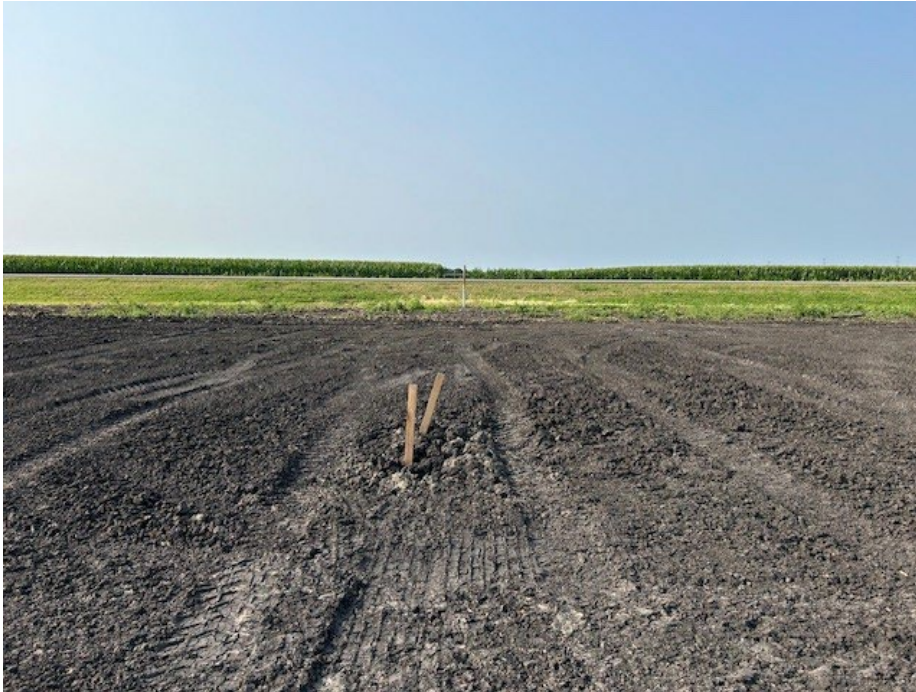
Photo No.: 3

Comments: Agricultural ROW, Bore #1 Site. The drilled crossing was completed, and the entry point was staked. The ROW was final-graded, and no environmental concerns were identified.

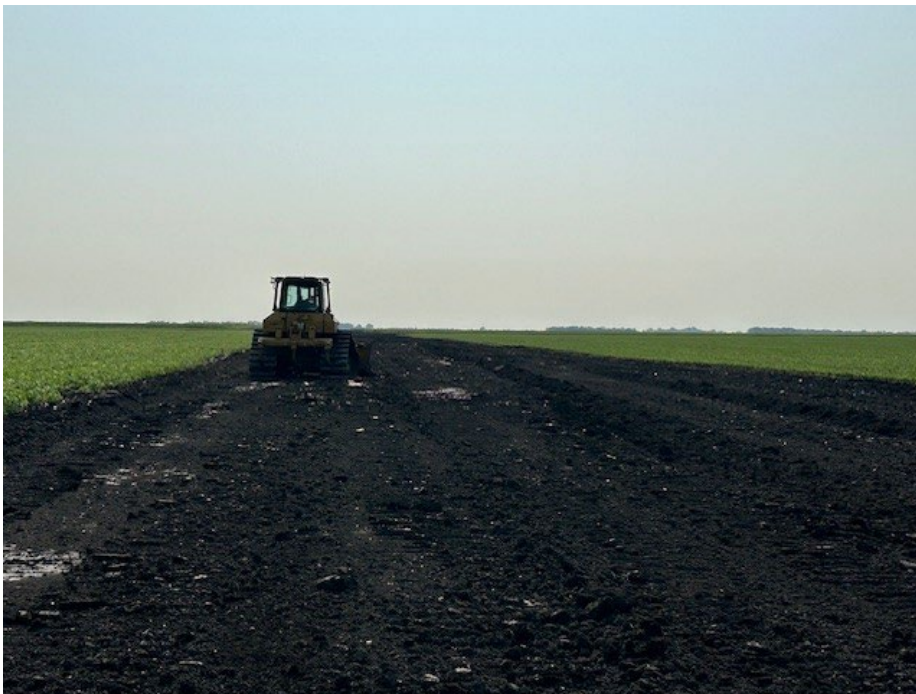
Photo No.: 4

Comments: Agricultural ROW. Final grading was in progress along the ROW, and no environmental concerns were identified.

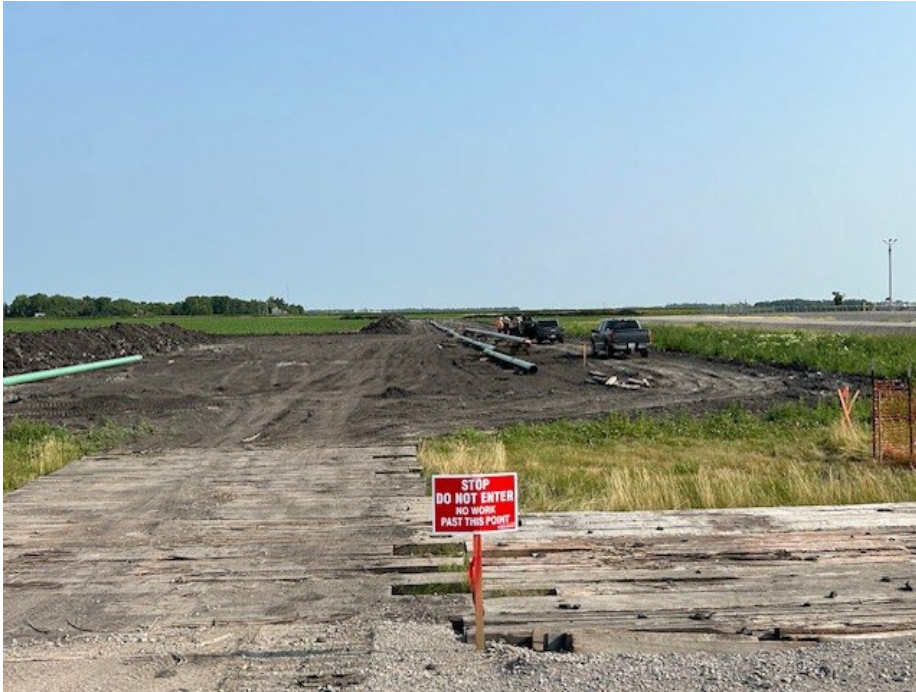
Photo No.: 5

Comments: Agricultural ROW, Bore #8 Site. At the planned crossing beneath the BNSF Railroad, an equipment mat bridge was in place across the ditch for access; however, signs were in place to restrict heavy equipment access. The ROW was clearly staked, with topsoil properly segregated along the edge of the ROW. The pipe was strung and welders were on site. No environmental concerns were identified.

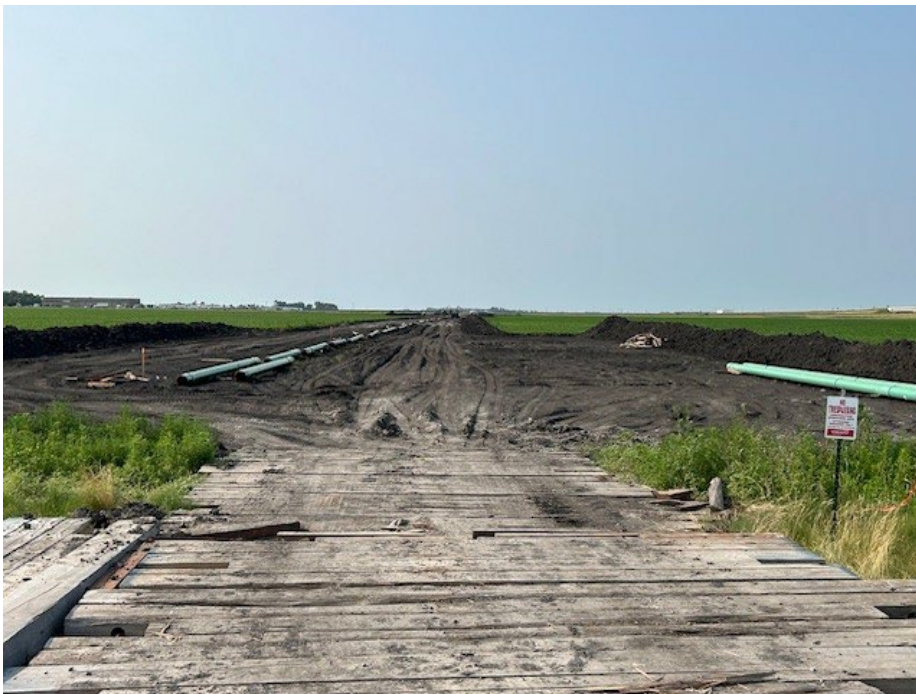
Photo No.: 6

Comments: Agricultural ROW, Bore #8 Site. At the planned crossing beneath the BNSF Railroad, an equipment mat bridge was in place across the ditch for access; however, signs were in place to restrict heavy equipment access. The ROW was clearly staked, with topsoil properly segregated along the edge of the ROW. The pipe was staged for welding. No environmental concerns were identified.

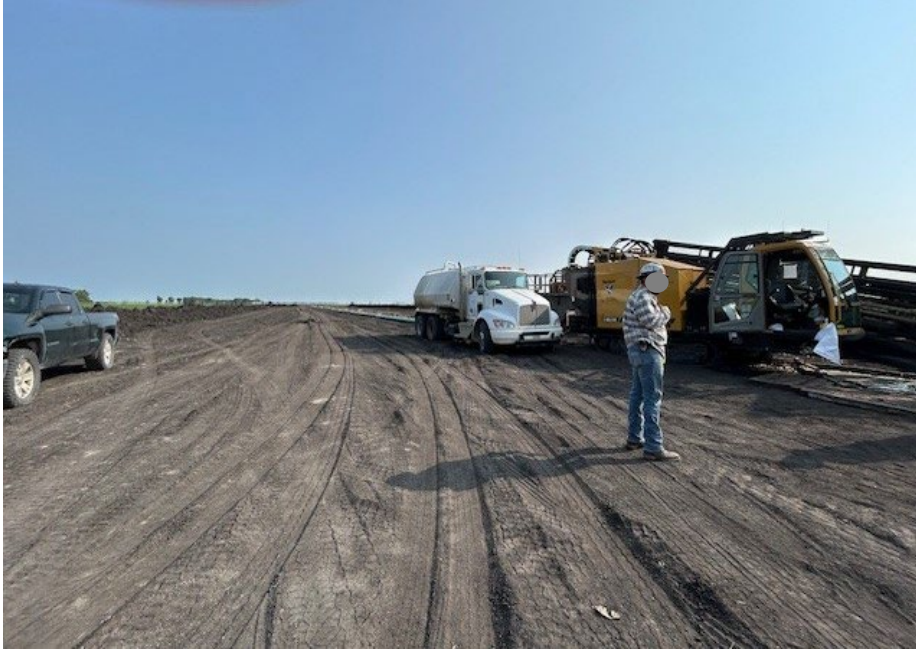
Photo No.: 7

Comments: Agricultural ROW, Bore #9 Site. On the west side of I-94, the crossing was in progress and then completed during the inspection, with pipe pulled through the borehole on July 24, 2024. All drilling mud was contained, and no environmental concerns were identified.

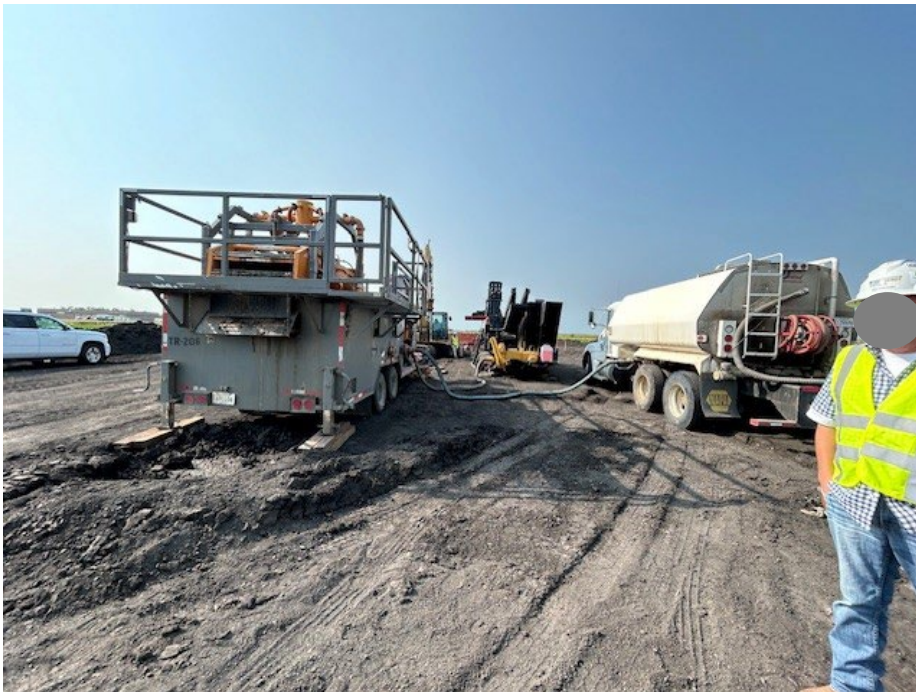
Photo No.: 8

Comments: Agricultural ROW, Bore #9 Site. On the west side of I-94, the crossing was in progress and then completed during the inspection, with pipe pulled through the borehole on July 24, 2024. All drilling mud was contained, and no environmental concerns were identified.

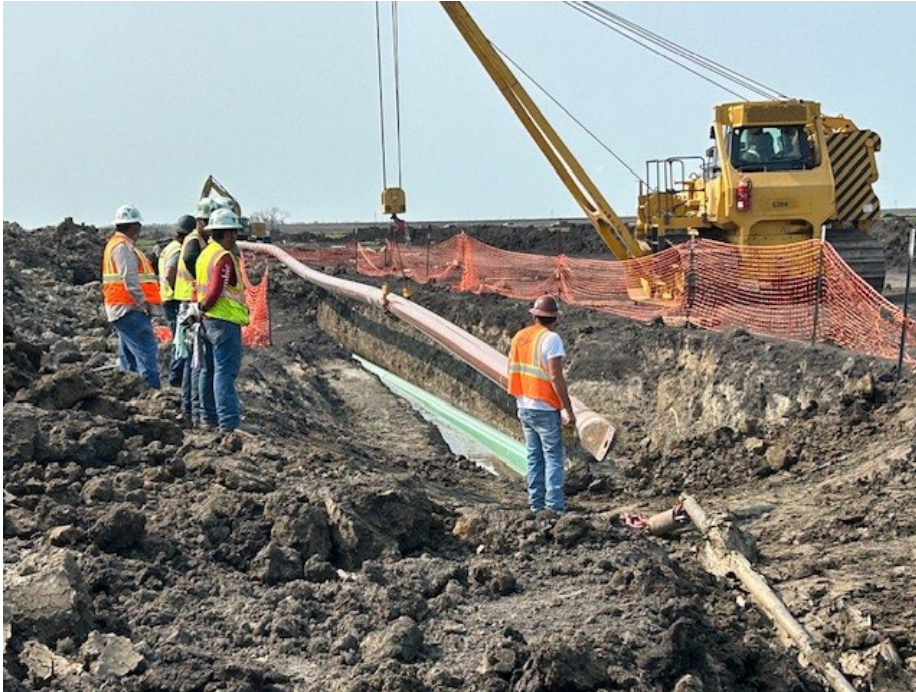
Photo No.: 9

Comments: Agricultural ROW, Bore #10 Site. On the east side of the I-94 crossing, the pipe string was being lifted for insertion through the borehole. Recent rains resulted in standing water in the trench. A crew was ready to test pipe coating prior to insertion into borehole.

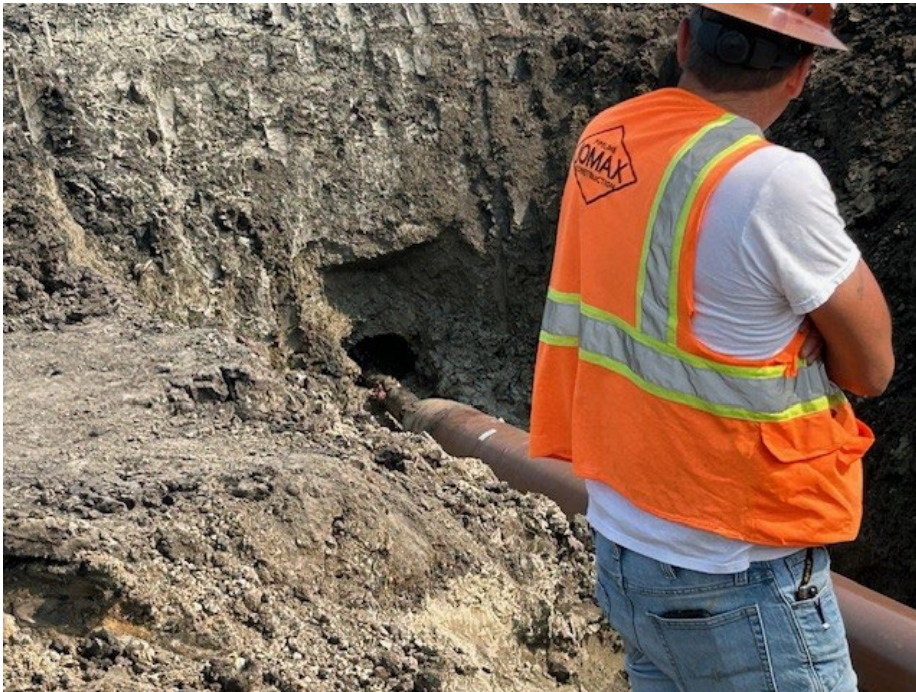
Photo No.: 10

Comments: Agricultural ROW, Bore #10 Site. On east side of the I-94 crossing, the pipe string was pulled west through the borehole beneath I-94.

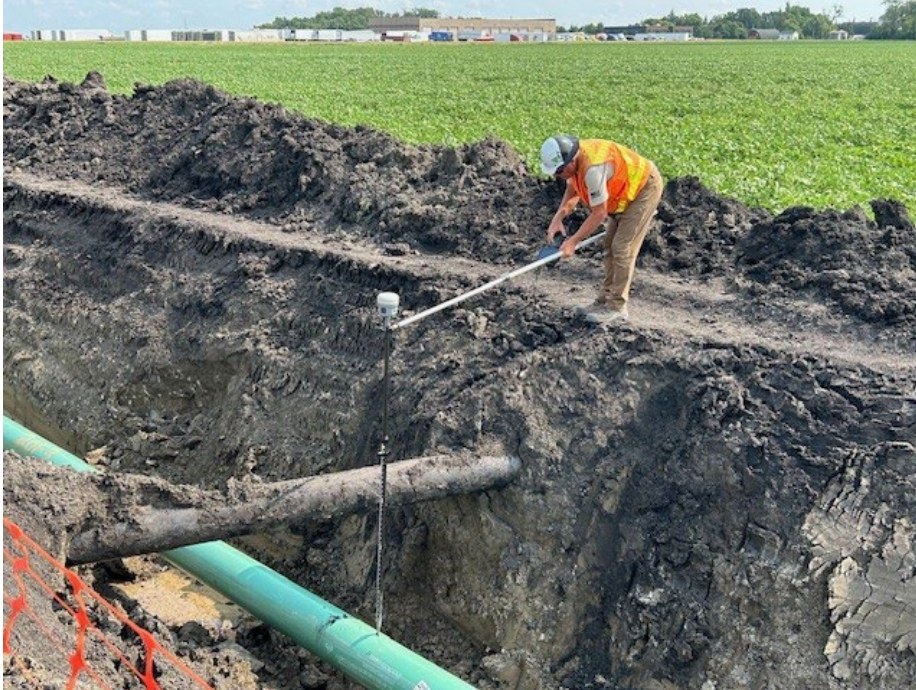
Photo No.: 11

pipeline, and a surveyor was collecting data for the Project engineering (Photo No. 11). At the waterbody crossing near the access road to the planned Valve Set #2 site (MP 11.3), the resource was clearly staked and marked with signs. Equipment mats and ECDs were properly installed, as needed (Photo Nos. 12 and 13). The Valve Set #2 site was graded, with topsoil properly segregated along the edge of the ROW, and no off-ROW impacts or environmental concerns identified (Photo No. 13). At MP 17.7, pipe was welded along the ROW with a slight bend in the line to accommodate a shallow water feature crossing (Photo No. 14). Standing water from a recent rain event was observed along low-lying areas of the ROW (Photo No. 15). ECDs were properly installed to prevent off-ROW sediment transport, and no environmental concerns were identified. The Valve Set #3 (Kindred Border Station) installation was complete, and the valve pad was being installed (Photo No. 16). The first layer of soil was being applied on top of geofabric. A second layer of soil would be added, followed by two layers of gravel topped with concrete. The inspection continued on to a sensitive resource area at MP 27.3 (Photo No. 17). No environmental concerns were identified. Two waterbody (canal) crossings at MP 28.1 and MP 31.2 were found to be stable with equipment mat bridges in place for access to the ROW beyond (Photo Nos. 18 and 19). At the ROW access to the planned Valve Set #4 site, overhead powerlines were clearly marked with signs, and topsoil was properly segregated along the edge of the ROW beyond (Photo No. 19). No environmental concerns were identified.

Comments: Agricultural ROW. The WBI pipeline crosses beneath a NuStar pipeline, and a surveyor was collecting data for the Project engineering. The ROW was stable, with no off-ROW impacts or environmental concerns identified.

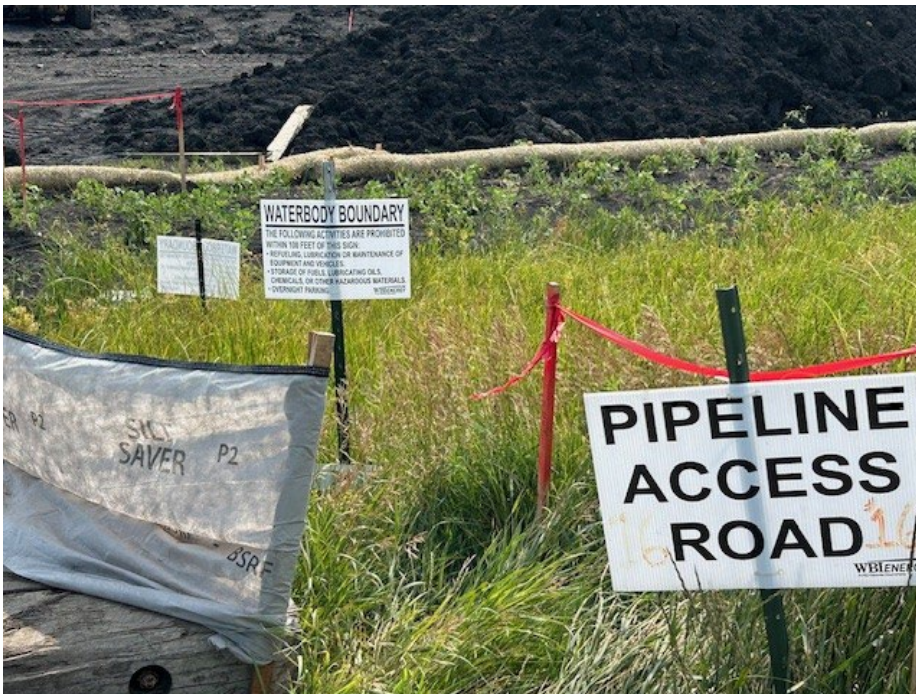
Photo No.: 12

Comments: Agricultural ROW, Waterbody Crossing Site. At the waterbody crossing near the access road to the planned Valve Set #2 site, the resource was clearly staked and marked with signs. Equipment mats and ECDs were properly installed, as needed. No environmental concerns were identified.

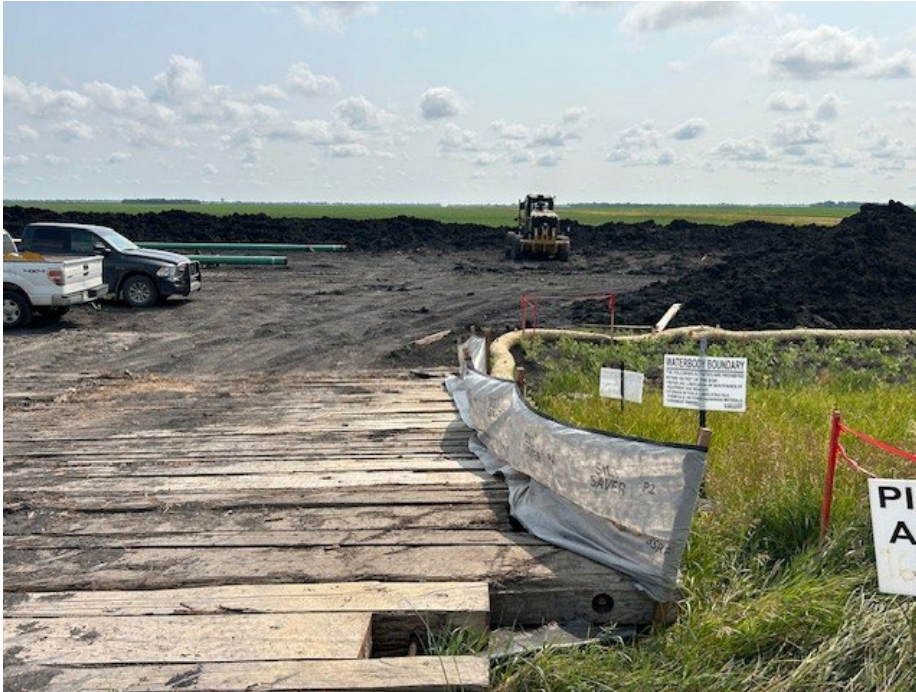
Photo No.: 13

Comments: Agricultural ROW, Waterbody Crossing, Valve Set #2 Site. At the waterbody crossing near the access road to the planned Valve Set #2 site, the resource was clearly staked and marked with signs. Equipment mats and ECDs were properly installed, as needed. Along the workspace, topsoil was properly segregated along the edge of the ROW, and no off-ROW impacts or environmental concerns were identified.

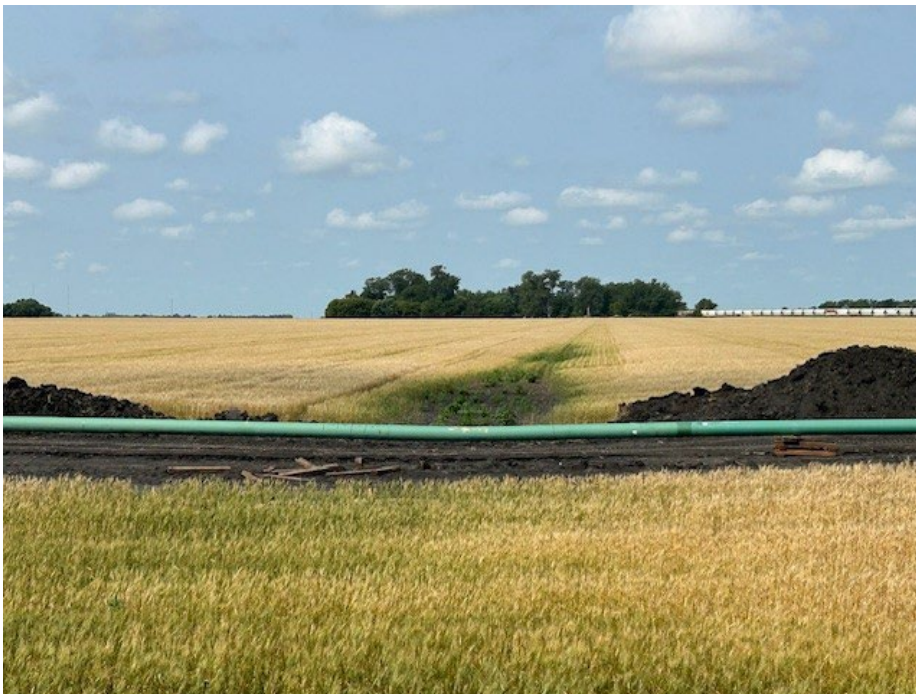
Photo No.: 14

Comments: Agricultural ROW. Pipe was welded along the ROW with a slight bend in the line to accommodate a shallow water feature crossing. No environmental concerns were identified.

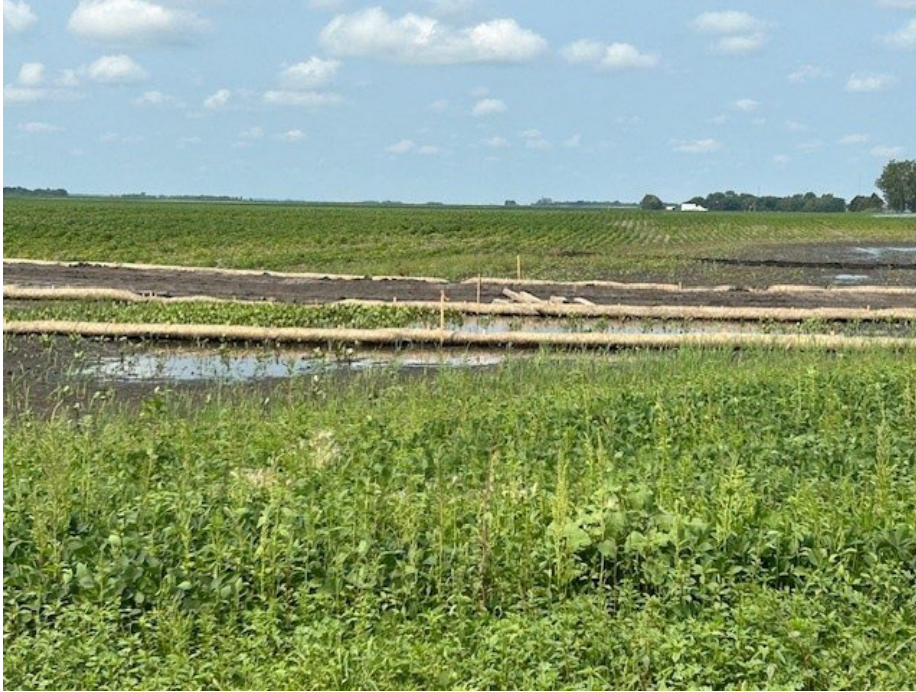
Photo No.: 15

Comments: Agricultural ROW. Standing water from a recent rain event was observed along low-lying areas of the ROW. ECDs were properly installed to prevent off-ROW sediment transport, and no environmental concerns were identified.

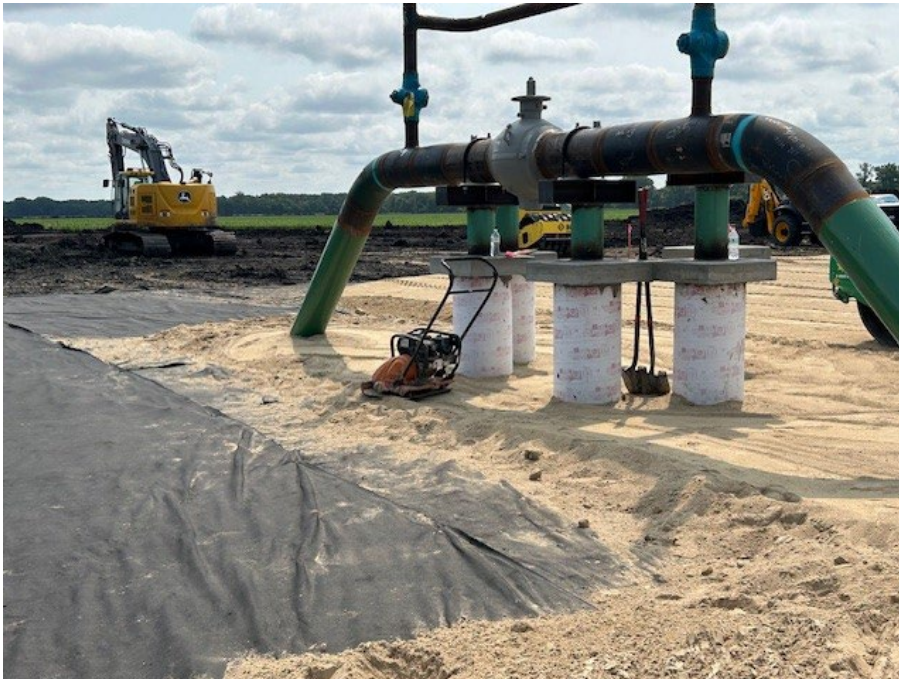
Photo No.: 16

Comments: Aboveground Facility, Valve Set #3 Site (Kindred Border Station). The valve set installation was complete, and the valve pad was being installed. The first layer of soil was being applied on top of geofabric. A second layer of soil would be added, followed by two layers of gravel topped with concrete.

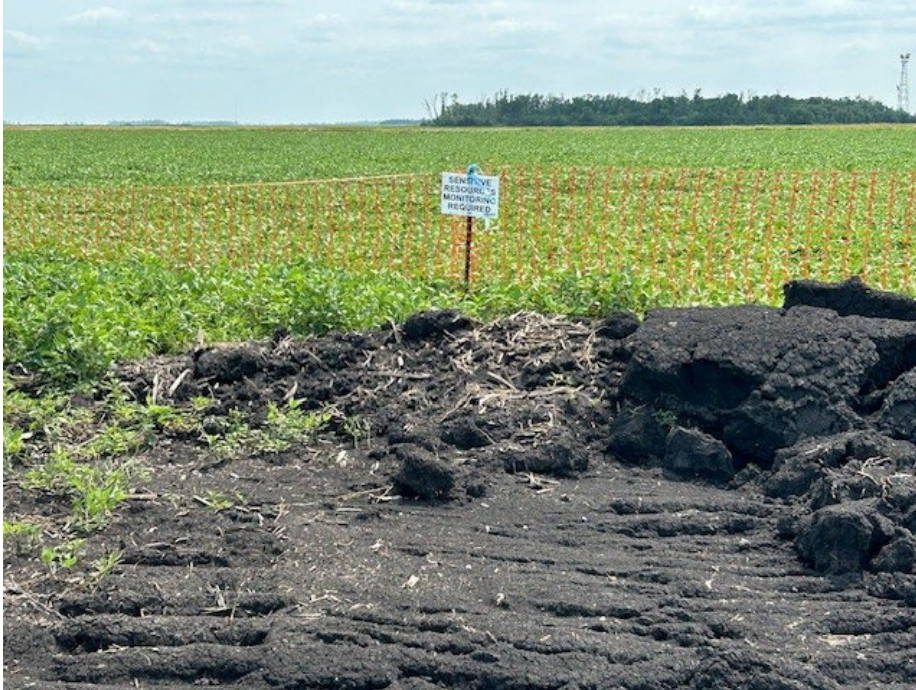
Photo No.: 17

Comments: Agricultural ROW. The sensitive resource area was inspected and no environmental concerns were identified.

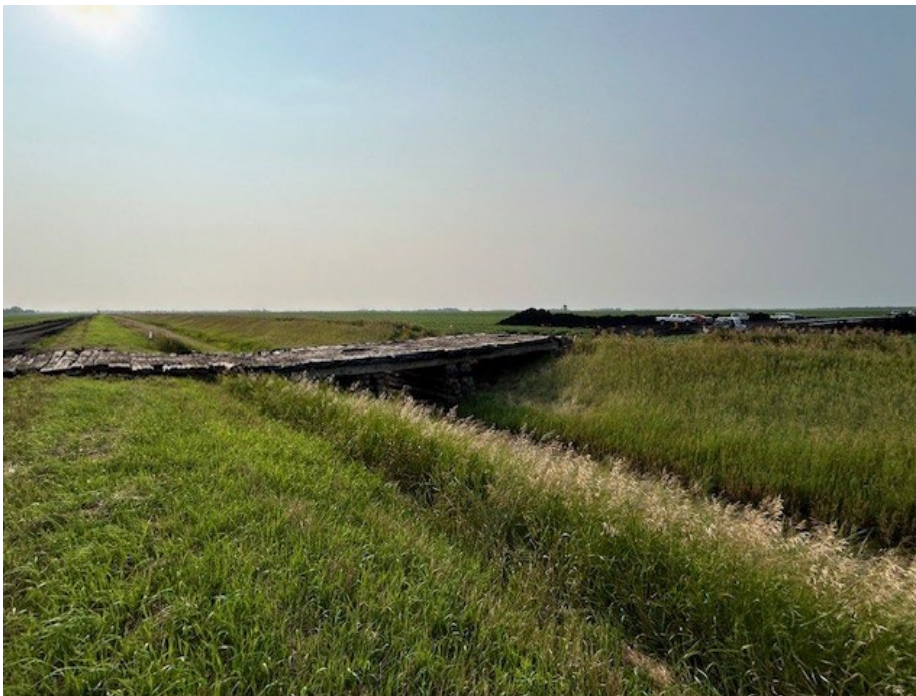
Photo No.: 18

Comments: Open ROW, Waterbody Crossing. An equipment mat bridge was installed at the canal crossing to access the ROW beyond. No environmental concerns were identified.

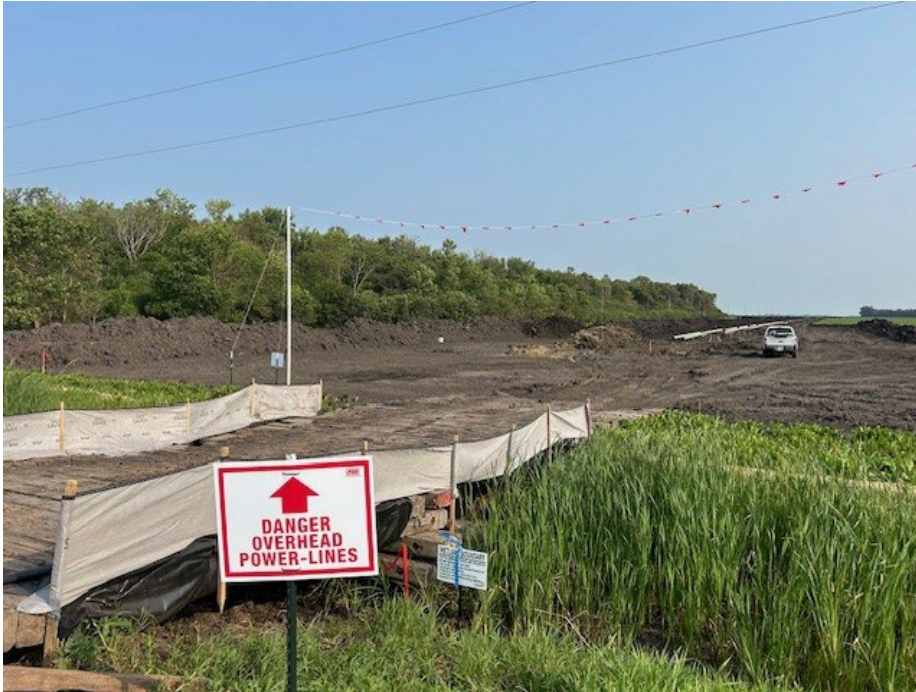
Photo No.: 19

Comments: Open ROW, Waterbody Crossing. An equipment mat bridge was in place across the canal for access to the planned Valve Set #4 site. Overhead powerlines were clearly marked with signs, topsoil was properly segregated along the edge of the ROW, and no environmental concerns were identified.

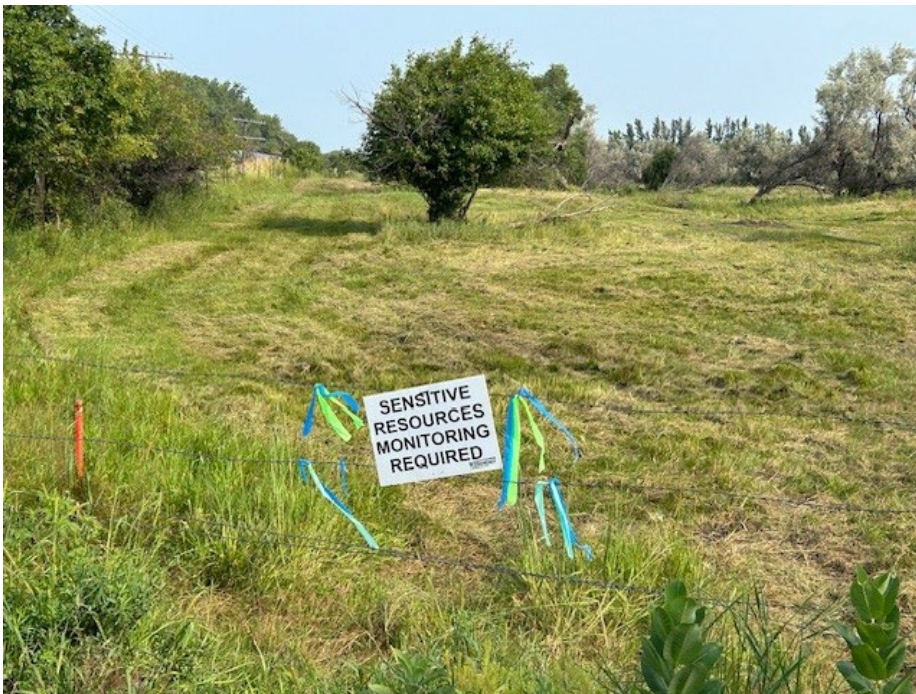
Photo No.: 20

At MP 35.8, access to a segment of the ROW was restricted to protect several migratory bird nests in nearby trees, marked with yellow flagging (Photos Nos. 20 and 21). Work within this area will be avoided until the birds have fledged. Mowing was occurring further along the ROW at MP 36.1 in preparation for grading (Photo No. 22). The location of the planned Valve Set #5 was clearly staked, and topsoil was properly segregated along the edge of the ROW (Photo 23). The inspection ended along the graded ROW adjacent to the planned Bore #50 site on the west side of I-29 (Photo No. 24). This was the southernmost extent of grading along the ROW at the time of the inspection. No off-ROW impacts or environmental concerns were identified.

Comments: Open ROW. Access to the ROW was restricted to protect several migratory bird nests in nearby trees. Work within this area will be avoided until the birds have fledged.

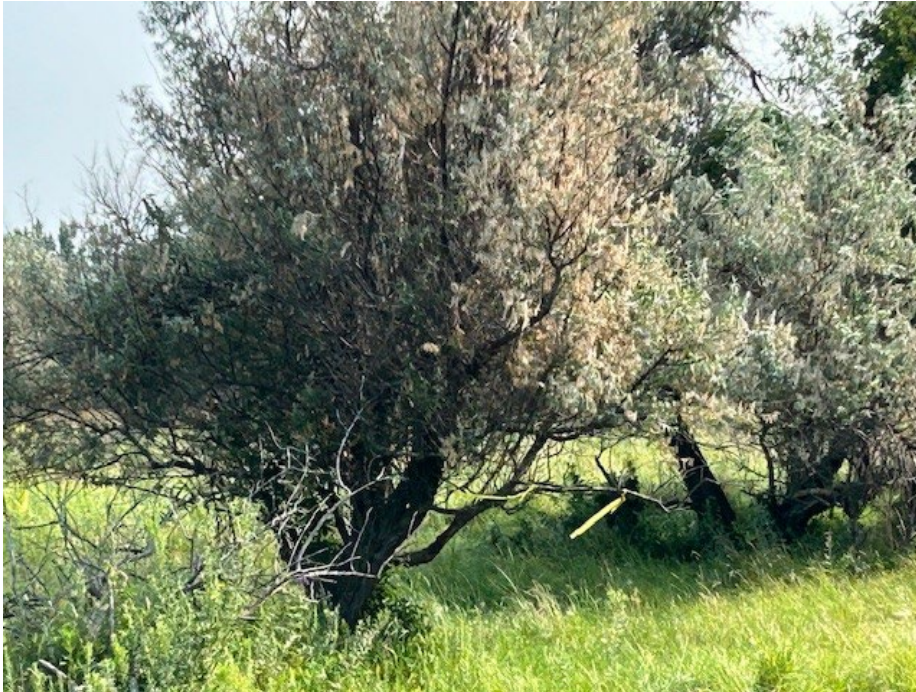
Photo No.: 21

Comments: Open ROW. Access to the ROW was restricted to protect several migratory bird nests in nearby trees (marked with yellow flagging). Work within this area will be avoided until the birds have fledged.

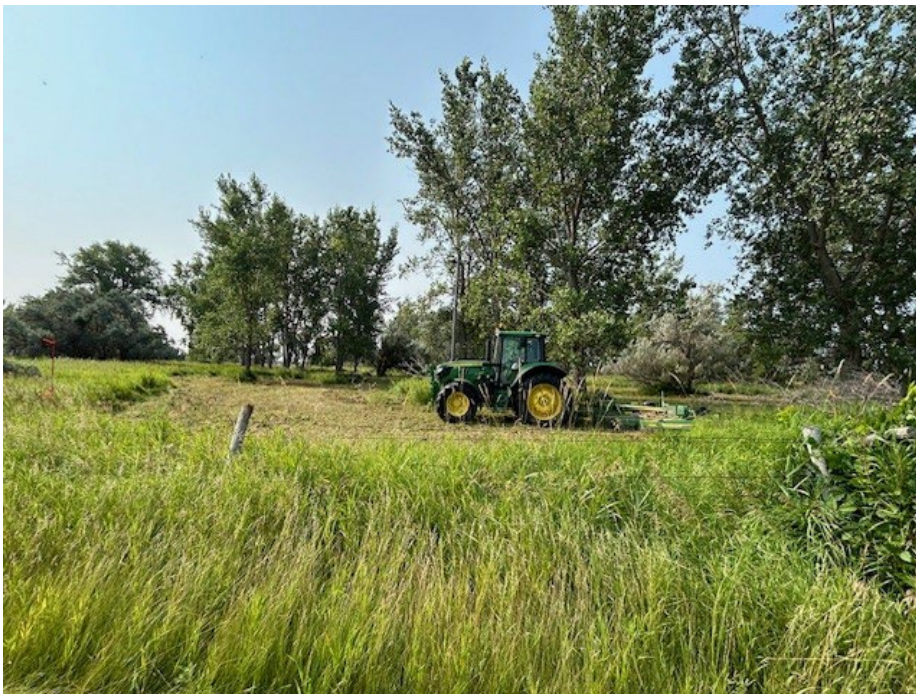
Photo No.: 22

Comments: Open ROW. Mowing was in progress along the ROW in preparation for grading. No environmental concerns were identified.

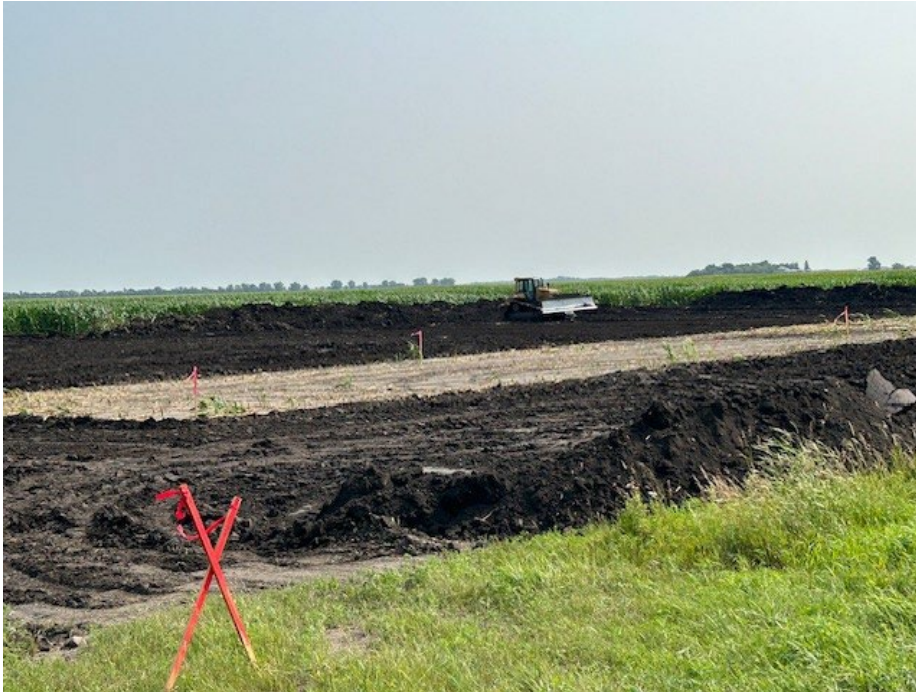
Photo No.: 23

Comments: Agricultural ROW, Valve Set #5 Site. The planned valve set site was clearly staked, with topsoil properly segregated along the edge of the ROW. No off-ROW impacts or environmental concerns were identified.

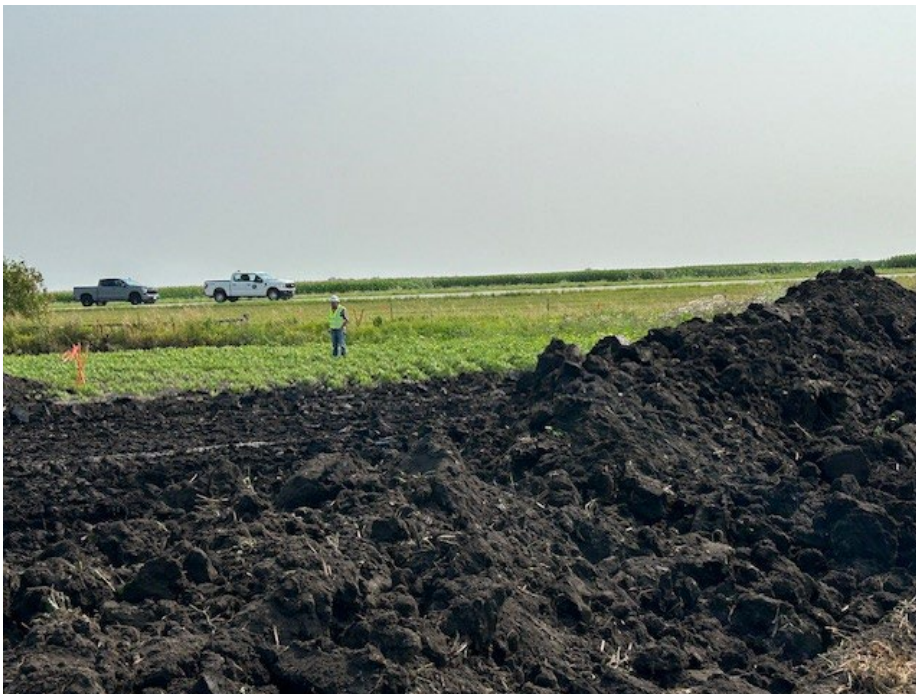
Photo No.: 24

Comments: Agricultural ROW, Bore #50 Site. The edge of the Bore #50 site, on the west side of I-29, was the southernmost extent of grading along the ROW at the time of the inspection. No off-ROW impacts or environmental concerns were identified.
