## FEDERAL ENERGY REGULATORY COMMISSION FIELD INSPECTION REPORT

**Date** August 21 and 22, 2024

**Project** WBI Energy Transmission, Inc.  
Wahpeton Expansion Project  
Cass and Richland Counties, North Dakota  
Docket No.: CP22-466-000  
Authority: Section 7(c)

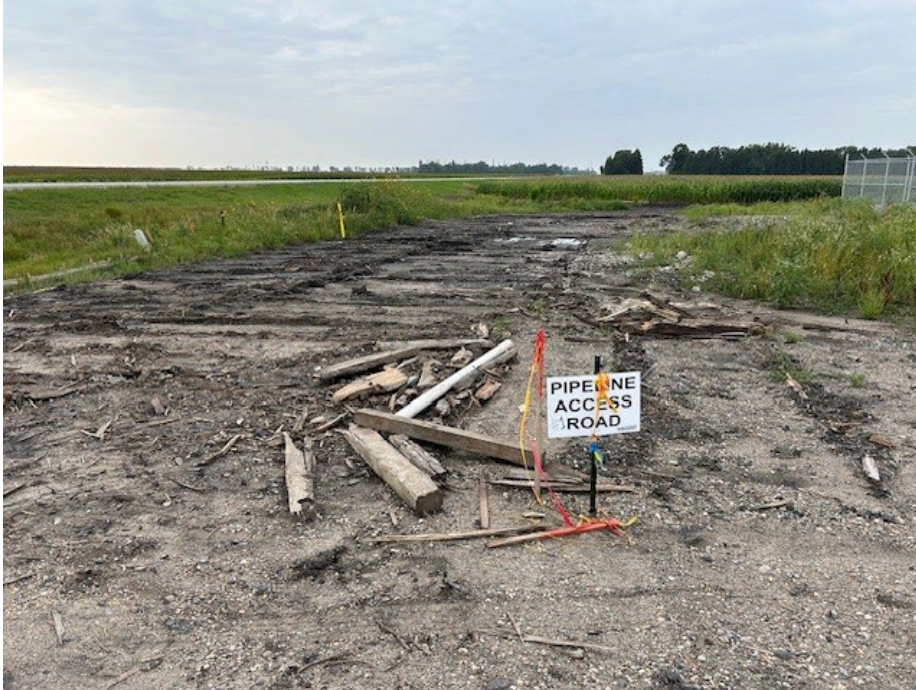
**Photo No.:** 1

**Comments:** Agricultural ROW. At the WBI Mapleton CS, the new Valve Set #1 and pad installations were complete and stable (not pictured), and equipment mats were removed from the ROW access point for final cleanup. No environmental concerns were identified.

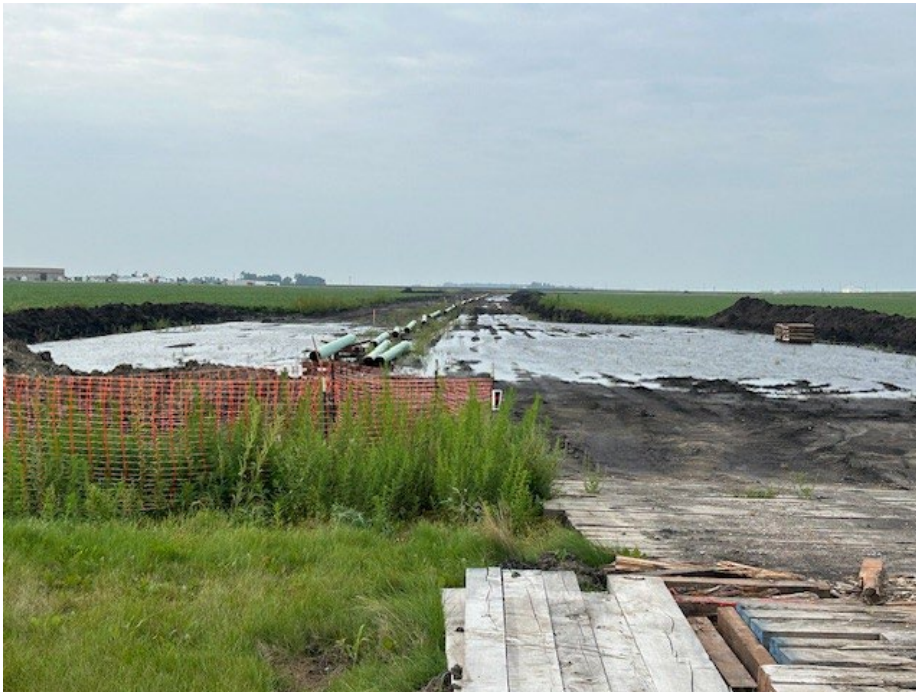
**Photo No.:** 2

**Comments:** Agricultural ROW, Bore #8 Site. The ROW on the west side of the bore crossing was flooded from heavy rainfall the week before the inspection. Saturated/flooded soils conditions prevented equipment from accessing the ROW for ongoing construction activities. No environmental concerns were identified.

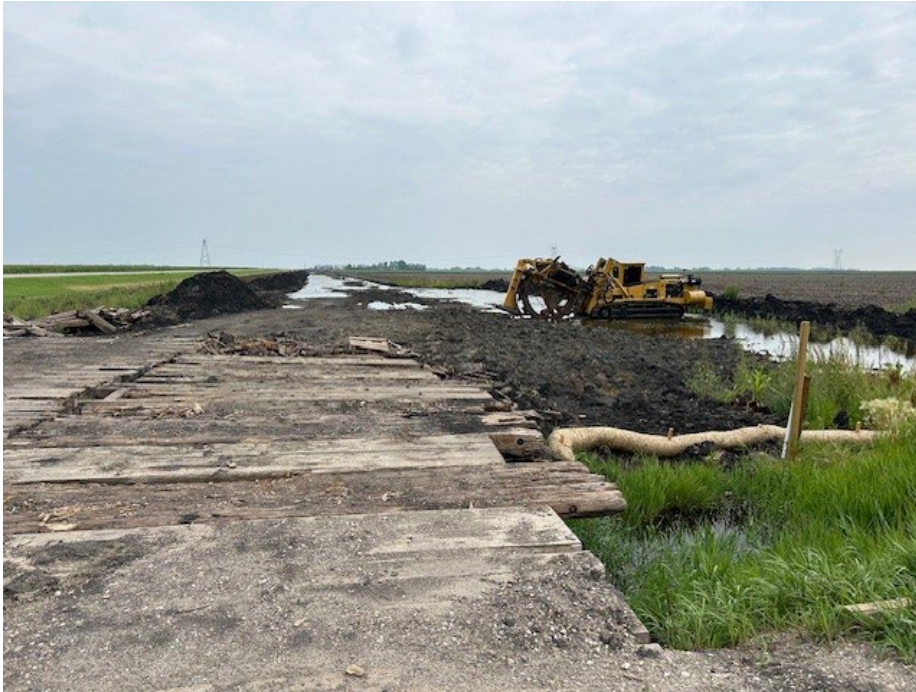
**Photo No.:** 3

**Comments:** Agricultural ROW, Bore #16 Site. The ROW was flooded at the bore crossing site, where several pieces of heavy equipment remained in place to minimize rutting along the ROW. No environmental concerns were identified.

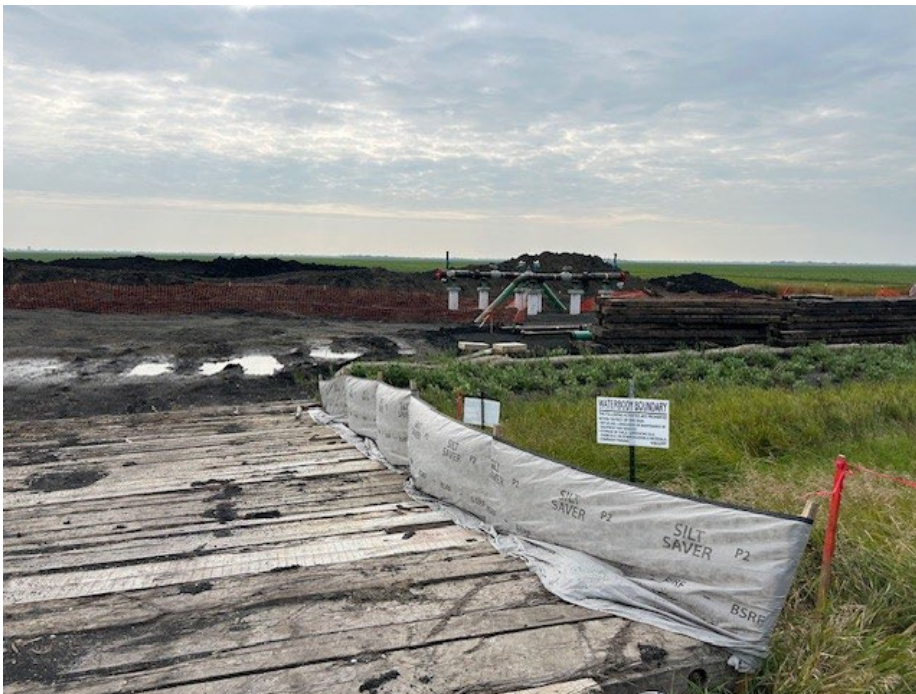
**Photo No.:** 4

**Comments:** Aboveground Facility, Valve Set #2 Site. The valve set installation was complete, but pad installation was delayed by flooding. ECDs protected the adjacent waterbody from sediment migration. No environmental concerns were identified.

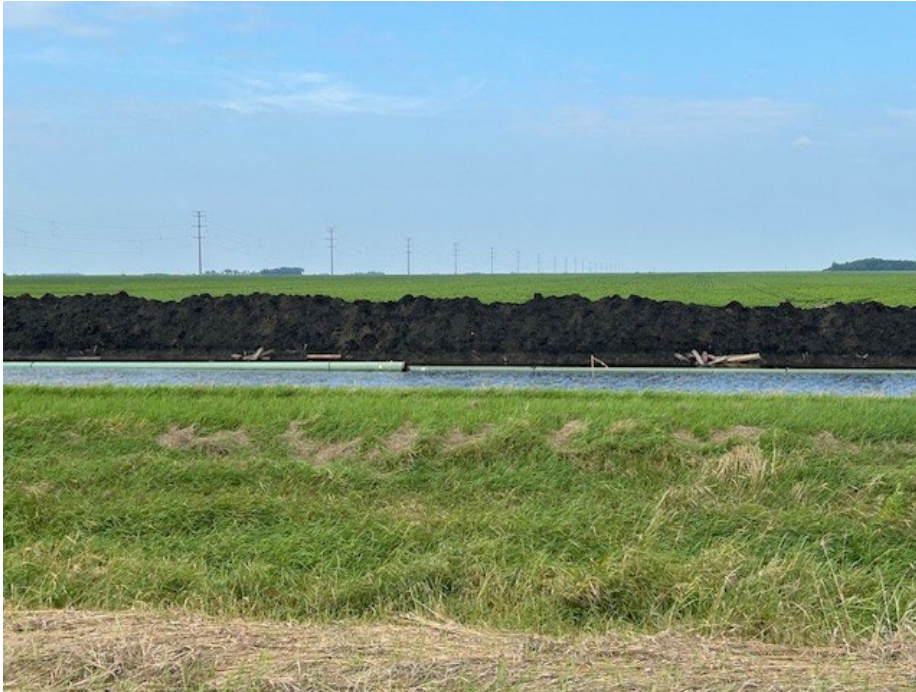
**Photo No.:** 5

**Comments:** Agricultural ROW. The ROW south of the Bore #18 crossing was completely flooded, preventing access. Segregated topsoil was stable, and no environmental concerns were identified.

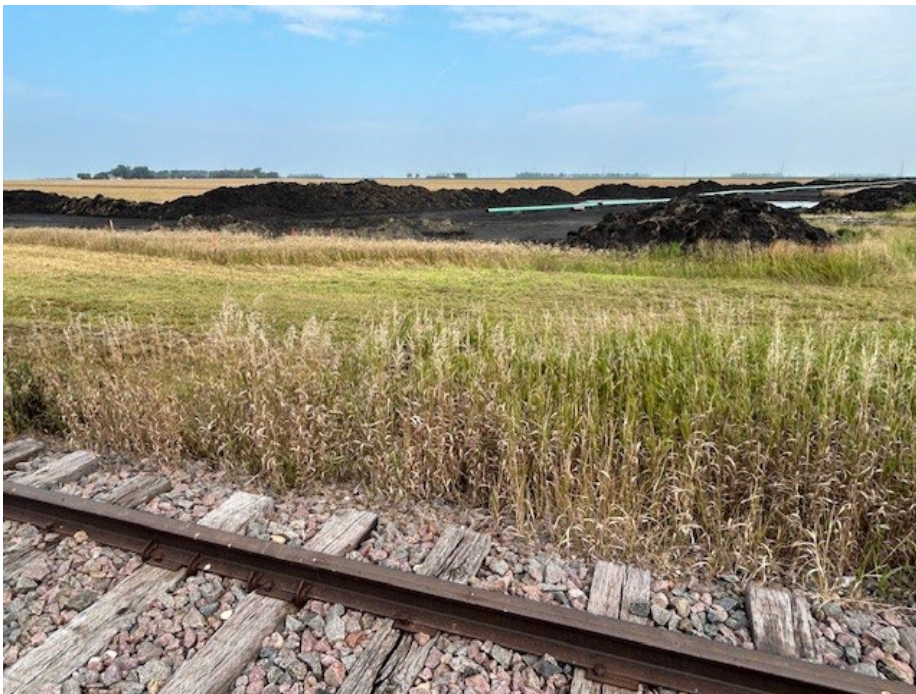
**Photo No.:** 6

**Comments:** Agricultural ROW, Bore #25 Site. Pipe segments were staged for welding, but the crossing beneath the BNSF Railroad was pending. The ROW was clearly staked, with topsoil properly segregated along the edge of the ROW. No environmental concerns were identified.

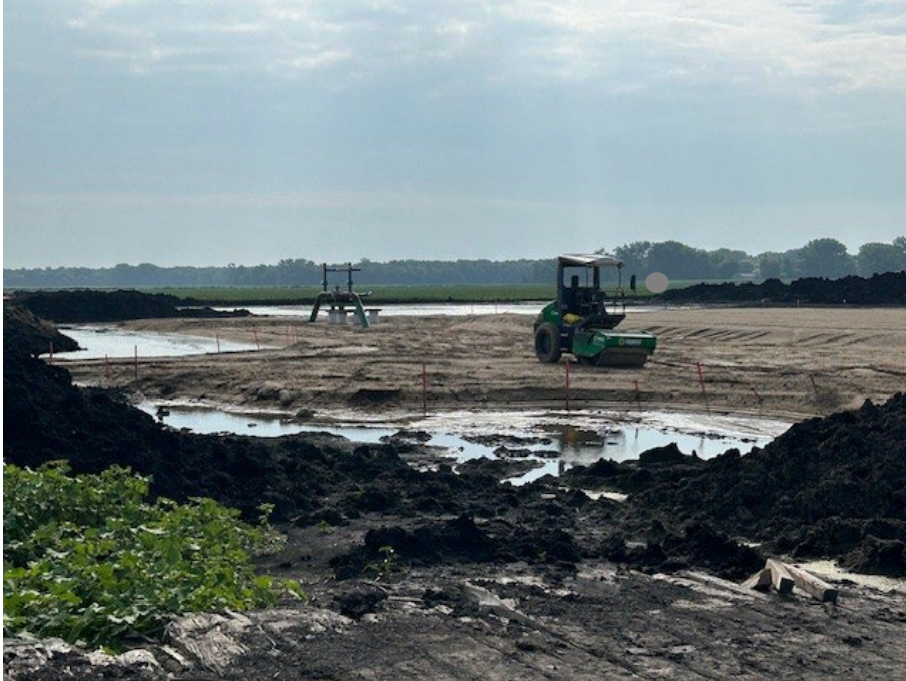
**Photo No.:** 7

**Comments:** Aboveground Facility, Valve Set #3 Site (Kindred Border Station). Several lifts of soil were installed on top of geofabric at the valve set site; however, completion of the pad was delayed by flooding. No environmental concerns were identified.

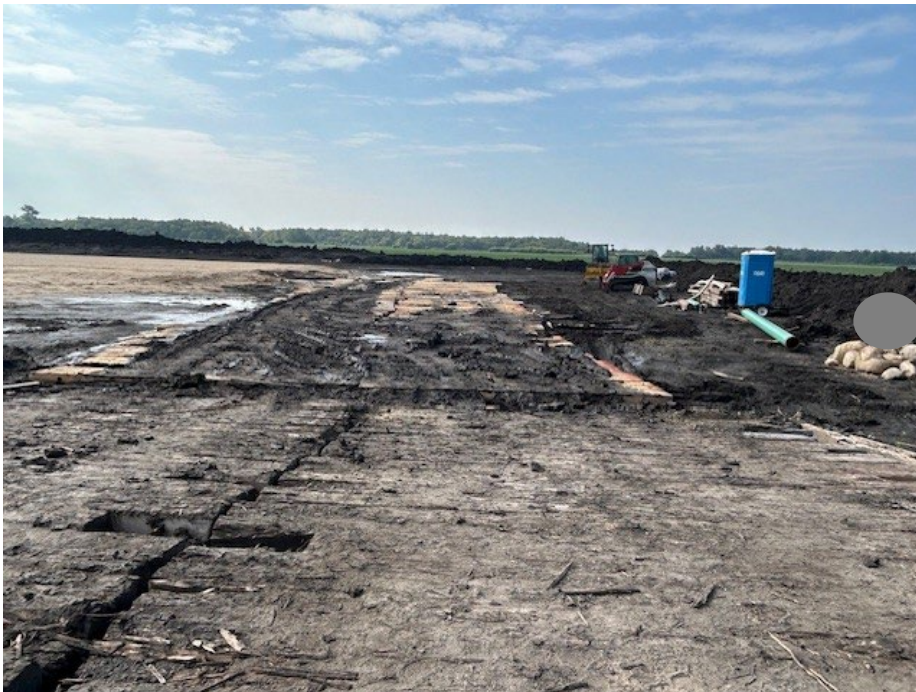
**Photo No.:** 8

**Comments:** Agricultural ROW. The pipeline tie-in site was extremely muddy, delaying completion of the tie-in. No environmental concerns were identified.

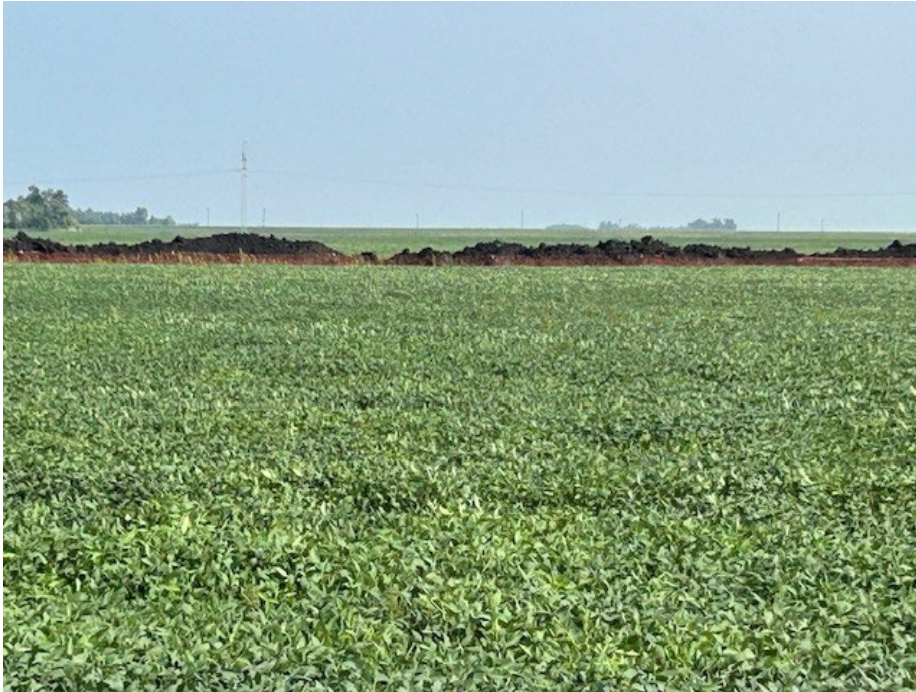
**Photo No.:** 9

**Comments:** Agricultural ROW. ROW clearing and grading were completed along an area formerly closed to access due to a potential sensitive resource area. No environmental concerns were identified.

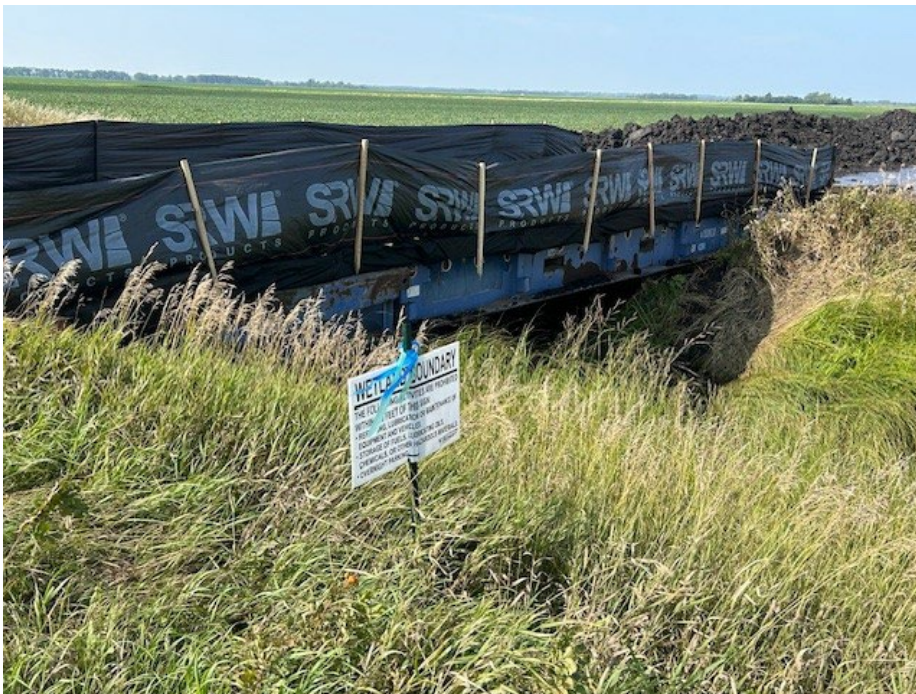
**Photo No.:** 10

**Comments:** Agricultural ROW, Bore #35 Site. The bore site for crossing beneath the wetland area was flooded; however, ECDs had prevented any sediment migration into the wetland. No environmental concerns were identified.

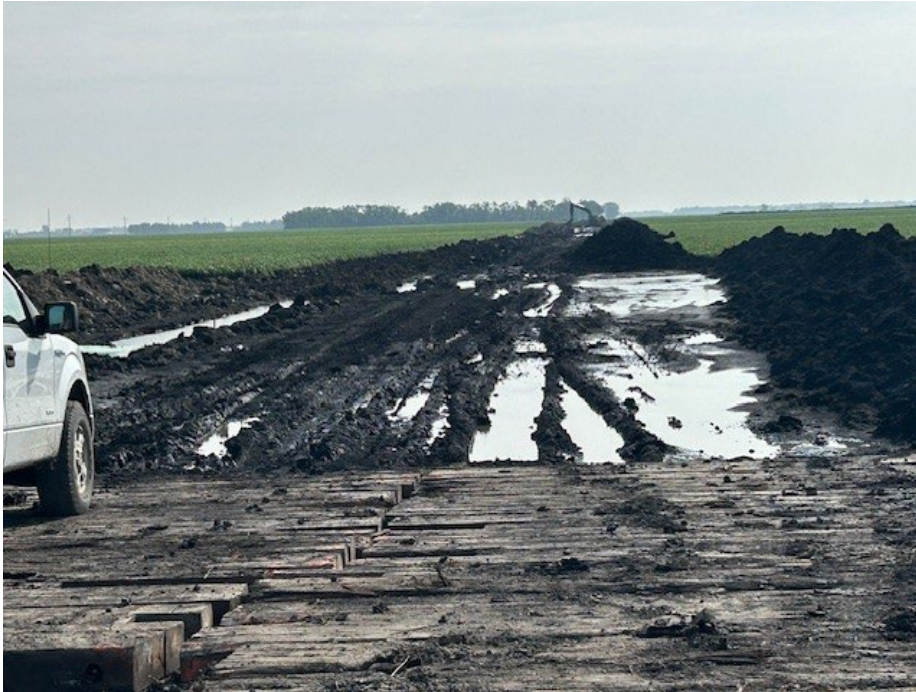
**Photo No.:** 11

**Comments:** Agricultural ROW, Bore #35 Site. The bore crossing sites were flooded on both sides of the road. However, the ROW was stable, with no off-ROW impacts or environmental concerns identified.

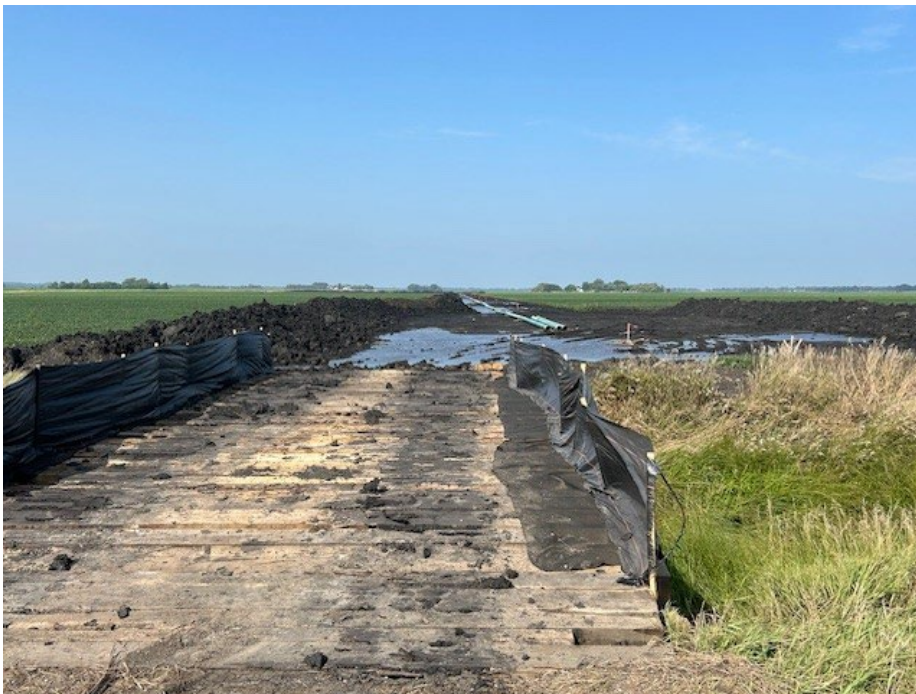
**Photo No.:** 12

**Comments:** Agricultural ROW, Bore #35 Site. The bore crossing sites were flooded on both sides of the road. However, the ROW was stable, with no off-ROW impacts or environmental concerns identified.

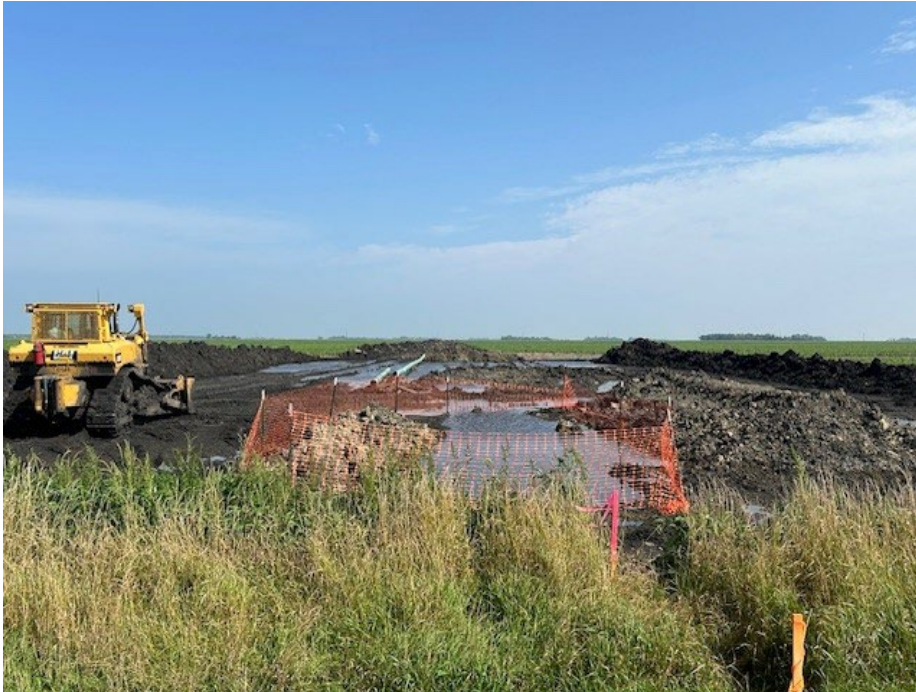
**Photo No.:** 13

**Comments:** Agricultural ROW, Bore #37 Site. The bore crossing site and ROW were flooded, preventing access. However, the ROW was stable, with no off-ROW impacts or environmental concerns identified.

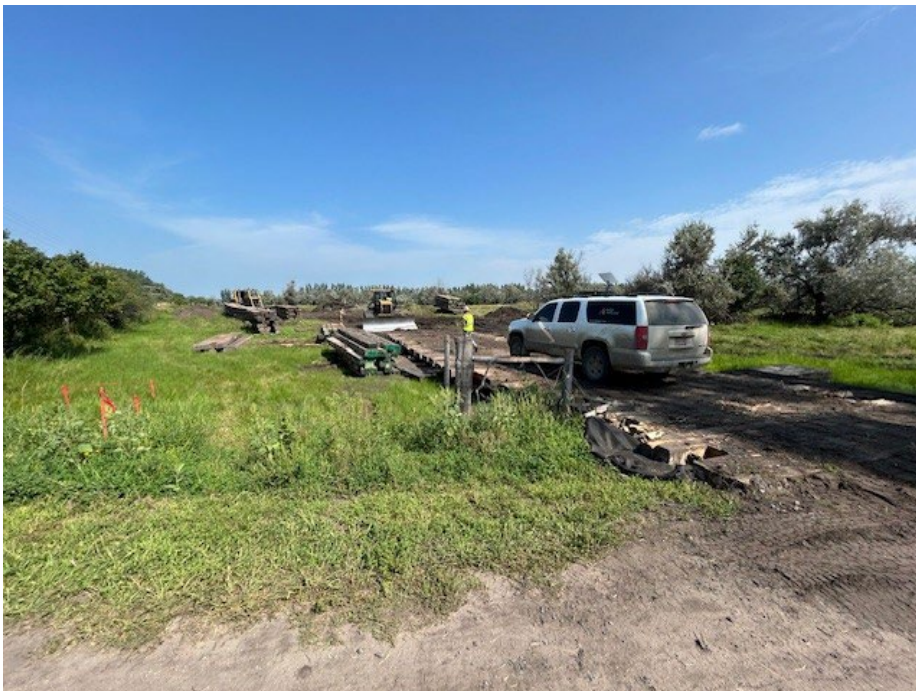
**Photo No.:** 14

**Comments:** Open ROW, Bore #42 Site. Along the ROW near/at the Bore # 42 crossing, clearing and grading were in progress, where the area was previously closed to protect nesting birds. No environmental concerns were identified.

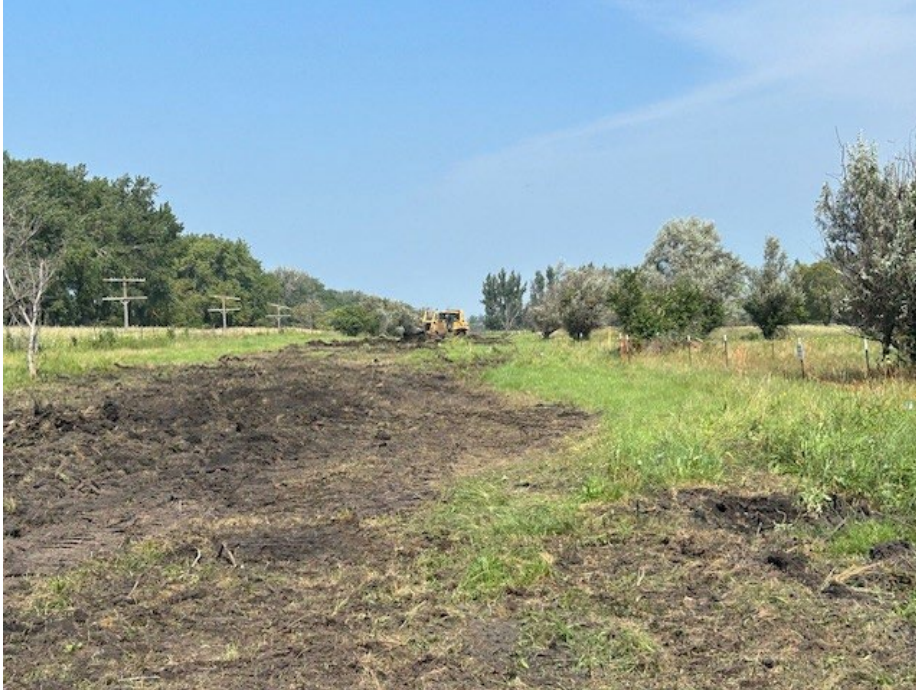
**Photo No.:** 15

**Comments:** Open ROW, Bore #42 Site. Along the ROW near/at the Bore # 42 crossing, clearing and grading were in progress, where the area was previously closed to protect nesting birds. No environmental concerns were identified.

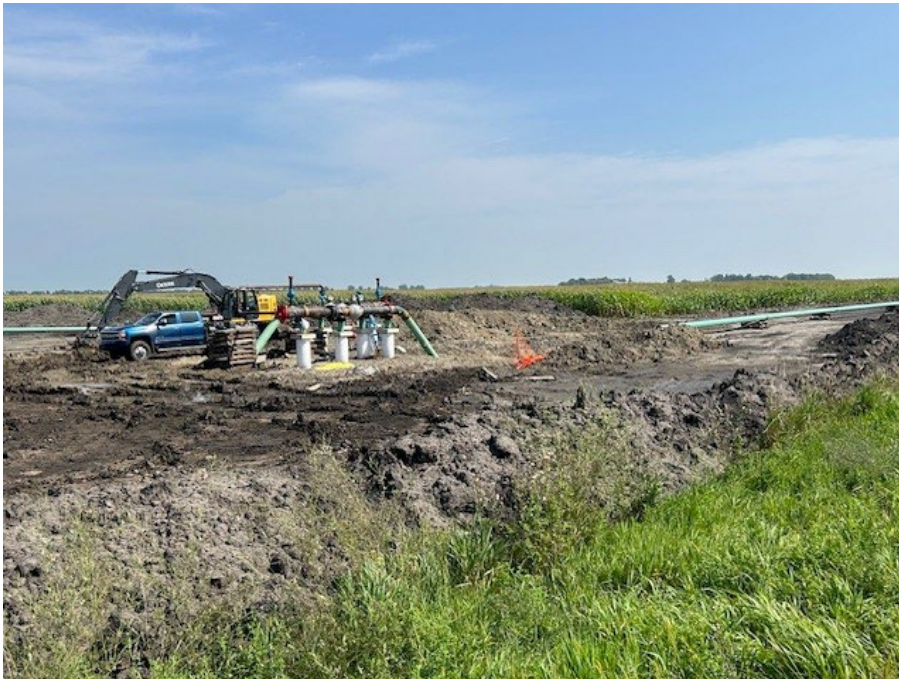
**Photo No.:** 16

**Comments:** Aboveground Facility, Valve Set #5 Site. The valve set installation was complete; however, completion of the pad was delayed by flooding. No environmental concerns were identified.

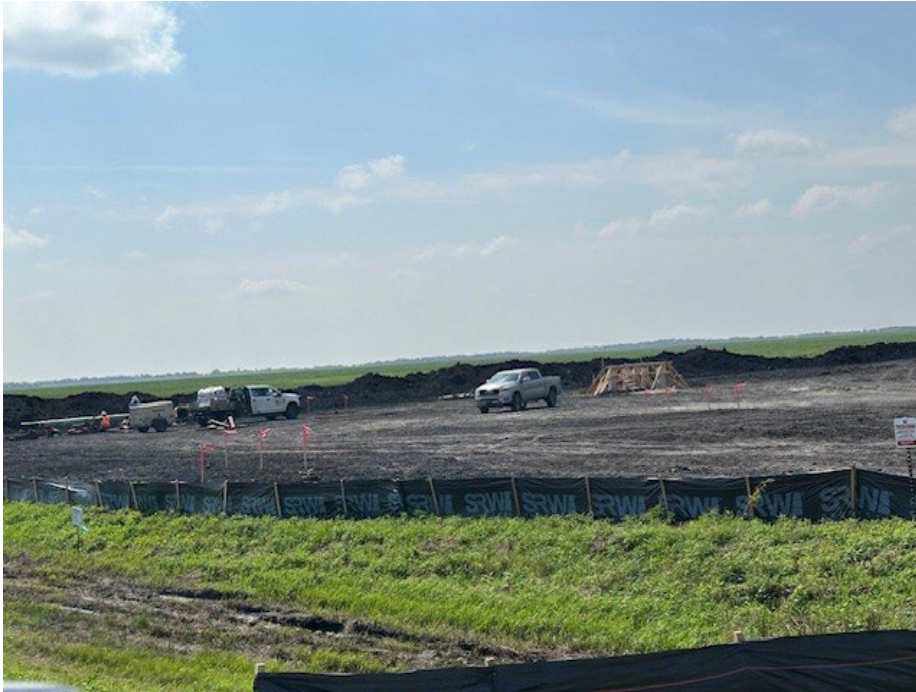
**Photo No.:** 17

**Comments:** Aboveground Facility. Wahpeton Border Station. The Wahpeton Border Station site was cleared and graded. All ECDs were in place, and no environmental concerns were identified.

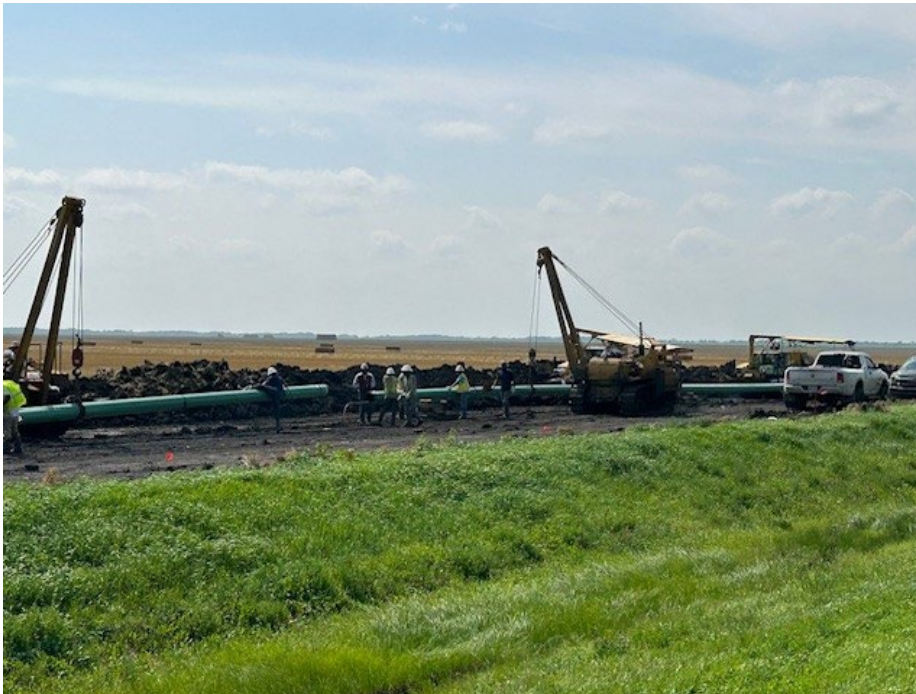
**Photo No.:** 18

**Comments:** Agricultural ROW. The southern half of the ROW was less inundated with water than the northern half, so a welding crew was welding the pipe on this portion of the ROW. No environmental concerns were identified.

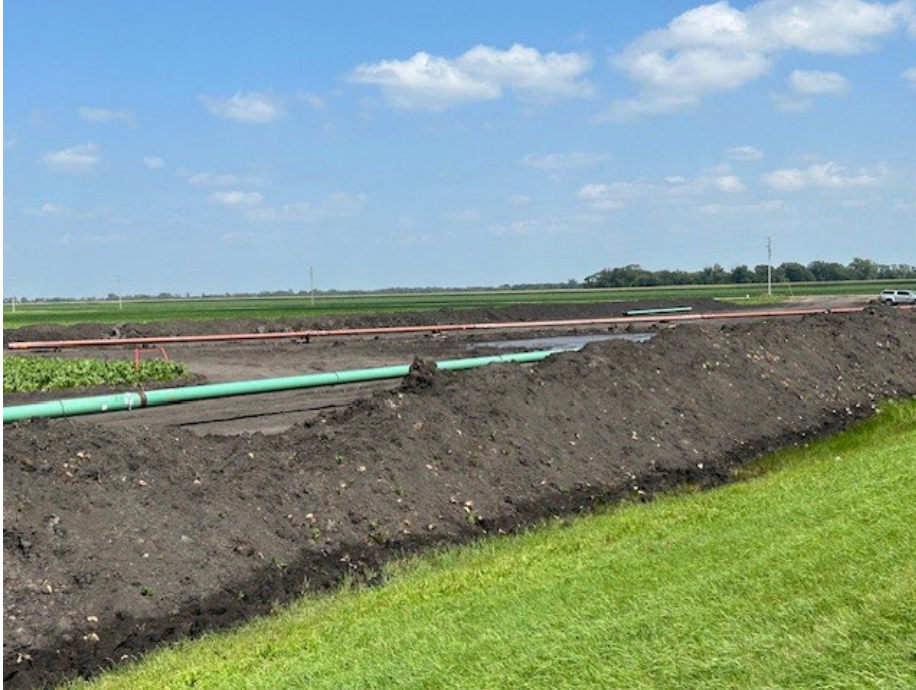
**Photo No.:** 19

**Comments:** Agricultural ROW, Bore #67 Site. Welded pipe string was staged along the ROW for the bore crossing, pending favorable working conditions. The ROW was clearly staked, segregated topsoil stockpiles were stable, and no environmental concerns were identified.

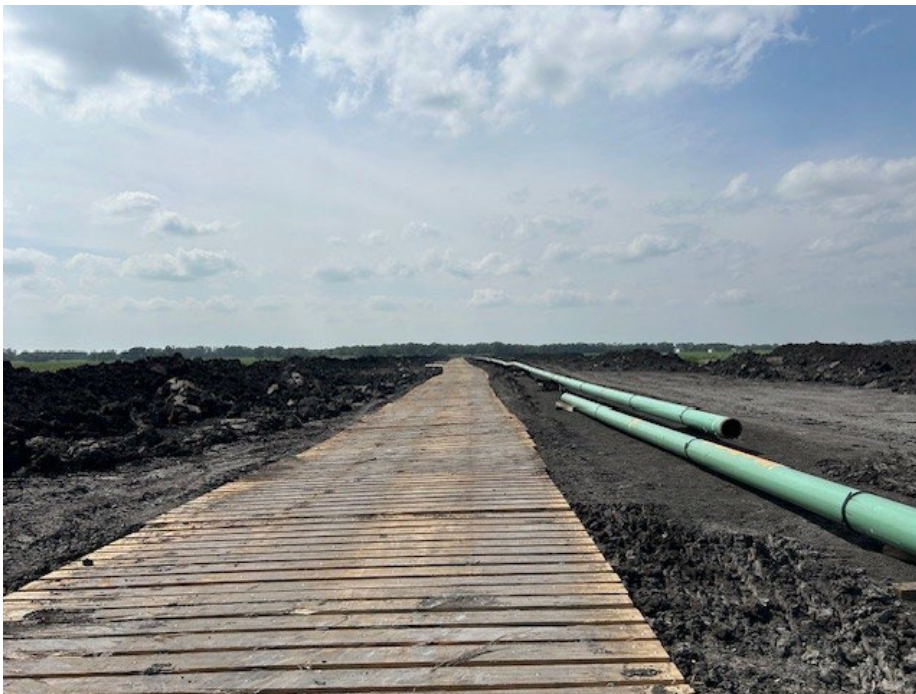
**Photo No.:** 20

**Comments:** Agricultural ROW, Bore #64 Site. Access to the bore site, for crossing beneath the Wild Rice River, was saturated/muddy but protected with equipment mats to allow access for the drill rig. Trenching along the ROW was pending dryer soil conditions. No environmental concerns were identified.

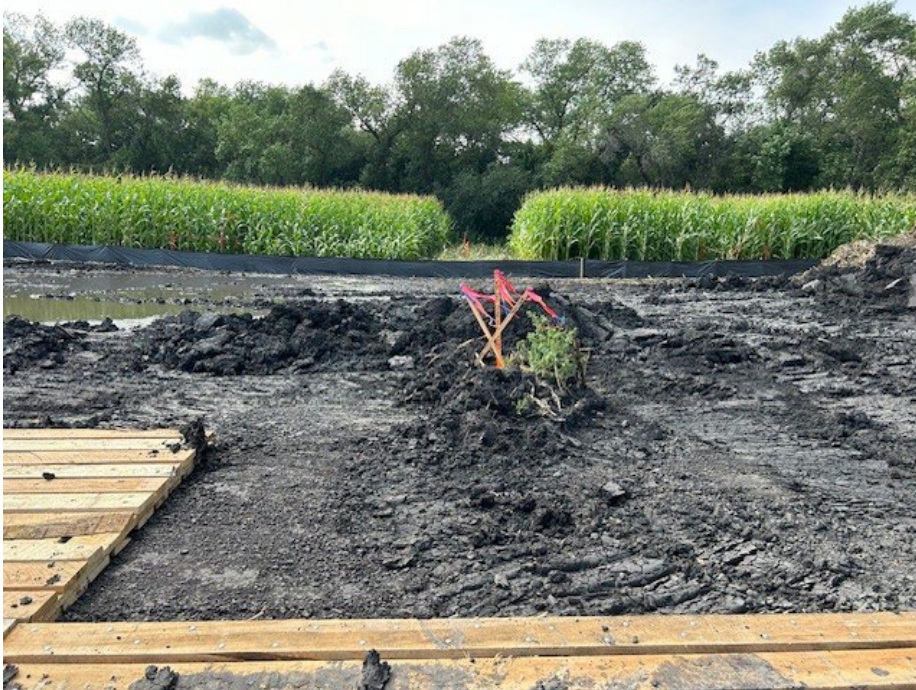
**Photo No.:** 21

**Comments:** Agricultural ROW, Bore # 64 Site. Access to the bore site, for crossing beneath the Wild Rice River, was saturated/muddy but protected with equipment mats to allow access for the drill rig. Trenching along the ROW was pending dryer soil conditions. No environmental concerns were identified.

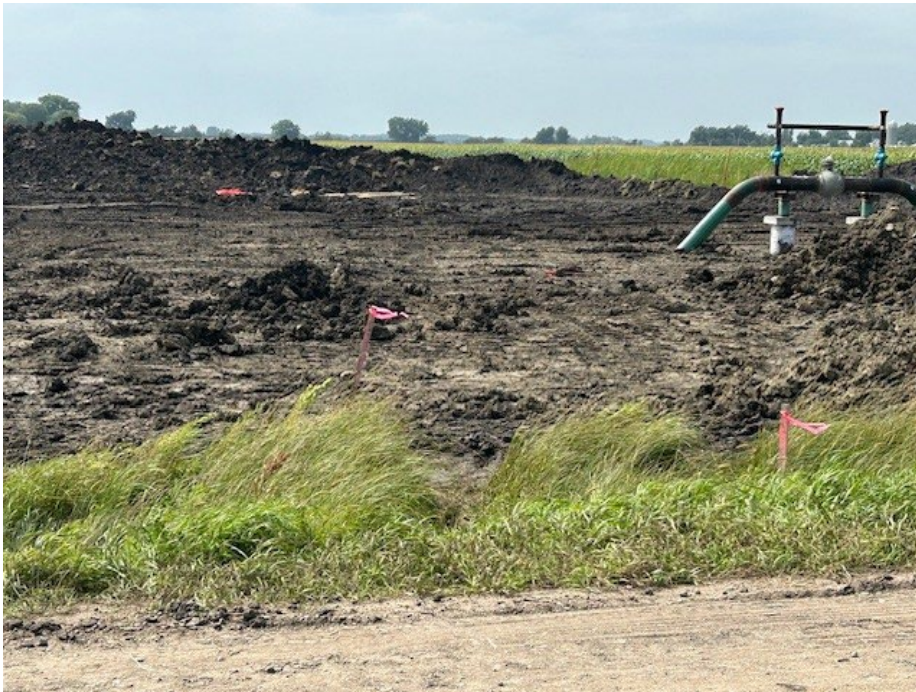
**Photo No.:** 22

**Comments:** Aboveground Facility. Valve Set #6. The valve set installation was complete; however, completion of the pad was delayed by heavy rains, rendering the ROW inaccessible. No environmental concerns were identified.

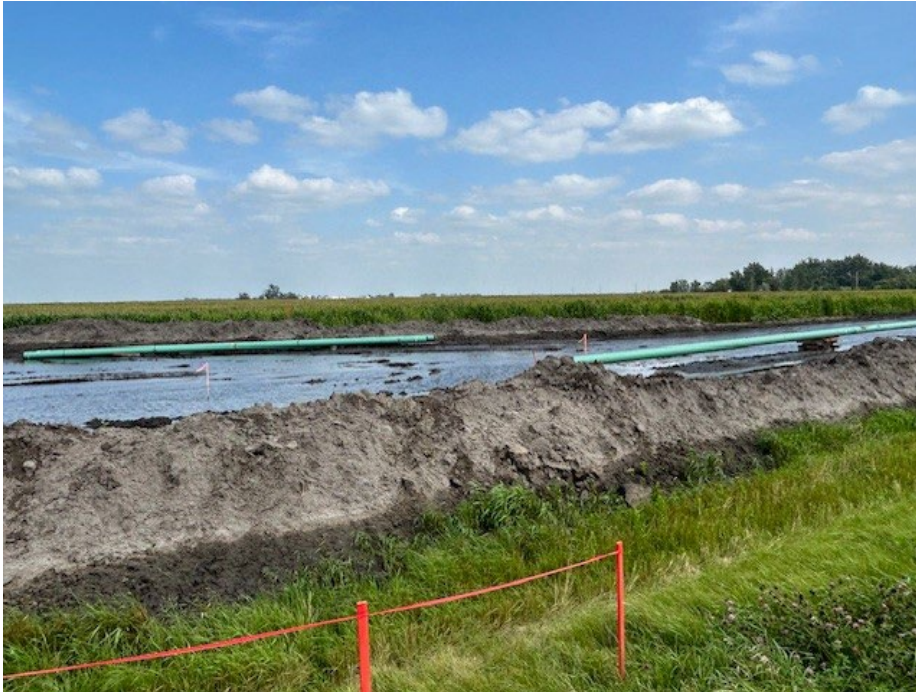
**Photo No.:** 23

**Comments:** Agricultural ROW. The ROW was flooded, preventing access. However, no off-ROW impacts or environmental concerns were identified.

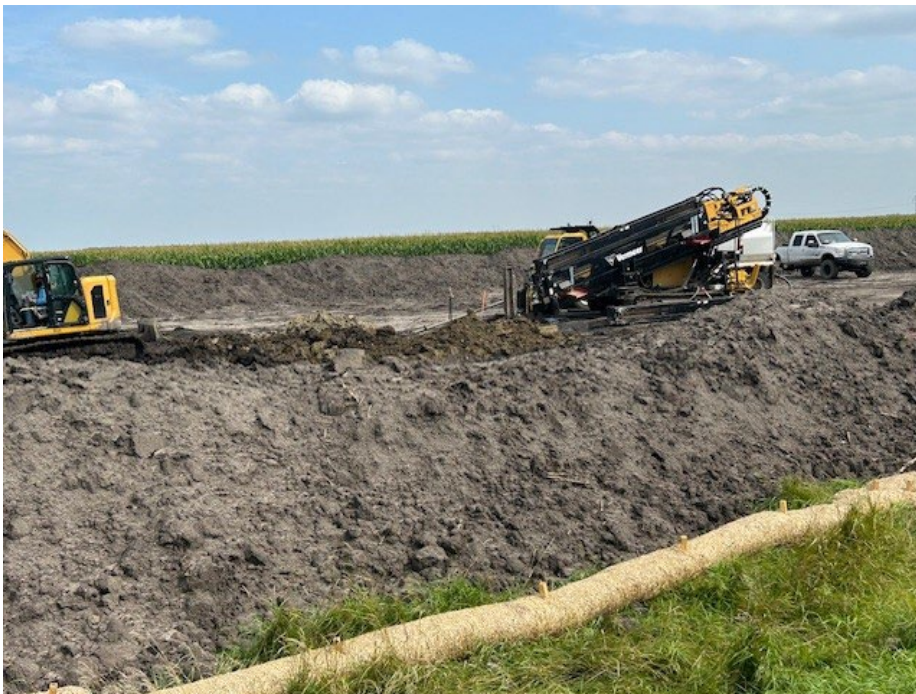
**Photo No.:** 24

**Comments:** Agricultural ROW, Bore # 57 site. The crossing beneath Pitcairn Creek was in progress. All drilling mud was contained, and no environmental concerns were identified.

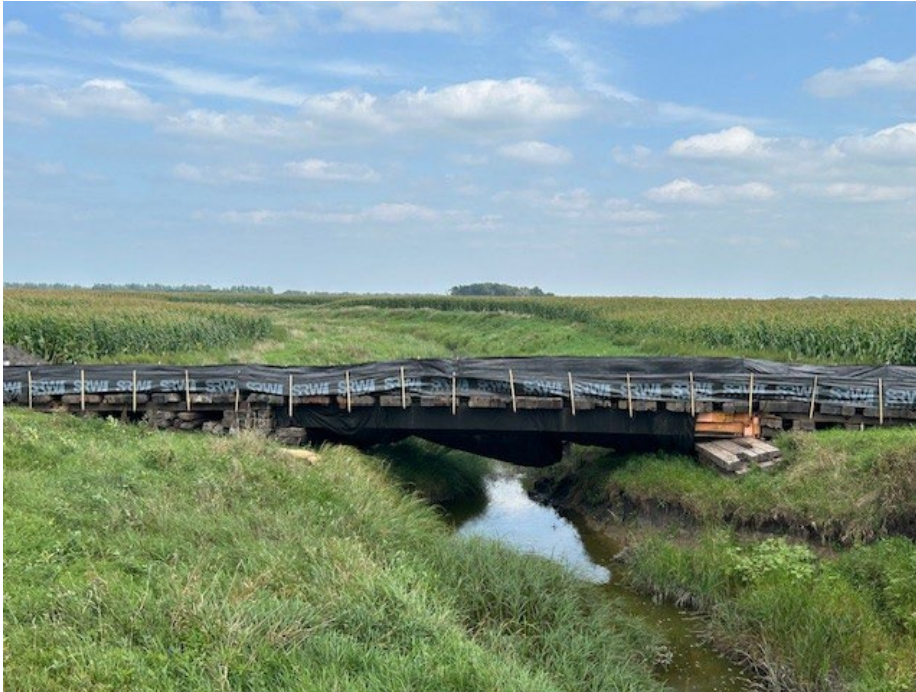
**Photo No.:** 25

**Comments:** Agricultural ROW, Bore # 57 Site. The crossing beneath Pitcairn Creek was in progress, and an equipment bridge was properly installed across the waterbody. All drilling mud was contained, and no environmental concerns were identified.

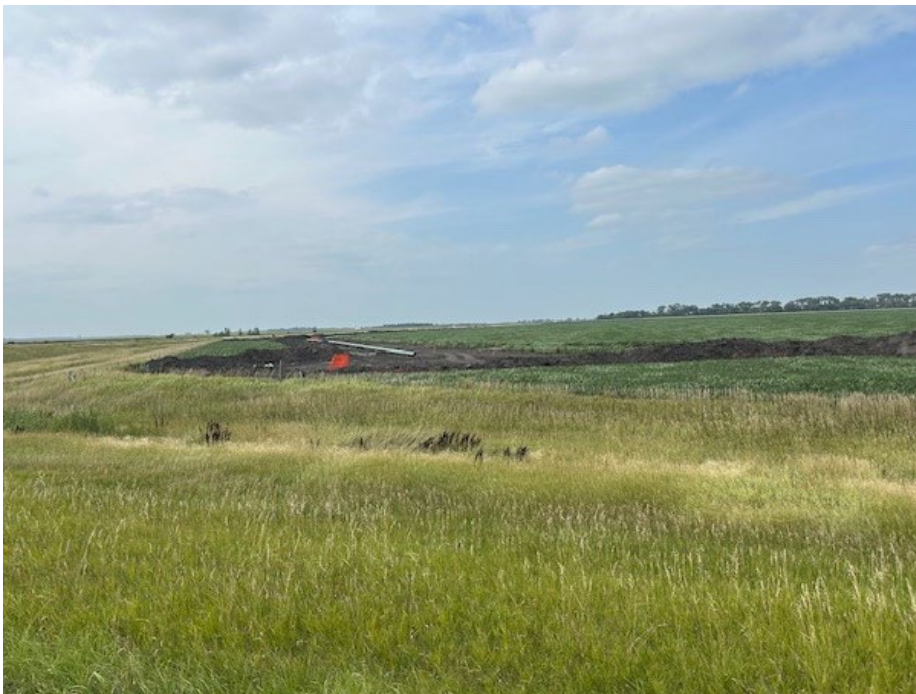
**Photo No.:** 26

**Comments:** Agricultural ROW. The ROW west of the onramp to I-29 from County Road 4 was clearly staked, with topsoil properly segregated. No off-ROW impacts or environmental concerns were identified.
