FEDERAL ENERGY REGULATORY COMMISSION FIELD INSPECTION REPORT

Date October 15 and 16, 2024

Project WBI Energy Transmission, Inc.
Wahpeton Expansion Project
Cass and Richland Counties, North Dakota
Docket No.: CP22-466-000
Authority: Section 7(c)

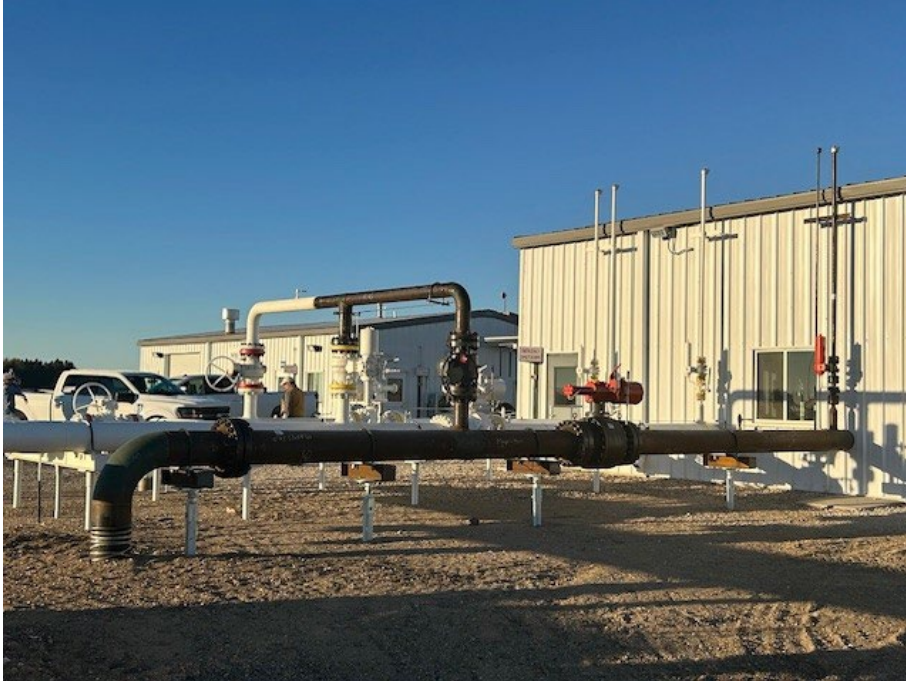
Photo No.: 1

Comments: Aboveground Facility, Mapleton Compressor Station. The pipe modifications were complete, with final painting pending. The area was free of rutting and construction debris. Protective equipment mats remained in place at the construction entry point from the public road. The entry was well maintained, and the road was free of tracked mud and construction materials. No environmental concerns were identified.

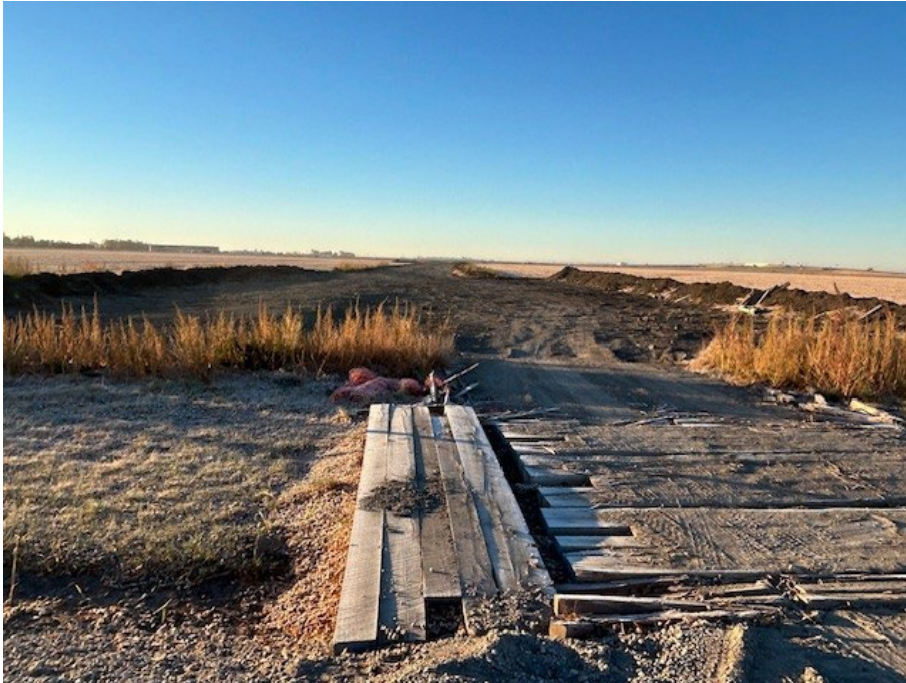
Photo No.: 3

Comments: Agricultural ROW, Bore #7 and #8 Site. Equipment mats at the ROW entry point were properly installed and maintained. The public road was free of tracked mud and debris. No environmental concerns were identified.

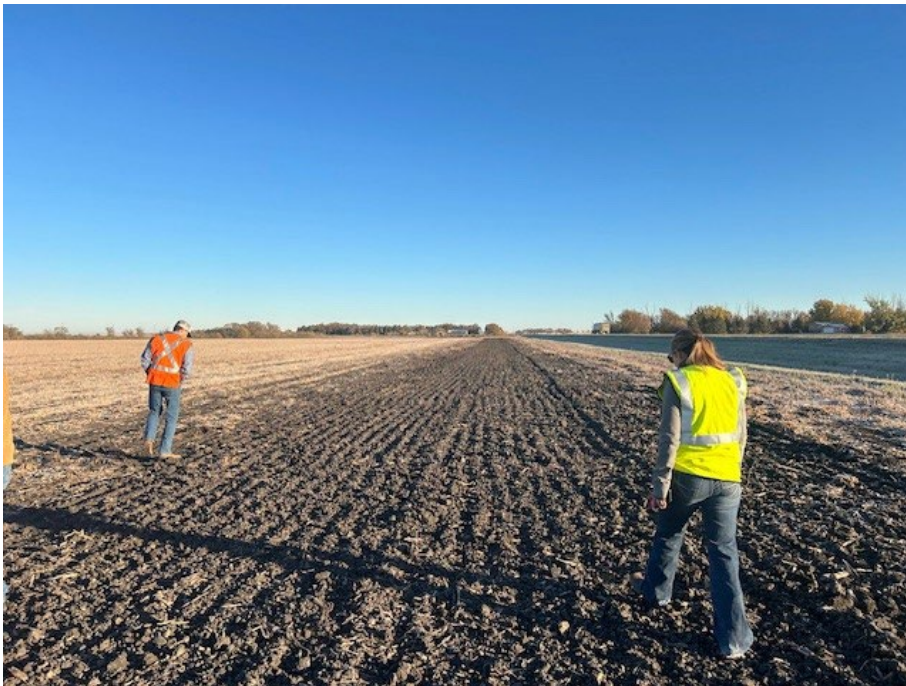
Photo No.: 4

Comments: Agricultural ROW. The former access road to the ROW was being walked after the equipment mat was removed to ensure that no mat debris was left behind. No debris or other environmental concerns were identified.

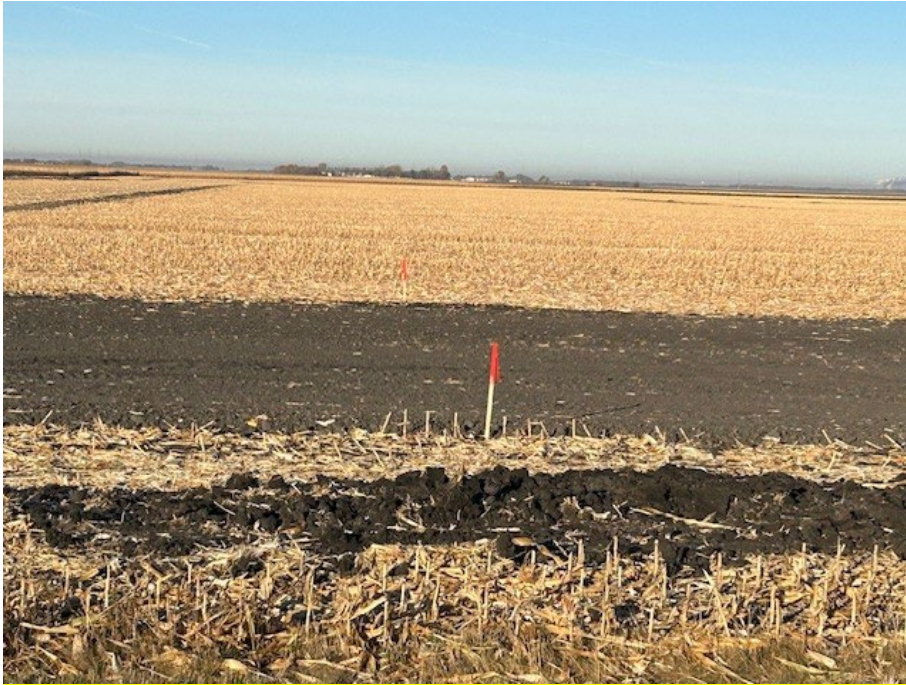
Photo No.: 5

Comments: Agricultural ROW. The ROW was re-staked, as stakes were absent during the September FERC inspection. The ROW was final-graded with contours and topsoil restored, and no environmental concerns were identified.

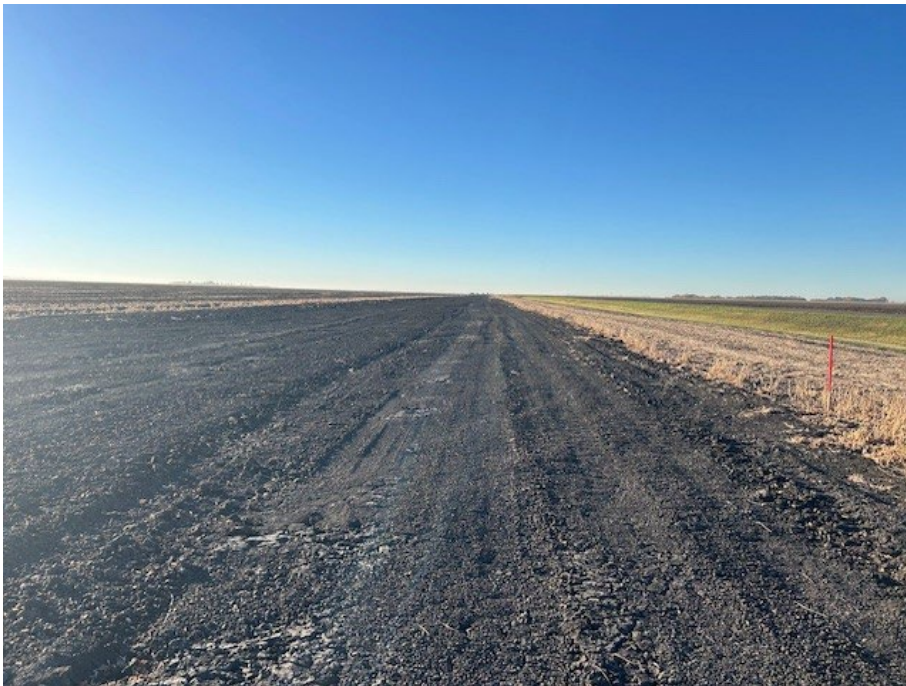
Photo No.: 6

Comments: Agricultural ROW. Final cleanup and rough-grading were complete, and stakes remained in place. No environmental concerns were identified.

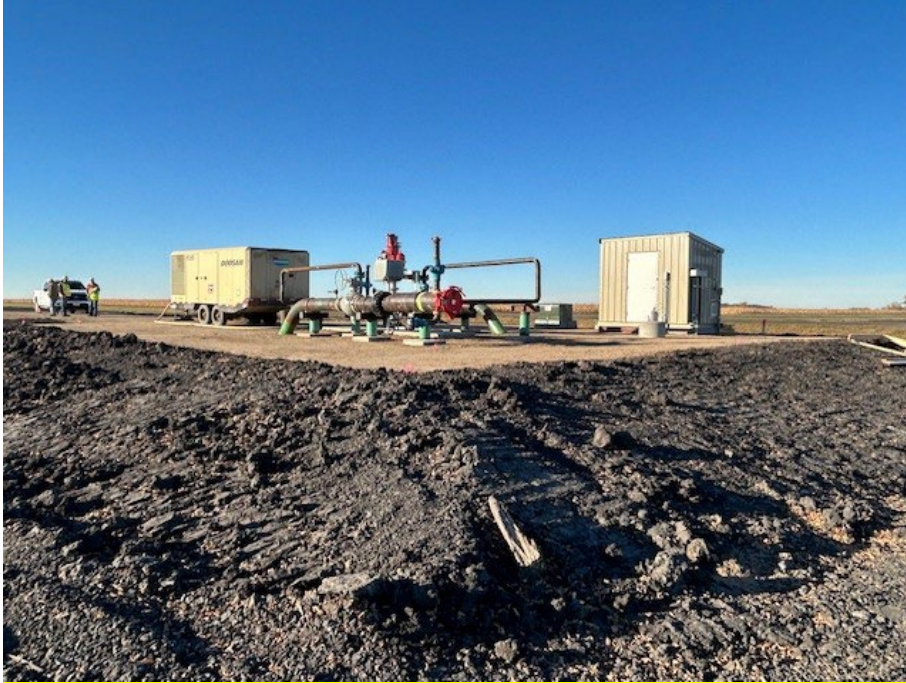
Photo No.: 7

Comments: Aboveground Facility, Valve Set #2. Construction of the valve set was complete, and electricity was installed but pending final connection. The site was stable with no environmental concerns identified.

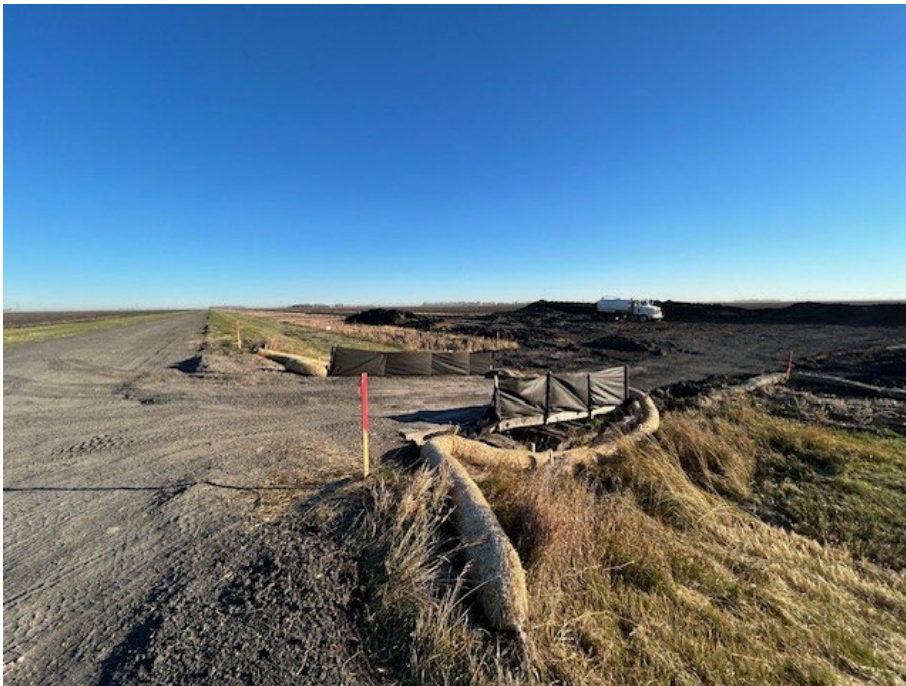
Photo No.: 8

Comments: Aboveground Facility, Valve Set #2 Site. Topsoil remained properly segregated, and all construction materials and activities were within well-marked workspace limits. Equipment mats at the construction entry point were well maintained, and the adjacent public road was free of tracked mud and construction debris. No environmental concerns were identified.

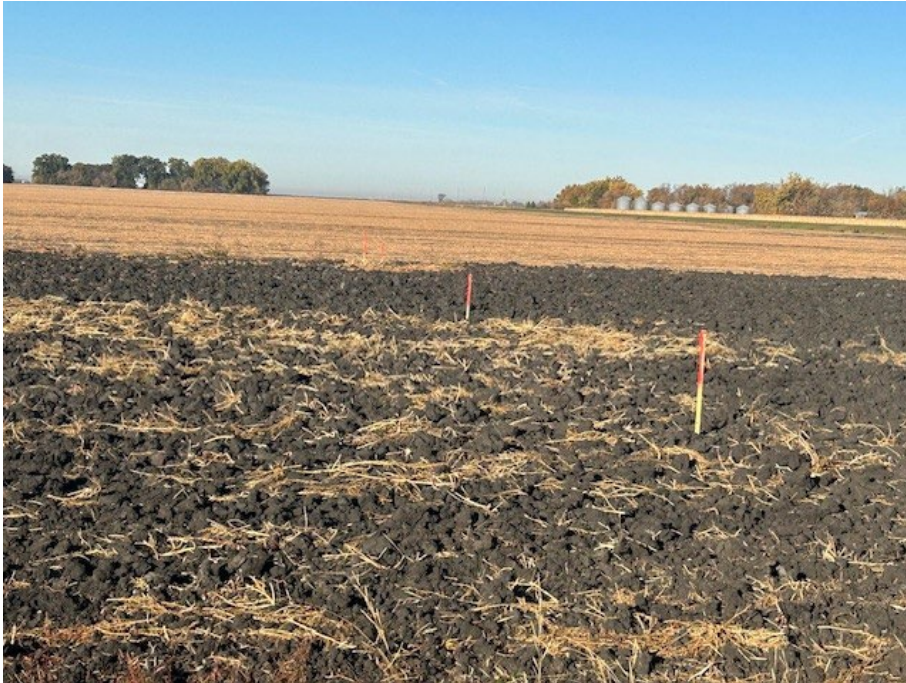
Photo No.: 9

Comments: Agricultural ROW. This section of ROW was final-graded by WBI but then later disked by the landowner. The ROW remained clearly staked, and no environmental concerns were identified.

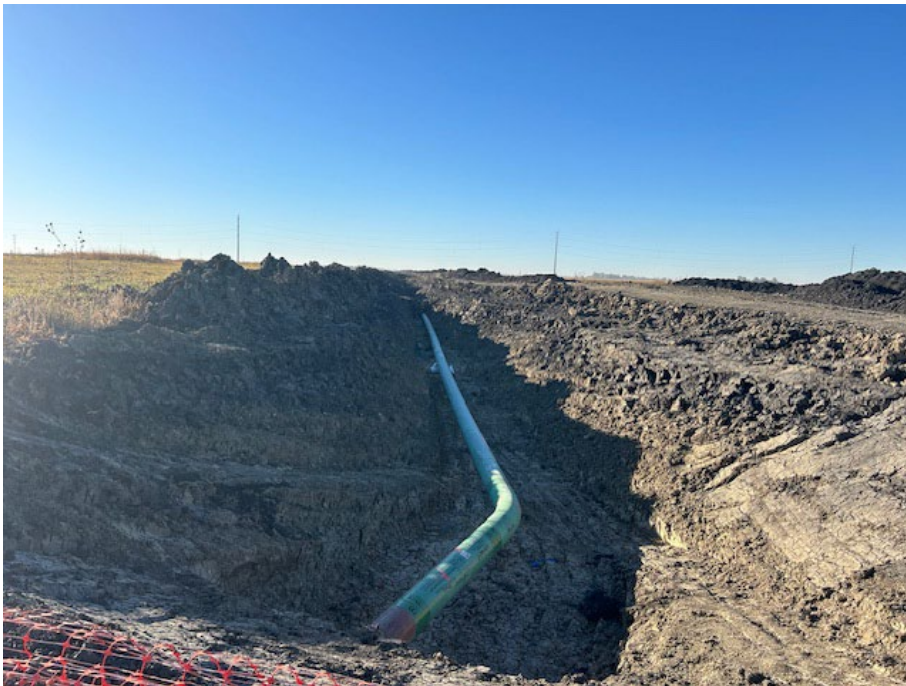
Photo No.: 10

Comments: Agricultural ROW, Bore #23 Site. The tie-in was complete with backfilling of the trench pending. Workspace limits were well marked, and resource identification signs remained in place (no photo). No environmental concerns were identified.

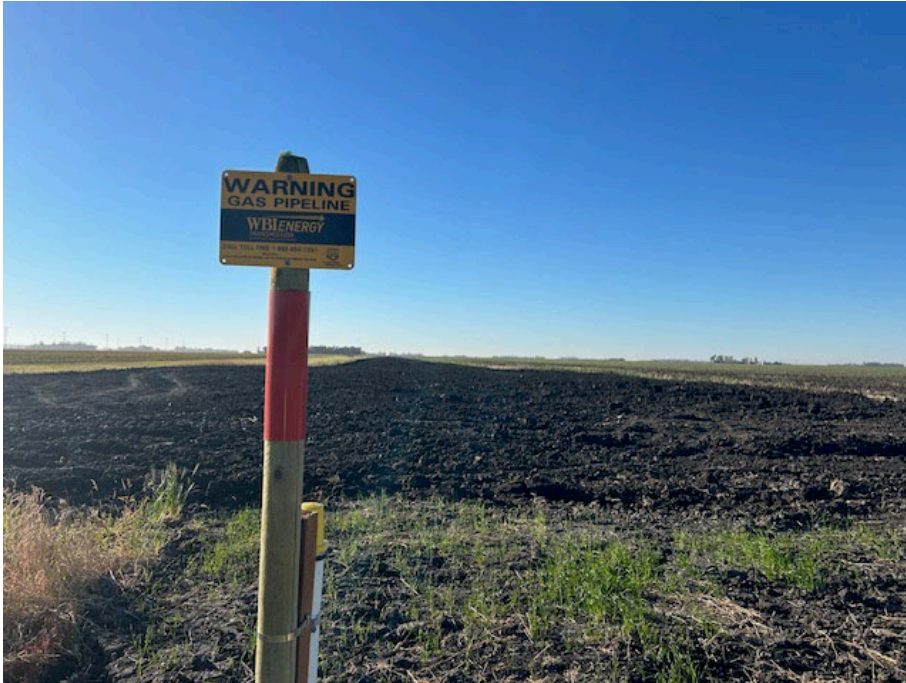
Photo No.: 11

Comments: Agricultural ROW, Bore #25 Site. The bore beneath the BNSF Railroad was complete, and the adjacent ROW was cleaned up and rough-graded. The entrance to the ROW from the public road was clearly staked and marked with signs. No environmental concerns were identified.

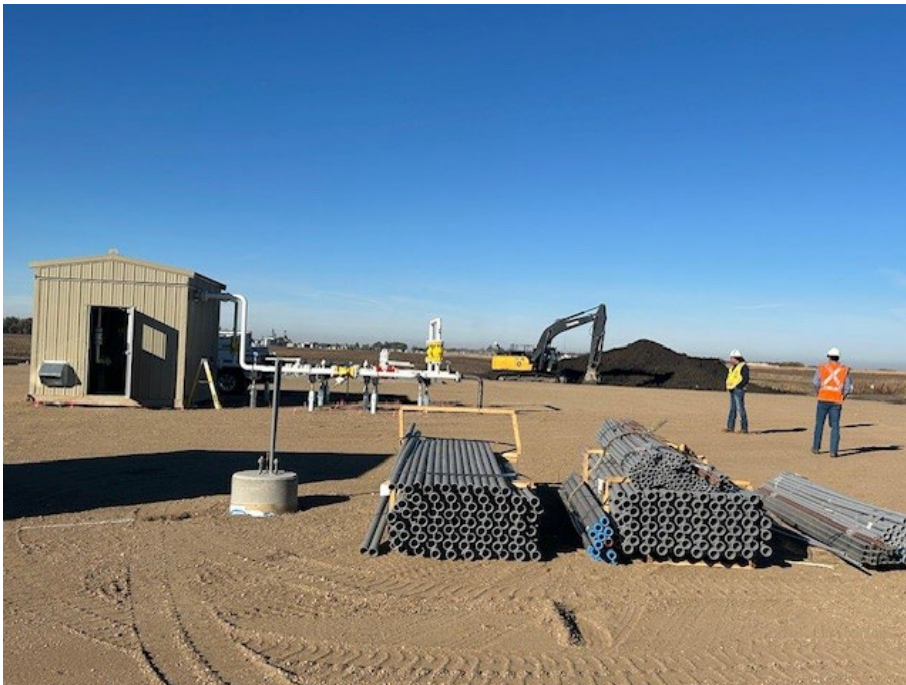
Photo No.: 12

Comments: Aboveground Facility, Valve Set #3, Kindred Border Station. The valve set and pad were complete. Fencing material was staged on the pad. Construction materials were within approved workspace limits, which were well marked with stakes and flagging. Topsoil was being returned to the ROW (backhoe in background). No environmental concerns were identified.

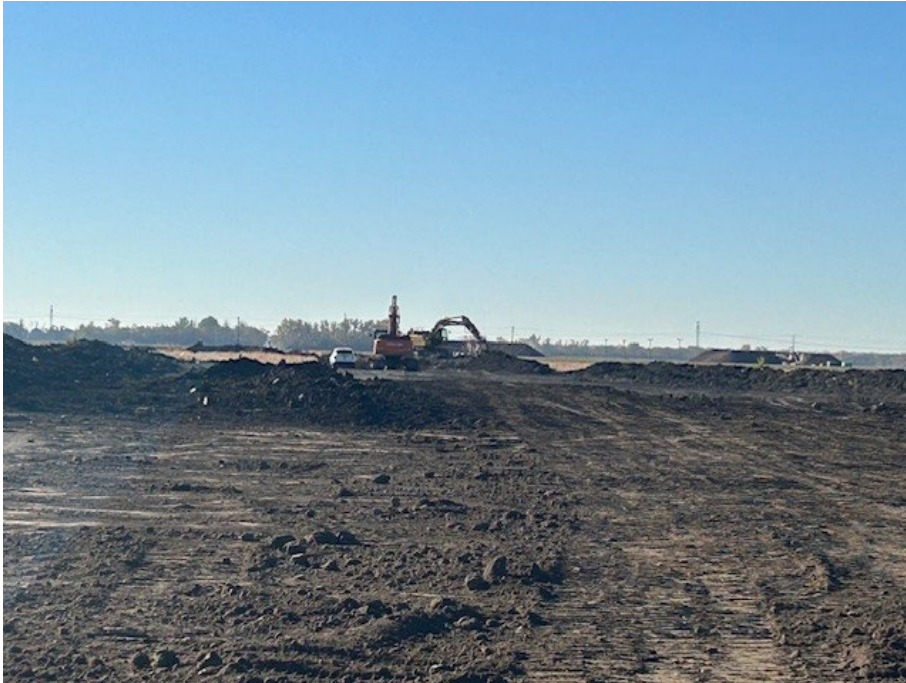
Photo No.: 13

Comments: Agricultural ROW. Adjacent to west side of the Bore #32 crossing beneath the Sheyenne River, backfilling was in progress. Workspace limits were well marked, and topsoil remained properly segregated and staged within workspace limits. Construction materials were staged within a temporary workspace approved by the FERC. No environmental concerns were identified.

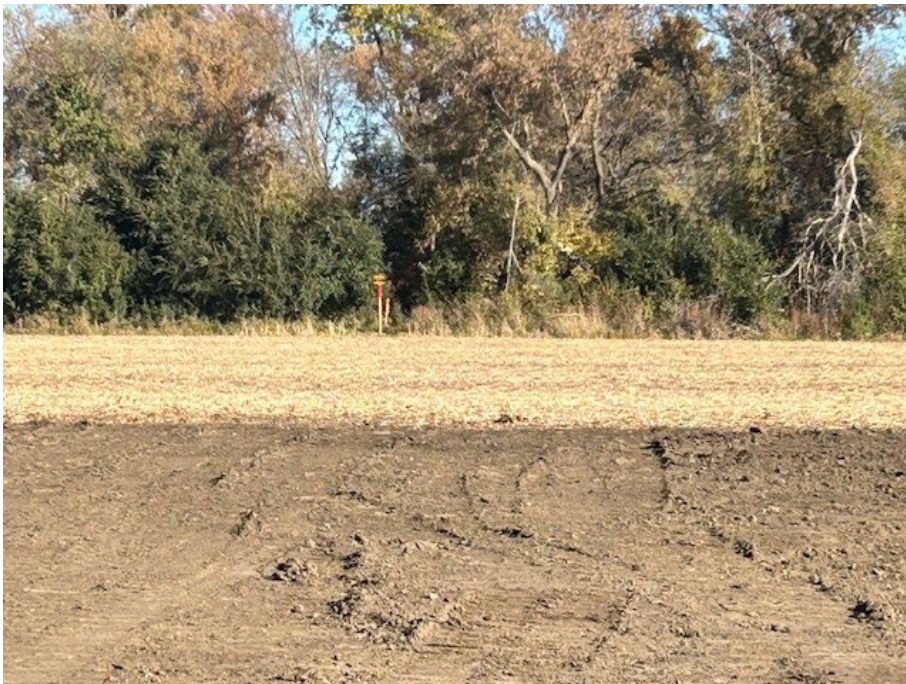
Photo No.: 14

Comments: Agricultural ROW. On the west side of the Bore #32 crossing, the ROW was pending final grading. Pipeline signs were installed near the river's bank. No environmental concerns were identified.

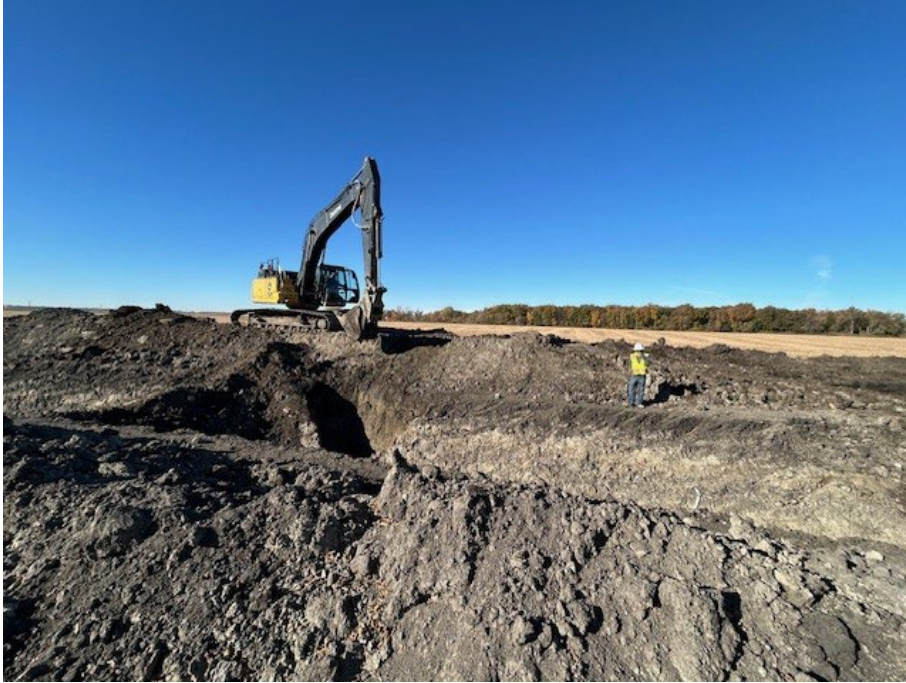
Photo No.: 15

Comments: Agricultural ROW. Backfilling was in-progress and spotters were present to monitor the work. No off-ROW impacts or other environmental concerns were identified.

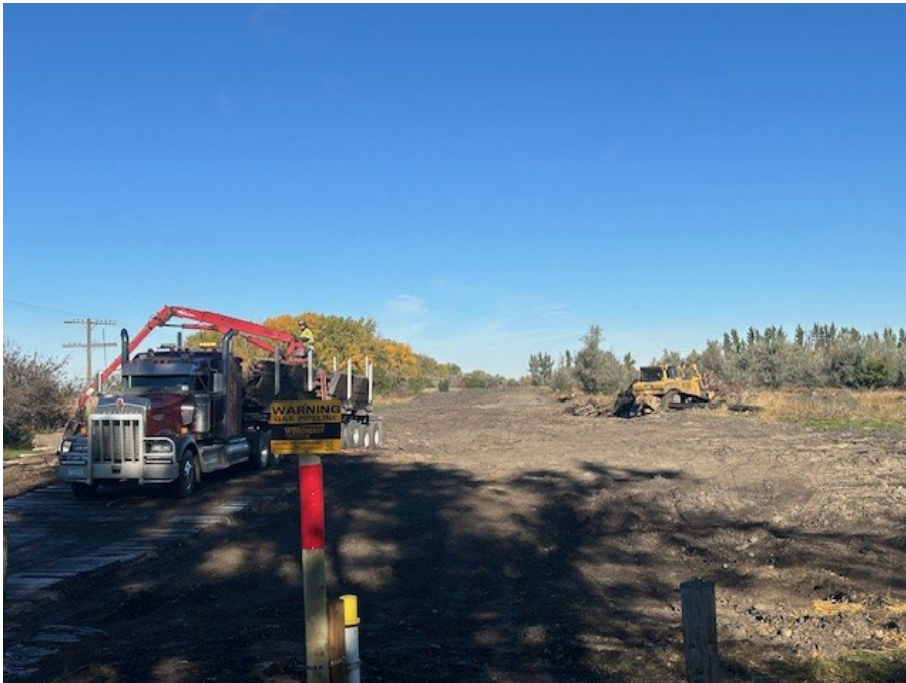
Photo No.: 16

Comments: Open ROW, Wetland Crossing. Equipment mats were being removed from the former sensitive resource area. All materials and equipment were within well-marked workspace limits. Resource protection signs remained in place along the wetland edge. No environmental concerns were identified.

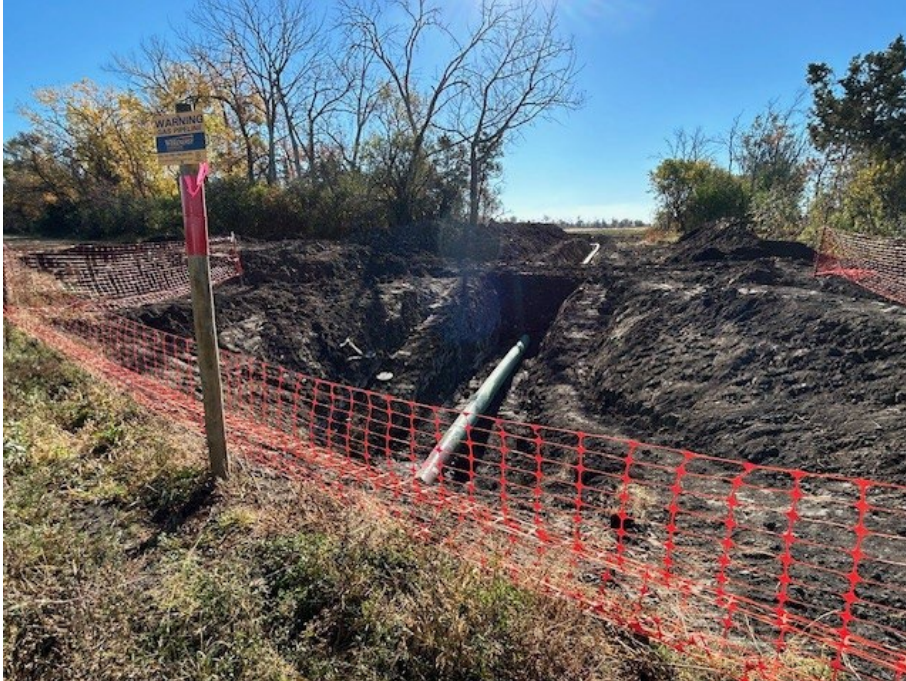
Photo No.: 17

Comments: Agricultural ROW, Bore #36 Site. Tie-in was complete with backfill pending. Workspace limits were well marked, and resource identification signs remained in place. No environmental concerns were identified.

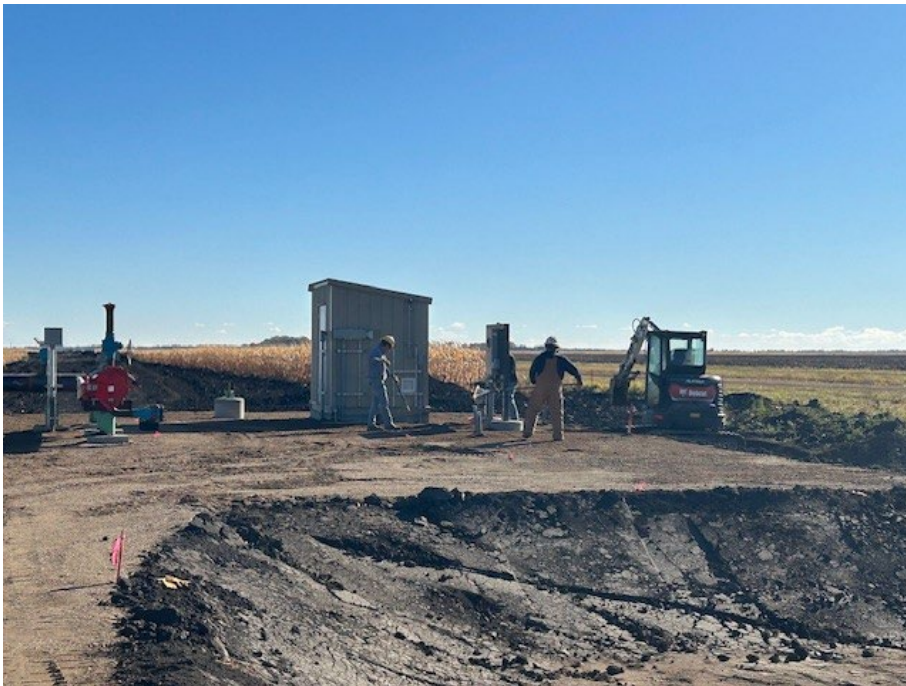
Photo No.: 18

Comments: Aboveground Facility, Valve Set #5 Site. Crews were backfilling the trench following the installation of electrical power. The ROW and valve site were stable and free of excessive rutting and erosion. Topsoil remained properly segregated and staged within workspace limits. The adjacent construction access point from the public road was well maintained, and the road was free of tracked mud and construction debris. No environmental concerns were identified.

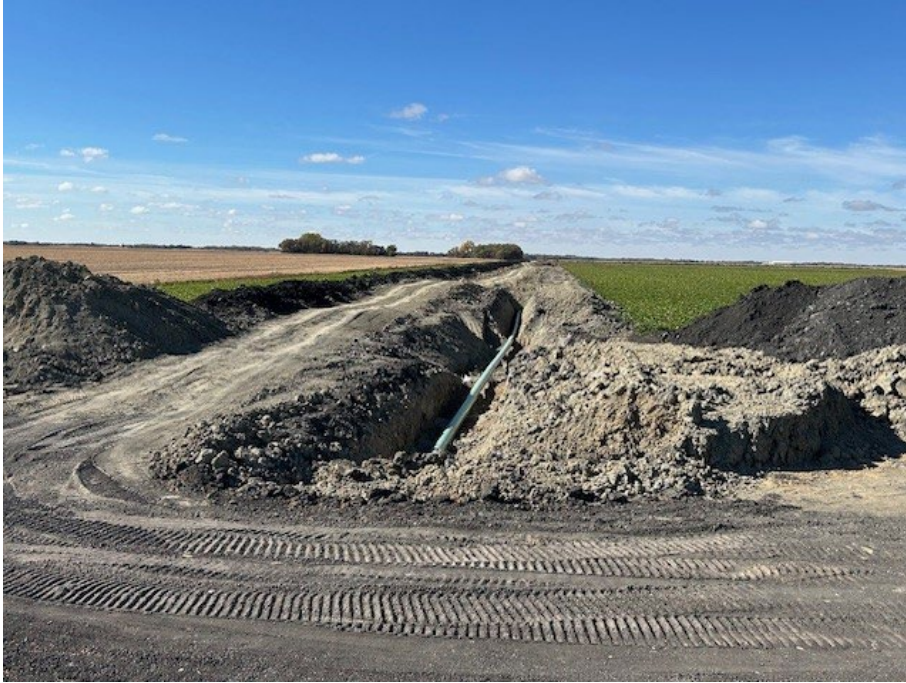
Photo No.: 19

Comments: Agricultural ROW. Tie-in with the Wahpeton Border Station was complete, and backfilling of the trench was pending. Topsoil remained properly segregated and staged along the ROW edge, and no off-ROW impacts or environmental concerns were identified.

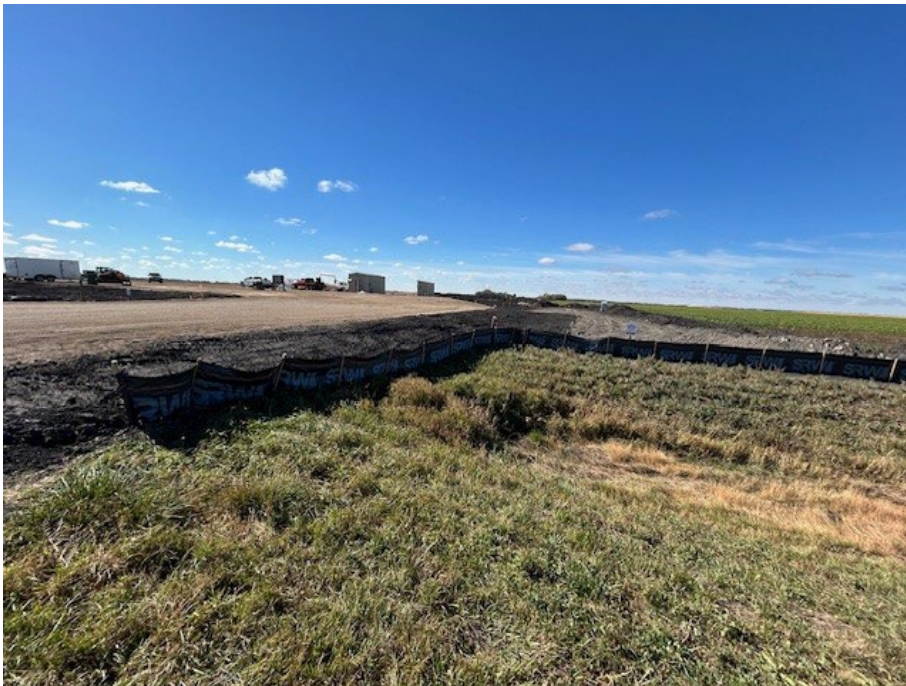
Photo No.: 20

Comments: Aboveground Facility, Wahpeton Border Station. The construction access point from the public road was well maintained, and the road was free of tracked mud and construction debris. The site was stable, and no environmental concerns were identified.

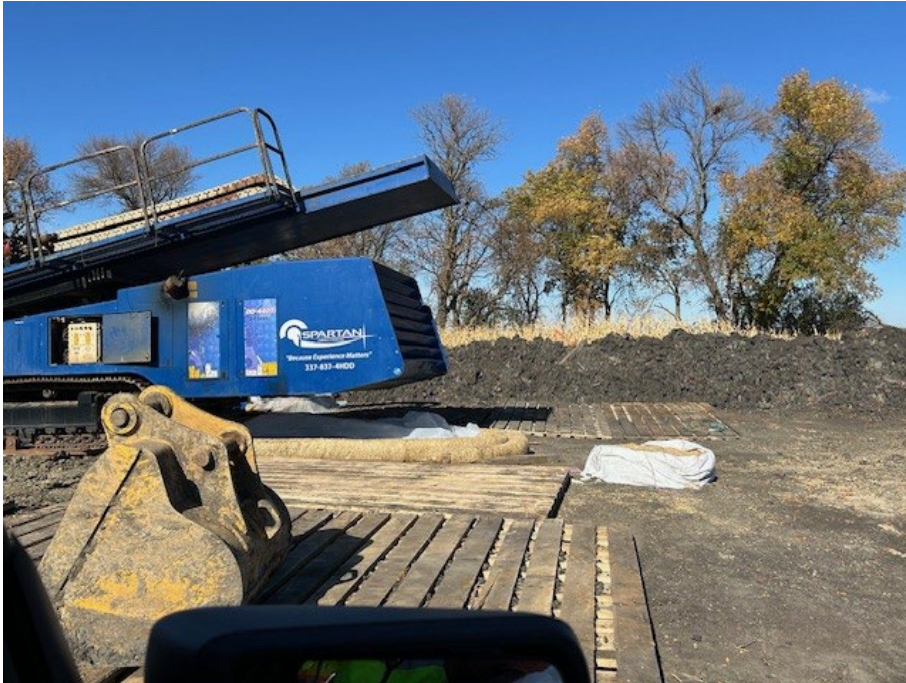
Photo No.: 21

Comments: Agricultural ROW, Bore #64 Site. Boring on the east side of the Wild Rice River HDD crossing was being initiated. All materials and equipment were within well-marked workspace limits. Hazardous materials and gas-operated pumps were stored within secondary containment, and spill kits were staged throughout the site. No environmental concerns were identified.

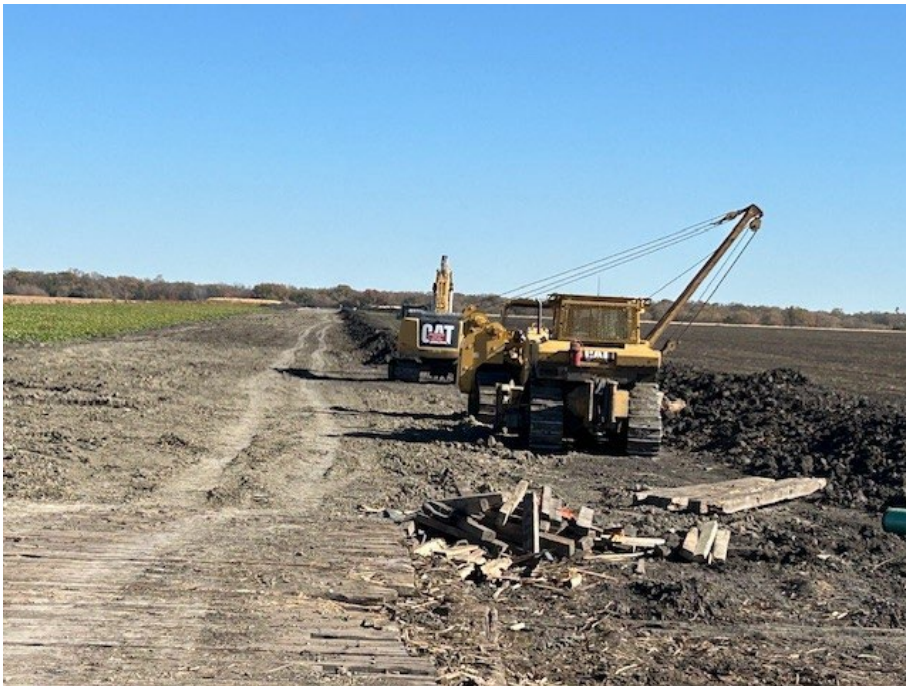
Photo No.: 22

Comments: Agricultural ROW. Adjacent to west side of the Bore #64 crossing beneath the Wild Rice River, tie-in equipment was staged on the ROW, pending completion of the bore crossing. No off-ROW impacts or environmental concerns were identified.
